**NYC Department of Education**  
**Building Condition Assessment Survey 2023 - 2024**

Architectural Inspection

Q247

**Asset:** P.S. /I.S. 128 - QUEENS, 69-10 65TH DRIVE, New York, 11379

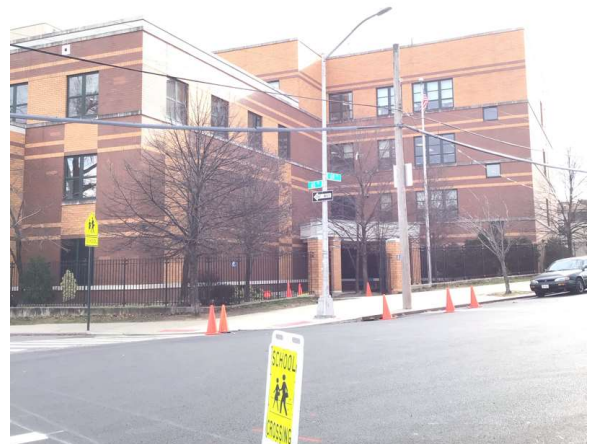
Corner of 69th Place and 65th Drive - Southeast View

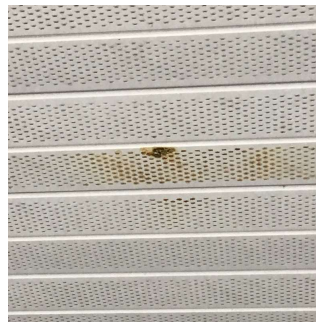
Facade A

Question	Response
<b>Architectural</b>	
<b>EXTERIOR</b>	Inspected
<b>AREAWAY</b>	Does not Exist
<b>AWNINGS AND CANOPIES</b>	Inspected
Condition	4 - Between Fair and Poor
Deficiency	METAL: DETERIORATION/DAMAGED/MISSING PIECES

10  
 S.F.  
 REPLACE  
 PRIORITY 4  
 LEVEL 2

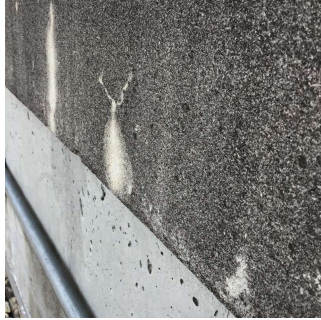
Violations	Facade A No violations recorded.
<b>CHIMNEY</b>	Inspected
Material Type(s)	Metal
Condition	2 - Between Good and Fair
Deficiency	No deficiencies recorded
<b>COPING</b>	Inspected
Condition	3 - Fair
Deficiency	CAST STONE: DISINTEGRATING / FREEZE THAW
Roof Plan reference	<p>Q247</p>

Deficiency Quantity	10
Quantity Uom	L.F.
Potential Action	REPLACE-IN-KIND
Urgency of Action	PRIORITY 4
Purpose of Action	LEVEL 2
Deficiency Photo1

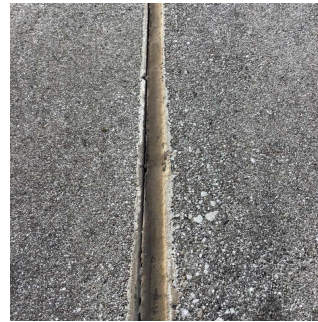
Violations	Roof 1 No violations recorded.
Deficiency	CAST STONE: DETERIORATED TRANSVERSE JOINTS

40  
L.F.  
MAINTENANCE  
PRIORITY 3  
LEVEL 2

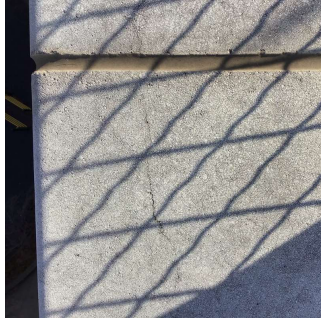
**CAST STONE: CRACKED/BROKEN PIECES**

15  
L.F.  
REPLACE-IN-KIND  
PRIORITY 4  
LEVEL 2

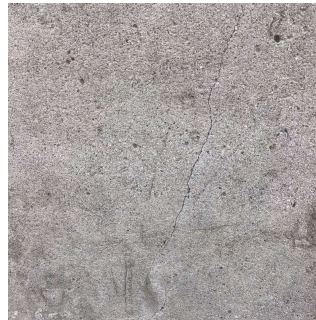
Roof 1  
 No violations recorded.

Question	Response
<b>EXTERIOR</b>	
<b>EXTERIOR WALLS</b>	
Elevation	 
Deficiency Quantity	20
Quantity Uom	S.F.
Potential Action	REPAIR
Urgency of Action	PRIORITY 3
Purpose of Action	LEVEL 2
Deficiency Photo1	 
Violations	Facade E No violations recorded.
<b>EXTERIOR SOFFITS</b>	Does not Exist
<b>LOADING DOCK</b>	Does not Exist
<b>LOUVER</b>	Inspected
Condition	2 - Between Good and Fair
Deficiency	No deficiencies recorded
<b>PARAPETS</b>	Inspected
Material Type(s)	Masonry, Concrete
Replacement Quantity	7,900
Replacement Uom	C.F.
Instance on 2020 Addition	Inspected
Instance Condition	1 - Good
Instance Quantity	1,900
Instance Quantity Uom	C.F.
Deficiency	No deficiencies recorded
Instance on Original Building	Inspected
Instance Condition	2 - Between Good and Fair
Instance Quantity	6,000
Instance Quantity Uom	C.F.
Deficiency	CONCRETE: MINOR CRACKS, SPALLING

15  
 S.F.  
 REPAIR  
 PRIORITY 3  
 LEVEL 2

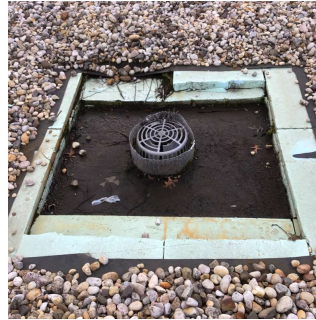
Roof 3

Installation Year	2009
Source of Installation	Custodial Staff
Deficiency	IRMA: ROOFING: LOSS OF GRAVEL
Roof Plan reference

MAINTENANCE  
 PRIORITY 3  
 LEVEL 2

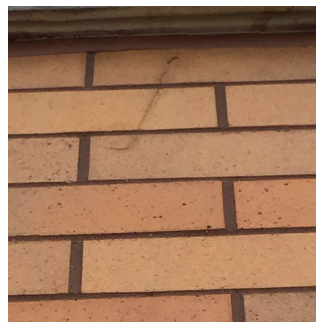
Violations	PH1 No violations recorded.
Deficiency	BULKHEAD/PENTHOUSE WALLS/EXTERIOR: CRACKS/SPALLING - MINOR

10  
 S.F.  
 REPAIR  
 PRIORITY 3  
 LEVEL 2

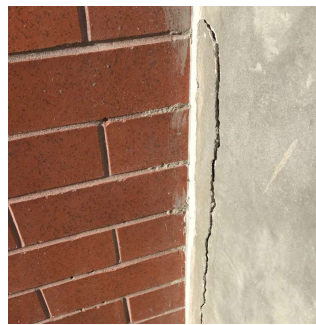
Facade E  
 No violations recorded.

<b>CUPOLA/ SPIRES/ TOWERS</b>	Does not Exist
<b>DORMER</b>	Does not Exist
<b>DUNNAGE STEEL</b>	Inspected
Condition	2 - Between Good and Fair
Deficiency	No deficiencies recorded
<b>SKYLIGHT/ROOF VENT</b>	Does not Exist
<b>ROOF/GRAVITY TANK</b>	Does not Exist
<b>STAIRS/RAMPS: EXTERIOR</b>	Inspected
<b>BUILDING CHEEK/FLANK WALLS</b>	Inspected
Condition	3 - Fair
Deficiency	CAST IN PLACE CONCRETE: CRACKS/SPALLING - MAJOR

15  
 S.F.  
 REPLACE  
 PRIORITY 4  
 LEVEL 2

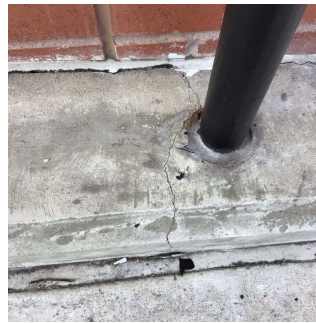
Facade E

CONCRETE: CRACKS/SPALLING - MAJOR

10  
 S.F.  
 REPLACE  
 PRIORITY 4  
 LEVEL 2

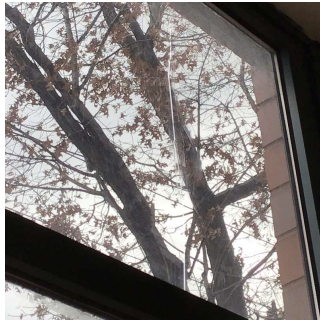
Material Type(s)	Inspected Aluminum
Instance on Aluminum - Other: 2020 Addition	Inspected
Instance Condition	1 - Good
Instance Quantity	2,000
Instance Quantity Uom	S.F.
Are these windows insulated	Yes
Installation Year	2020
Source of Installation	Custodial Staff
Deficiency	No deficiencies recorded
Instance on Aluminum - Other: Original Building	Inspected
Instance Condition	2 - Between Good and Fair
Instance Quantity	3,800
Instance Quantity Uom	S.F.
Are these windows insulated	Yes
Installation Year	2009
Source of Installation	Custodial Staff
Deficiency	ALUMINUM - OTHER: BROKEN PANE
Roof Plan reference	Q247

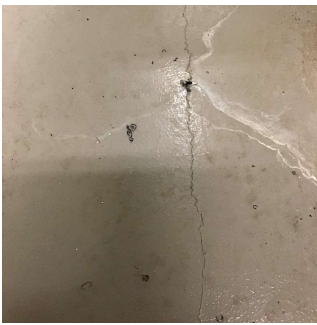
Violations	Basement - Room C17 No violations recorded.
Deficiency	CONCRETE SLAB ON GRADE: THRU CRACKS
Deficiency Location/Instance	Basement - Rooms C16, C14, C21C, C06A, C02A
Deficiency Quantity	40
Quantity Uom	S.F.
Potential Action	REPAIR
Urgency of Action	PRIORITY 3
Purpose of Action	LEVEL 5

Basement - Room C16
Violations	No violations recorded.
Deficiency	CONCRETE: CRACKS/SPALLED/REINFORCEMENT EXPOSED
Deficiency Location/Instance	PH1
Deficiency Quantity	10
Quantity Uom	S.F.
Potential Action	REPAIR
Urgency of Action	PRIORITY 3
Purpose of Action	LEVEL 5
Deficiency Photo1

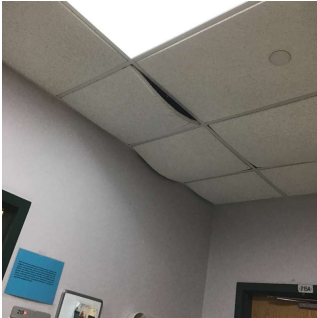
Deficiency	ACOUSTIC TILES: DAMAGED/MISSING
Deficiency Location/Instance	Room 206E, Corridor near Room 213

Corridor near Room 213
Violations	No violations recorded.
Deficiency	ACOUSTIC TILES: DAMAGED/MISSING
Deficiency Location/Instance	Rooms 125, 201, 310, 416, Corridor near Room 433G, and others.
Deficiency Quantity	200
Quantity Uom	S.F.
Potential Action	REPLACE
Urgency of Action	PRIORITY 3
Purpose of Action	LEVEL 2
Deficiency Photo1

Question	Response
<b>INTERIOR</b>	
<b>CLASSROOMS/CORRIDORS/ADMIN SPACES</b>	
<b>Ceiling</b>	
Deficiency Quantity	20
Quantity Uom	S.F.
Potential Action	REPLACE
Urgency of Action	PRIORITY 5
Purpose of Action	LEVEL 6
Deficiency Photo1

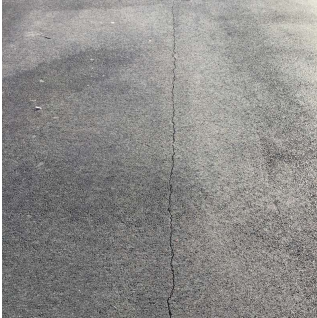
Question	Response
<b>SITE</b>	
<b>PAVING</b>	
<b>Student Use</b>	
<b>Asphalt</b>	
Deficiency Location/Instance	Schoolyard
Deficiency Quantity	200
Quantity Uom	S.F.
Potential Action	REPLACE
Urgency of Action	PRIORITY 3
Purpose of Action	LEVEL 2
Deficiency Photo1

Violations	Schoolyard No violations recorded.
<b>Concrete</b>	Does not Exist
<b>Pavers</b>	Does not Exist
<b>Site Sidewalks &amp; Walkways</b>	Inspected
<b>Asphalt</b>	Inspected
Condition	1 - Good
Deficiency	No deficiencies recorded
<b>Concrete</b>	Inspected
Condition	3 - Fair
Deficiency	DAMAGED/DETERIORATED/MISSING SECTIONS
Deficiency Location/Instance	Near Exits 1, 2
Deficiency Quantity	50
Quantity Uom	S.F.
Potential Action	REPLACE
Urgency of Action	PRIORITY 3
Purpose of Action	LEVEL 2
Deficiency Photo1

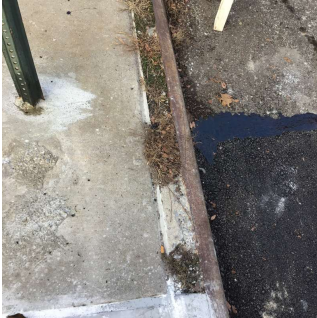
Juniper Valley
Violations	No violations recorded.
<b>Deficiency</b>	<b>DAMAGED CURBS</b>
Deficiency Location/Instance	65th Drive, 69th Street, 70th Street , juniper Valley Road.
Deficiency Quantity	60
Quantity Uom	L.F.
Potential Action	REPLACE
Urgency of Action	PRIORITY 3
Purpose of Action	LEVEL 2
Deficiency Photo1

65th Drive
Violations	No violations recorded.
<b>Pavers</b>	Does not Exist
<b>PLAYGROUNDS</b>	Inspected
Instance on Northeast Side of the Building	Inspected
<b>Benches</b>	
Instance on Northeast Side of the Building	Inspected

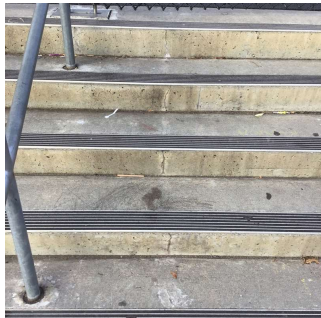
70th Street	
Violations	No violations recorded.

Deficiency Location/Instance	70th Street
Deficiency Quantity	10
Quantity Uom	S.F.
Potential Action	REPLACE
Urgency of Action	PRIORITY 3
Purpose of Action	LEVEL 2
Deficiency Photo1
