NYC Department of Education
Building Condition Assessment Survey 2023 - 2024

Architectural Inspection

Asset: P.S. 254 - QUEENS, 84-40 101ST STREET, New York, 11418

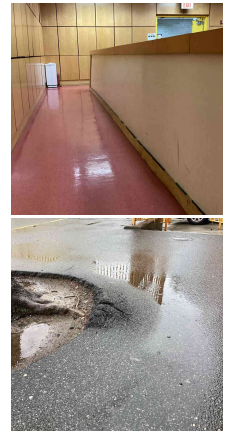
No	Potential Falling Debris	Unstable and leaning partial wall at Auditorium ramp is a potential safety hazard.	INTERIOR AUDITORIUM Walls	Left Side near Ramp	Jason Ramos	Fireman
No	Tripping Hazard	Severely heaving asphalt pavement is a potential tripping hazard.	SITE PAVING Student Use Asphalt	Schoolyard	Jason Ramos	Fireman

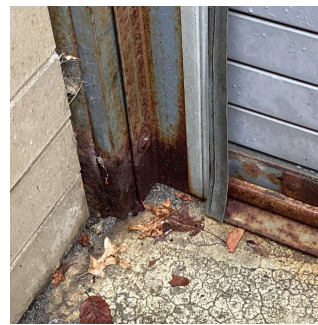
Facade D
No violations recorded.

ROLL-UP DOOR: DETERIORATED DOOR AND FRAME - MAJOR DETERIORATION

600
S.F.
REPLACE
PRIORITY 4
LEVEL 2

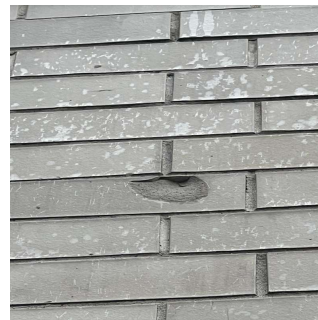
Facade B

Deficiency Quantity	10
Quantity Uom	S.F.
Potential Action	MAINTENANCE
Urgency of Action	PRIORITY 3
Purpose of Action	LEVEL 2
Deficiency Photo1	No photo recorded
Violations	No violations recorded.
EXTERIOR WALLS	Inspected
Material Type(s)	Masonry
Replacement Quantity	39,000
Replacement Uom	S.F.
Instance on All Facades	Inspected
Instance Condition	4 - Between Fair and Poor
Instance Quantity	39,000
Instance Quantity Uom	S.F.
Deficiency	BRICK: MINOR CRACKS AND SPALLING

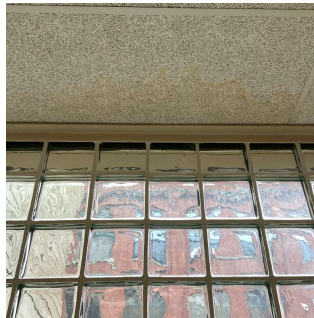
Facade D - Corridor near Stair D/2 (Facade A - Stair C/2, C/3, C/4, D/2, similar throughout glass block walls)

GLASS BLOCK: WATER INFILTRATION IN INSTRUCTIONAL SPACE

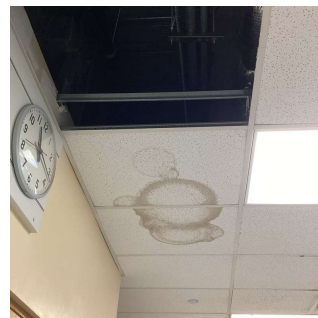
Roof 1 - Room 406 (Roof 2 - Corridor near Stair C/4 similar)
No violations recorded.

**MODIFIED BITUMEN: ROOFING: MAJOR ACTIVE ROOF
LEAKS IN INSTRUCTIONAL SPACE**

200
S.F.
REPLACE ROOFING WITHOUT MAJOR EQUIPMENT
REMOVAL
PRIORITY 5
LEVEL 2

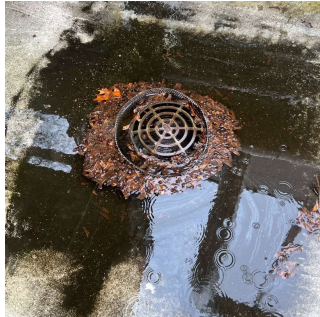
<p>Roof 1</p> <p>No violations recorded.</p>
ROOFING DRAINS	
<p>Condition</p>	<p>Inspected</p>
<p>Deficiency</p>	<p>5 - Poor</p>
<p>Roof Plan reference</p>	<p>CLOGGED</p>
<p>Deficiency Quantity</p> <p>Quantity Uom</p> <p>Potential Action</p> <p>Urgency of Action</p> <p>Purpose of Action</p>

Violations	Roof 6 No violations recorded.
Specialties	Inspected
BULKHEAD/PENTHOUSE	Inspected
Condition	3 - Fair
Deficiency	BULKHEAD/PENTHOUSE WALLS/EXTERIOR: DETERIORATED JOINTS
Roof Plan reference

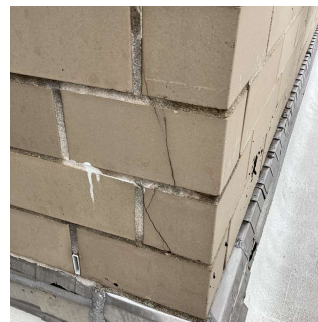
Violations	BH No violations recorded.
Deficiency	BULKHEAD/PENTHOUSE WALLS/EXTERIOR: CRACKS/SPALLING - MINOR

20
S.F.
REPAIR
PRIORITY 3
LEVEL 2

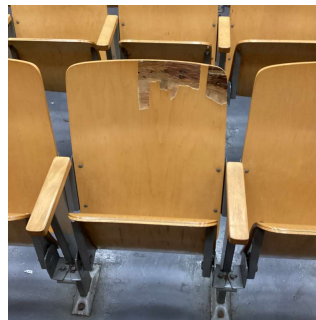
Seat B/9

Deficiency	DAMAGED/BROKEN/INOPERABLE
Deficiency Location/Instance	Seats A/16, B/9, 22, D/4, F/22 and others
Deficiency Quantity	12
Quantity Uom	EACH
Potential Action	REPLACE
Urgency of Action	PRIORITY 3
Purpose of Action	LEVEL 2
Deficiency Photo1

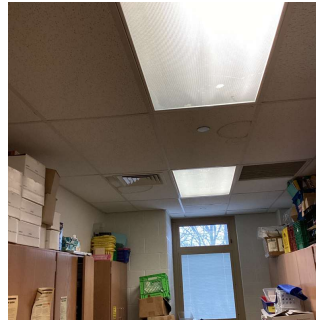
Room 413A

Question	Response
INTERIOR	
CLASSROOMS/CORRIDORS/ADMIN SPACES	
Ceiling	
Condition	2 - Between Good and Fair
Deficiency	TECTUM: DAMAGED/MISSING - ACTIVE LEAK
Deficiency Location/Instance	Corridor near Stair D/2
Deficiency Quantity	10
Quantity Uom	S.F.
Potential Action	REPLACE
Urgency of Action	PRIORITY 5
Purpose of Action	LEVEL 2
Deficiency Photo1	 
Violations	Corridor near Stair D/2 No violations recorded.
Deficiency	TECTUM: DAMAGED/MISSING
Deficiency Location/Instance	Corridor near Room 415, Corridor near Stair D/3
Deficiency Quantity	20
Quantity Uom	S.F.
Potential Action	REPLACE
Urgency of Action	PRIORITY 3
Purpose of Action	LEVEL 2
Deficiency Photo1	 
Violations	Corridor near Room 415 No violations recorded.
Deficiency	ACOUSTIC TILES: DAMAGED/MISSING
Deficiency Location/Instance	Rooms 413A, 412, 319, 301, Corridor near Room 102 and others
Deficiency Quantity	160
Quantity Uom	S.F.
Potential Action	REPLACE
Urgency of Action	PRIORITY 3

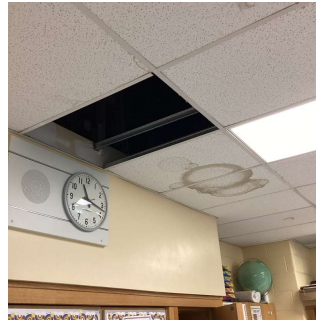
Room 406

ACOUSTIC TILES: DAMAGED/MISSING - ACTIVE LEAK

REPLACE

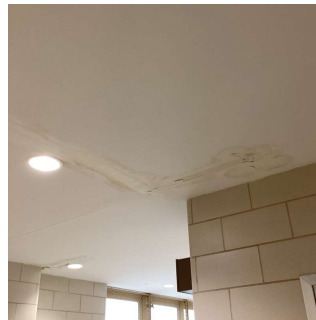
Corridor near Stair C/4

GYPSUM BOARD: DAMAGED/DETERIORATED - ACTIVE LEAK

REPLACE

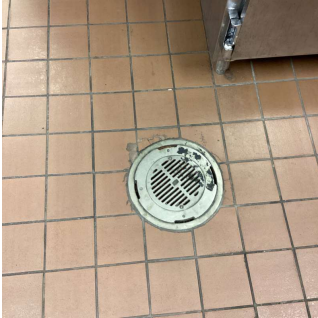
Violations	Serving area No violations recorded.

Instance on 1st Floor	Inspected
Condition	2 - Between Good and Fair
Deficiency	QUARRY TILE: BROKEN/MISSING TILES
Deficiency Location/Instance	Serving area
Deficiency Quantity	10
Quantity Uom	S.F.
Potential Action	REPLACE
Urgency of Action	PRIORITY 3
Purpose of Action	LEVEL 2
Deficiency Photo1

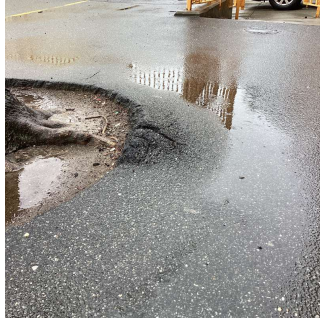
Violations	Schoolyard No violations recorded.
Deficiency	CRACKS - MAJOR
Deficiency Location/Instance	Schoolyard
Deficiency Quantity	700
Quantity Uom	S.F.
Potential Action	REPLACE
Urgency of Action	PRIORITY 3
Purpose of Action	LEVEL 2

Violations	Driveway near Schoolyard No violations recorded.
Pavers	Inspected
Condition	2 - Between Good and Fair
Deficiency	No deficiencies recorded
Student Use	Inspected
Gravel Exists?	No
Asphalt	Inspected
Condition	4 - Between Fair and Poor
Deficiency	HEAVING
Deficiency Location/Instance	Schoolyard
Deficiency Quantity	10
Quantity Uom	S.F.
Potential Action	REPLACE
Urgency of Action	PRIORITY 5
Purpose of Action	LEVEL 6
Deficiency Photo1

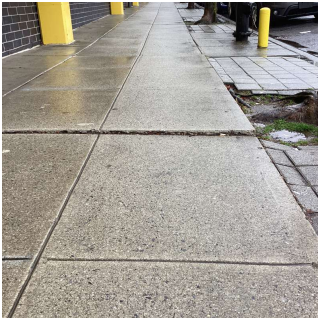
Violations	Exit 1 No violations recorded.
Pavers	Does not Exist
DOT Sidewalk	Inspected
Asphalt	Does not Exist
Concrete	Inspected
Condition	3 - Fair
Deficiency	HEAVING
Deficiency Location/Instance	101th Street
Deficiency Quantity	50

101th Street
Violations	No violations recorded.
Deficiency	DAMAGED/DETERIORATED/MISSING SECTIONS
Deficiency Location/Instance	101th Street
Deficiency Quantity	350
Quantity Uom	S.F.
Potential Action	REPLACE
Urgency of Action	PRIORITY 3
Purpose of Action	LEVEL 2
Deficiency Photo1

Question	Response
SITE	
PAVING	
DOT Sidewalk	
Concrete	
Quantity Uom	S.F.
Potential Action	REPLACE
Urgency of Action	PRIORITY 3
Purpose of Action	LEVEL 2
Deficiency Photo1

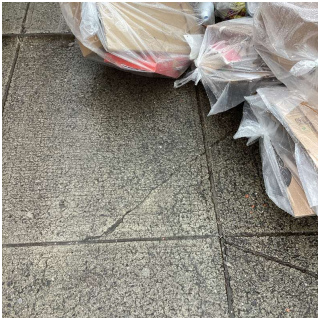
101th Street
Violations	No violations recorded.
Pavers	Inspected
Condition	3 - Fair
Deficiency	HEAVING
Deficiency Location/Instance	101th Street
Deficiency Quantity	100
Quantity Uom	S.F.
Potential Action	REPLACE
Urgency of Action	PRIORITY 3
Purpose of Action	LEVEL 2

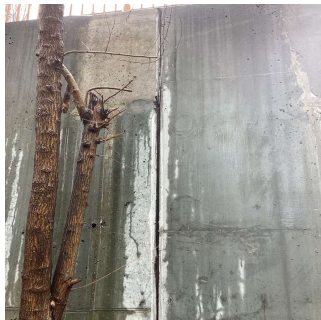
Violations	Near Playground No violations recorded.
Deficiency	CAST IN PLACE CONCRETE: DETERIORATED CONTROL/EXPANSION JOINT
Deficiency Location/Instance	Near Playground
Deficiency Quantity	10
Quantity Uom	L.F.
Potential Action	REPLACE
Urgency of Action	PRIORITY 3
Purpose of Action	LEVEL 2
Deficiency Photo1

Violations	Near Playground No violations recorded.
STAIRS/RAMPS: EXTERIOR	
	Inspected
Railings	
	Inspected
Condition	2 - Between Good and Fair
Deficiency	No deficiencies recorded
Site Cheek/flank Walls	
	Inspected
Condition	2 - Between Good and Fair
Deficiency	No deficiencies recorded
Stairs/ramps	
	Inspected
Condition	2 - Between Good and Fair
Deficiency	No deficiencies recorded
ARTWORK	
	Inspected
Instance	Interior - Entrance Lobby - 10039
Instance Photo
