NYC Department of Education
Building Condition Assessment Survey 2023 - 2024

Architectural Inspection

Q260

Asset: P.S. 307- QUEENS, 40-20 100TH STREET, New York, 11368

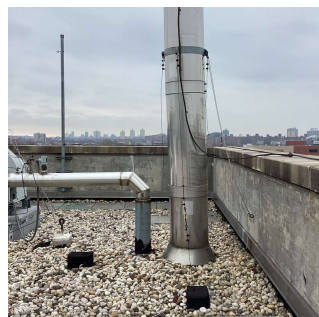
Question	Response
EXTERIOR	
CHIMNEY	
Condition	5 - Poor
Deficiency	METAL: LOOSE OR MISSING SUPPORTS
Roof Plan reference

Deficiency Quantity	3
Quantity Uom	EACH
Potential Action	REPLACE
Urgency of Action	PRIORITY 5
Purpose of Action	LEVEL 6
Deficiency Photo1

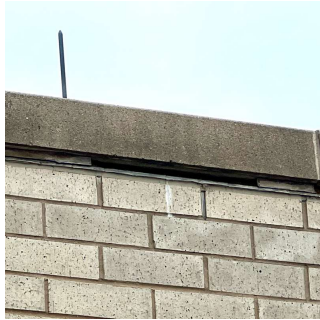
Violations	CH2 No violations recorded.
COPING	
Condition	Inspected
Condition	3 - Fair
Deficiency	CAST STONE: DETERIORATED BED JOINT
Roof Plan reference

Deficiency Quantity	50
Quantity Uom	L.F.
Potential Action	REPOINT
Urgency of Action	PRIORITY 3
Purpose of Action	LEVEL 2

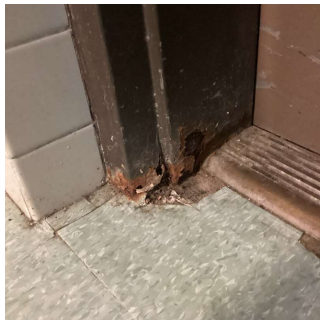
Violations	PH No violations recorded.
CORNICE	Does not Exist
DOORS	Inspected
DOORS AND FRAMES	Inspected
Condition	4 - Between Fair and Poor
Deficiency	METAL: DETERIORATED DOOR AND FRAME - MAJOR DETERIORATION
Roof Plan reference	 
Deficiency Quantity	3
Quantity Uom	EACH
Potential Action	REPLACE
Urgency of Action	PRIORITY 4
Purpose of Action	LEVEL 2
Deficiency Photo1

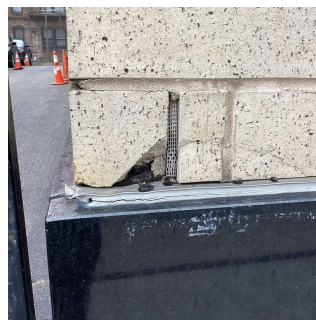
Facade A

BRICK: MAJOR / THRU CRACKS

10
S.F.
REMOVE AND REBUILD
PRIORITY 4
LEVEL 2

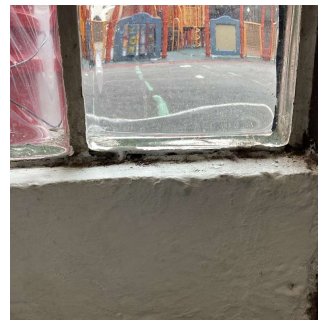
Facade D

GLASS BLOCK: DETERIORATED JOINTS

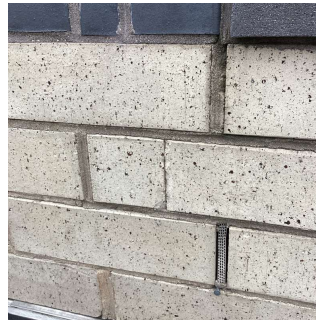
Facade A

BRICK: MINOR CRACKS AND SPALLING

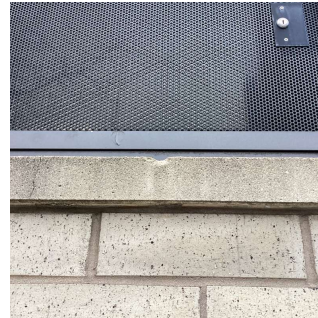
Facade A

BRICK: DETERIORATED MASONRY SILLS - MINOR

PRIORITY 3
LEVEL 2

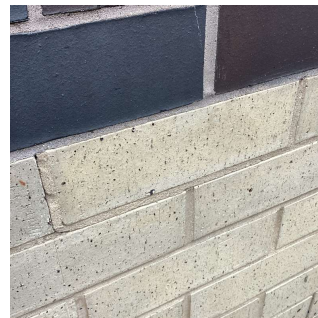
Facade C

BRICK: DETERIORATED JOINTS

100
S.F.
REPOINT
PRIORITY 3
LEVEL 2

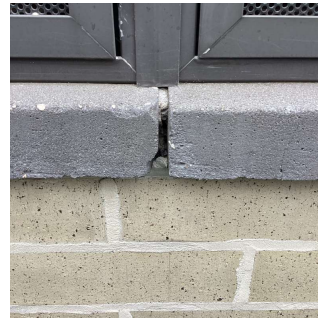
Facade C

BRICK: MASONRY SILLS - DETERIORATED JOINTS

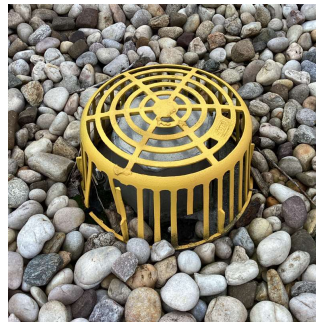
Roof 1

DETERIORATED

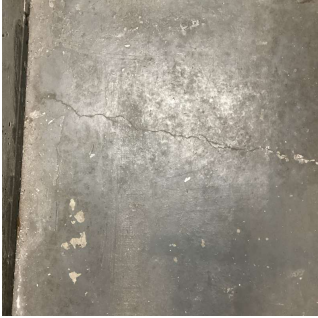
Question	Response
INTERIOR	
STRUCTURAL	
FLOOR STRUCTURE	
Potential Action	REPAIR
Urgency of Action	PRIORITY 3
Purpose of Action	LEVEL 5
Deficiency Photo1

Basement - Room B116
Violations	No violations recorded.
FOUNDATION WALLS	
Material Type(s)	Inspected Concrete
Condition	2 - Between Good and Fair
Deficiency	No deficiencies recorded
ROOF STRUCTURE	
Condition	Inspected 2 - Between Good and Fair
Deficiency	No deficiencies recorded
VAULTS-BUNKERS	
	Does not Exist
AUDITORIUM	
Instance on 1st Floor (342 Seats)	Inspected
Ceiling	
Instance on 1st Floor (342 Seats)	Inspected
Condition	2 - Between Good and Fair
Deficiency	No deficiencies recorded
Door(s)	
Instance on 1st Floor (342 Seats)	Inspected
Condition	2 - Between Good and Fair
Deficiency	No deficiencies recorded
Fixed H/C Lift	
Instance on 1st Floor (342 Seats)	Does not Exist
Fixed Seating	
Instance on 1st Floor (342 Seats)	Inspected
Condition	2 - Between Good and Fair

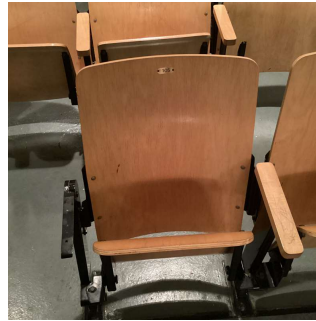
Seat A/105

Deficiency	DAMAGED/BROKEN/INOPERABLE
Deficiency Location/Instance	Seats A/105, B/108
Deficiency Quantity	2
Quantity Uom	EACH
Potential Action	REPLACE
Urgency of Action	PRIORITY 5
Purpose of Action	LEVEL 6

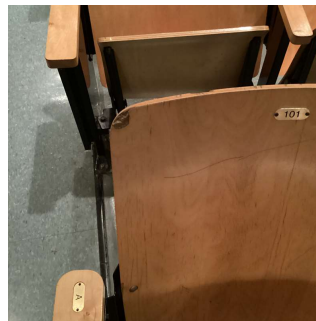
Seat A/101

DAMAGED/BROKEN/INOPERABLE

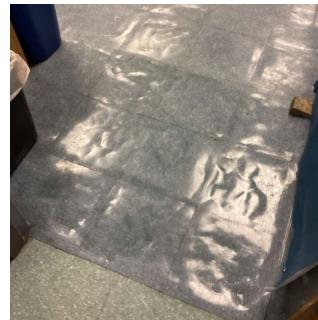
Room 215

VINYL TILES: DETERIORATED SUBSTRATE
Corridor near Stair A/3, 2, Room 215, Corridor near Room B102
40
S.F.
REPLACE
PRIORITY 3
LEVEL 2

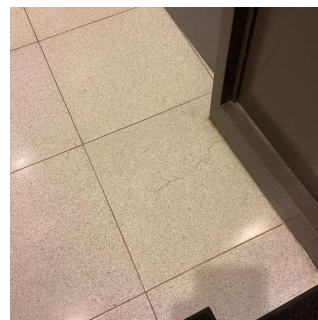
CERAMIC TILE: BROKEN/MISSING TILES
Corridor Near Exit 1, Corridor near Cafeteria
20
S.F.
REPLACE
PRIORITY 3
LEVEL 2

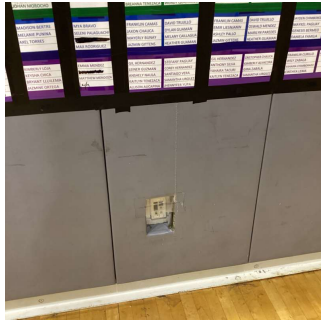
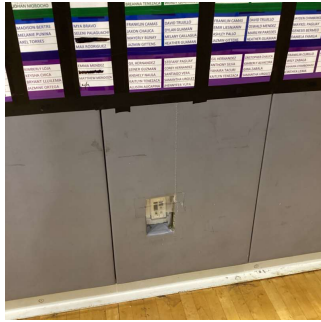
Deficiency	WALL PADDING: DETERIORATED
Deficiency Location/Instance	Near Locker Room
Deficiency Quantity	40
Quantity Uom	S.F.
Potential Action	REPLACE
Urgency of Action	PRIORITY 3
Purpose of Action	LEVEL 2
Deficiency Photo1

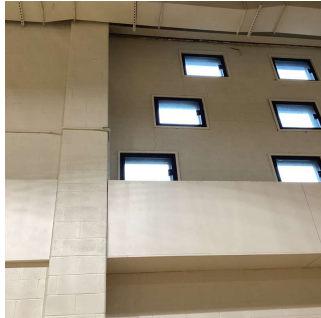
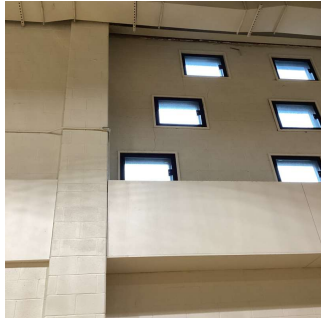
Left Side

Deficiency	MASONRY: CRACKS/SPALLING
Deficiency Location/Instance	Left Side, Near Locker Room
Deficiency Quantity	20
Quantity Uom	S.F.
Potential Action	REPLACE
Urgency of Action	PRIORITY 3
Purpose of Action	LEVEL 2
Deficiency Photo1

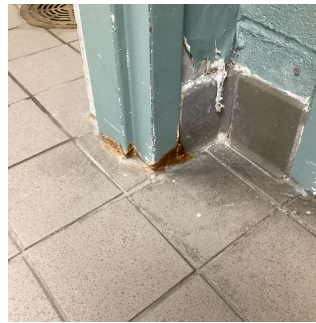
Violations	Near Prep area No violations recorded.
Door(s)	
Instance on 1st Floor	Inspected
Condition	3 - Fair
Deficiency	METAL: DETERIORATED DOOR AND FRAME
Deficiency Location/Instance	Room 132B
Deficiency Quantity	1
Quantity Uom	EACH

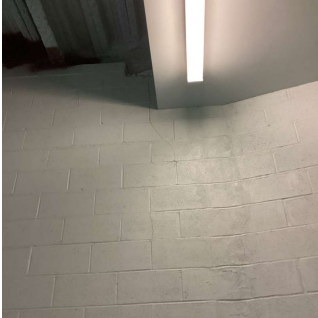
Question	Response
INTERIOR	
STAIRS/RAMPS: INTERIOR	
Walls	
Condition	2 - Between Good and Fair
Deficiency	MASONRY: CRACKS/SPALLING
Deficiency Location/Instance	Stair A/5
Deficiency Quantity	10
Quantity Uom	S.F.
Potential Action	REPLACE
Urgency of Action	PRIORITY 3
Purpose of Action	LEVEL 2
Deficiency Photo1

Violations	Stair A/5 No violations recorded.
TOILET ROOMS - STAFF	
Ceiling	
Condition	Inspected
Condition	2 - Between Good and Fair
Deficiency	ACOUSTIC TILES: DAMAGED/MISSING
Deficiency Location/Instance	Room 224
Deficiency Quantity	10
Quantity Uom	S.F.
Potential Action	REPLACE
Urgency of Action	PRIORITY 3
Purpose of Action	LEVEL 2
Deficiency Photo1

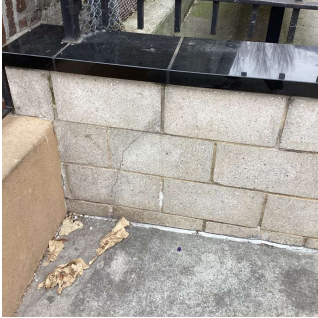
Violations	100th Street No violations recorded.
Deficiency	MASONRY UNIT: CRACKS/SPALLING - MAJOR
Deficiency Location/Instance	100th Street

Question	Response
SITE	
RETAINING WALLS	
Potential Action	REPLACE
Urgency of Action	PRIORITY 3
Purpose of Action	LEVEL 2
Deficiency Photo1

100th Street
Violations	No violations recorded.
SEATING	Inspected
Benches	Inspected
Concrete	Does not Exist
Metal/Wood/Plastic	Inspected
Condition	5 - Poor
Deficiency	DAMAGED/DETERIORATED
Deficiency Location/Instance	Near Main Entrance
Deficiency Quantity	4
Quantity Uom	EACH
Potential Action	REPLACE
Urgency of Action	PRIORITY 3
Purpose of Action	LEVEL 2
Deficiency Photo1
