NYC Department of Education
Building Condition Assessment Survey 2023 - 2024

Architectural Inspection

Q262

Asset: P.S. 262 - QUEENS, 95-16 89TH AVENUE, New York, 11421

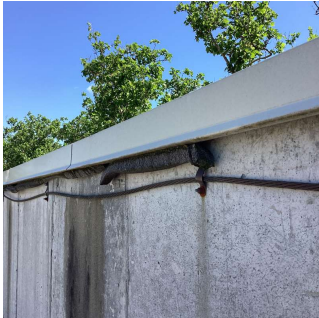
Question	Response
Architectural	
EXTERIOR	Inspected
AREAWAY	Does not Exist
AWNINGS AND CANOPIES	Inspected
Condition	2 - Between Good and Fair
Deficiency	No deficiencies recorded
CHIMNEY	Does not Exist
COPING	Inspected
Condition	2 - Between Good and Fair
Deficiency	METAL: DETERIORATED JOINTS
Roof Plan reference

Deficiency Quantity	30
Quantity Uom	L.F.
Potential Action	REPAIR
Urgency of Action	PRIORITY 3
Purpose of Action	LEVEL 2

Violations	Roof 1 No violations recorded.
CORNICE	Does not Exist
DOORS	Inspected
DOORS AND FRAMES	Inspected
Condition	3 - Fair
Deficiency	ROLL-UP DOOR: DETERIORATED DOOR AND FRAME - MINOR DETERIORATION
Roof Plan reference

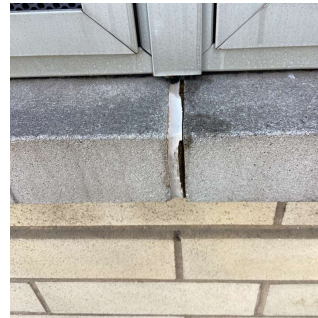
Question	Response
EXTERIOR	
EXTERIOR WALLS	
Instance Condition	3 - Fair
Instance Quantity	30,000
Instance Quantity Uom	S.F.
Deficiency	BRICK: DETERIORATED MASONRY SILLS - MINOR
Roof Plan reference	<p>Q262</p>
Elevation	
Deficiency Quantity	10
Quantity Uom	L.F.
Potential Action	REPAIR
Urgency of Action	PRIORITY 3
Purpose of Action	LEVEL 2
Deficiency Photo1	
Violations	Facade E No violations recorded.
Deficiency	BRICK: MASONRY SILLS - DETERIORATED JOINTS

REPOINT

PRIORITY 3

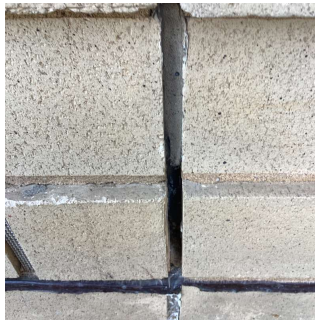
Facade E

BRICK: DETERIORATED CONTROL/EXPANSION JOINTS

MAINTENANCE

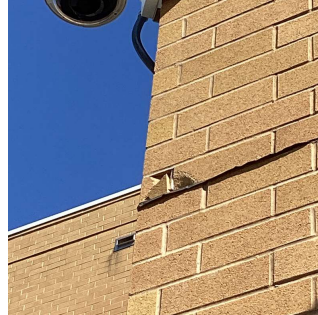
Facade C

BRICK: CRACKS/DISPLACED/SPALLED BRICK AT BUILDING CORNERS

REMOVE AND REBUILD
 PRIORITY 4
 LEVEL 2

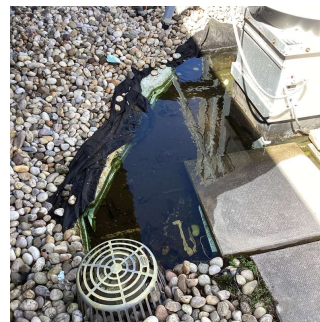
Roof 1
No violations recorded.

Is/Are the roof(s) suitable for Solar Panel installation?	No
Installation Year	2008
Source of Installation	Custodial Staff
Deficiency	IRMA: ROOFING: DAMAGED INSULATION

10
S.F.
REPLACE
PRIORITY 4
LEVEL 2

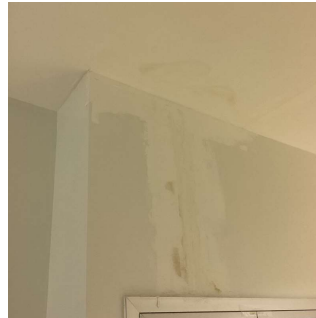
Roof 1 - Corridor near Room 311, also Corridor near Room 308, Rooms 303, 305

IRMA: ROOFING: MAJOR ACTIVE ROOF LEAKS IN INSTRUCTIONAL SPACE

400
S.F.
REPLACE ROOFING WITHOUT MAJOR EQUIPMENT REMOVAL
PRIORITY 5
LEVEL 2

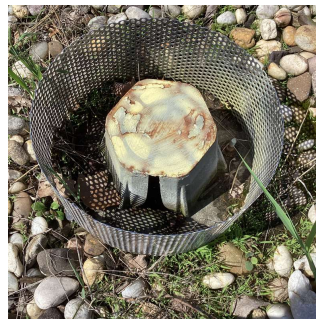
Roof 1

DETERIORATED

REPLACE

PRIORITY 4

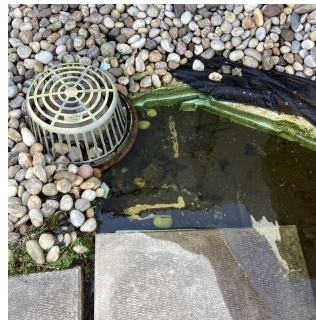
Roof 1
No violations recorded.

CLOGGED

1
EACH
MAINTENANCE
PRIORITY 5
LEVEL 2

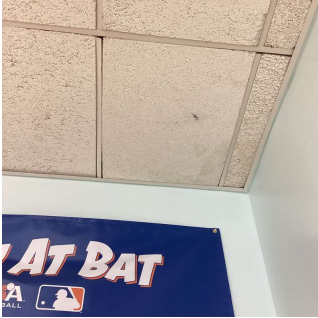
Question	Response
INTERIOR	
LIBRARY	Inspected
Walls	
Condition	2 - Between Good and Fair
Deficiency	No deficiencies recorded
LOCKER ROOM	Does not Exist
MULTI-PURPOSE ROOM	Inspected
Instance on 1st Floor	Inspected
Ceiling	
Instance on 1st Floor	Inspected
Condition	2 - Between Good and Fair
Deficiency	ACOUSTIC TILES: DAMAGED/MISSING
Deficiency Location/Instance	Near Entrance
Deficiency Quantity	10
Quantity Uom	S.F.
Potential Action	REPLACE
Urgency of Action	PRIORITY 3
Purpose of Action	LEVEL 2
Deficiency Photo1

Near Entrance
Violations	No violations recorded.
Door(s)	
Instance on 1st Floor	Inspected
Condition	2 - Between Good and Fair
Deficiency	No deficiencies recorded
Fixed Equipment	
Instance on 1st Floor	Does not Exist
Floor Finish	
Instance on 1st Floor	Inspected
Condition	2 - Between Good and Fair
Deficiency	No deficiencies recorded
Sliding-folding Partition	
Instance on 1st Floor	Does not Exist
Stage	
Instance on 1st Floor	Does not Exist

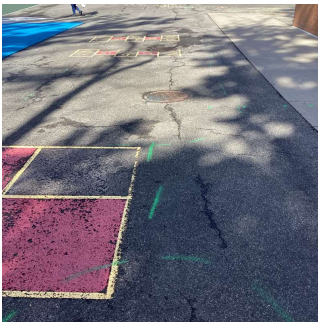
Question	Response
SITE	
PAVING	
Student Use	
Asphalt	Inspected
Condition	4 - Between Fair and Poor
Deficiency	CRACKS - MAJOR
Deficiency Location/Instance	Near Exits 2, 3, Center
Deficiency Quantity	600
Quantity Uom	S.F.
Potential Action	REPLACE
Urgency of Action	PRIORITY 3
Purpose of Action	LEVEL 2
Deficiency Photo1

Violations	Near Exit 2 No violations recorded.
Concrete	Inspected
Condition	2 - Between Good and Fair
Deficiency	No deficiencies recorded
Pavers	Does not Exist
Site Sidewalks & Walkways	
Inspected	
Asphalt	Does not Exist
Concrete	Inspected
Condition	2 - Between Good and Fair
Deficiency	No deficiencies recorded
Pavers	Does not Exist
DOT Sidewalk	
Inspected	
Asphalt	Does not Exist
Concrete	Inspected
Condition	3 - Fair
Deficiency	DAMAGED/DETERIORATED/MISSING SECTIONS
Deficiency Location/Instance	96th Avenue
Deficiency Quantity	50
Quantity Uom	S.F.
Potential Action	REPLACE
Urgency of Action	PRIORITY 3
Purpose of Action	LEVEL 2
