NYC Department of Education
Building Condition Assessment Survey 2023 - 2024

Architectural Inspection

Q263

Asset: P.S. /I.S 295 - QUEENS, 222-14 JAMAICA AVENUE, New York, 11428

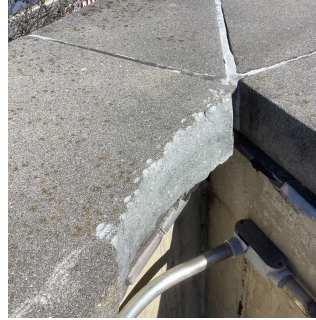
Roof 1

Question	Response
Architectural	
EXTERIOR	Inspected
AREAWAY	Does not Exist
AWNINGS AND CANOPIES	Does not Exist
CHIMNEY	Inspected
Material Type(s)	Metal
Condition	2 - Between Good and Fair
Deficiency	No deficiencies recorded
COPING	Inspected
Condition	3 - Fair
Deficiency	CAST STONE: CRACKED/BROKEN PIECES
Roof Plan reference

10
L.F.
REPLACE-IN-KIND
PRIORITY 4
LEVEL 2

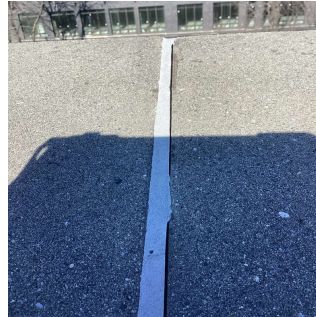
Roof 1

CAST STONE: DETERIORATED TRANSVERSE JOINTS

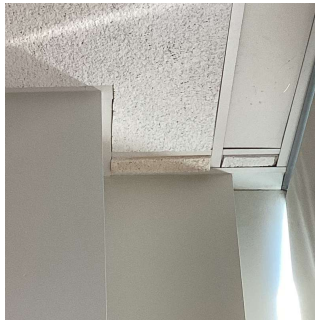
Facade C - Room 225, also Room 219, Facade A - Room 212

METAL PANEL: WATER INFILTRATION IN INSTRUCTIONAL SPACE

REPAIR

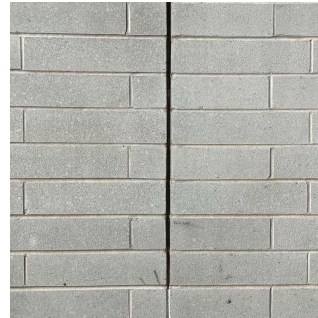
Facade D

BRICK: DETERIORATED CONTROL/EXPANSION JOINTS

PRIORITY 3
LEVEL 2

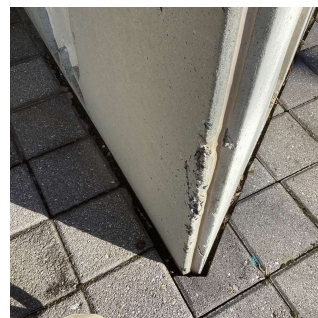
**CAST IN PLACE / PRE-CAST CONCRETE: MINOR
CRACKS/SPALLING**

10
S.F.
REPAIR
PRIORITY 3
LEVEL 2

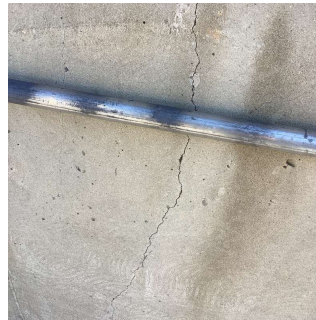
Roof 1
No violations recorded.

Question	Response
EXTERIOR	
EXTERIOR WALLS	
Elevation	 
Deficiency Quantity	20
Quantity Uom	L.F.
Potential Action	MAINTENANCE
Urgency of Action	PRIORITY 3
Purpose of Action	LEVEL 2
Deficiency Photo1	 
Violations	Facade A No violations recorded.
EXTERIOR SOFFITS	Inspected
Condition	2 - Between Good and Fair
Deficiency	No deficiencies recorded
LOADING DOCK	Does not Exist
LOUVER	Inspected
Condition	2 - Between Good and Fair
Deficiency	No deficiencies recorded
PARAPETS	Inspected
Material Type(s)	Masonry, Concrete
Replacement Quantity	6,000
Replacement Uom	C.F.
Instance on All Facades	Inspected
Instance Condition	3 - Fair
Instance Quantity	6,000
Instance Quantity Uom	C.F.
Deficiency	CONCRETE: MINOR CRACKS, SPALLING

30
S.F.
REPAIR
PRIORITY 3
LEVEL 2

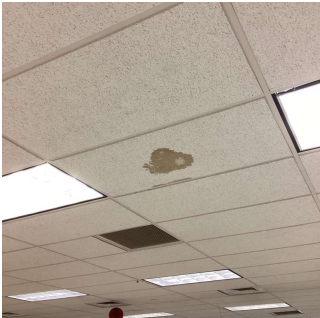
Question	Response
INTERIOR	
AUDITORIUM	
Stage	
Stage Curtains	
Deficiency	No deficiencies recorded
Walls	
Instance on 1st Floor (346 Seats)	Inspected
Condition	2 - Between Good and Fair
Deficiency	No deficiencies recorded
Window Curtains/Shades/Blinds	
Instance on 1st Floor (346 Seats)	Does not Exist
CAFETERIA	
Instance on Basement	Inspected
Ceiling	
Instance on Basement	Inspected
Condition	2 - Between Good and Fair
Deficiency	ACOUSTIC TILES: DAMAGED/MISSING
Deficiency Location/Instance	Center
Deficiency Quantity	10
Quantity Uom	S.F.
Potential Action	REPLACE
Urgency of Action	PRIORITY 3
Purpose of Action	LEVEL 2
Deficiency Photo1

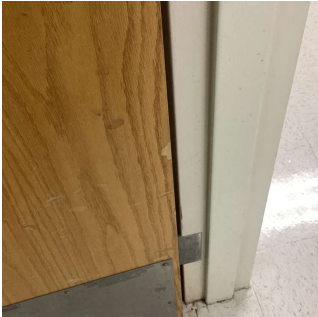
Question	Response
INTERIOR	
CLASSROOMS/CORRIDORS/ADMIN SPACES	
Ceiling	Inspected
Violations	No violations recorded.
Door(s)	Inspected
Condition	3 - Fair
Deficiency	WOOD: DETERIORATED DOOR
Deficiency Location/Instance	Rooms 210, 220
Deficiency Quantity	2
Quantity Uom	EACH
Potential Action	MAINTENANCE
Urgency of Action	PRIORITY 3
Purpose of Action	LEVEL 2
Deficiency Photo1

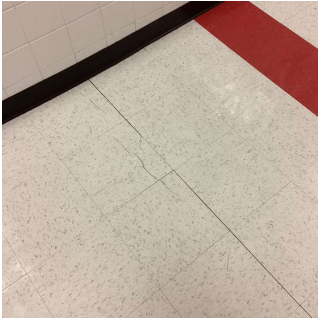
Violations	Room 210 No violations recorded.
Floor Finish	Inspected
Condition	2 - Between Good and Fair
Deficiency	VINYL TILES: DETERIORATED SUBSTRATE
Deficiency Location/Instance	Corridor near Room 108
Deficiency Quantity	10
Quantity Uom	S.F.
Potential Action	REPLACE
Urgency of Action	PRIORITY 3
Purpose of Action	LEVEL 2
Deficiency Photo1

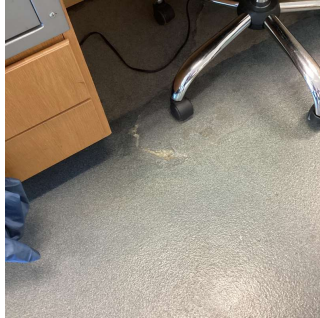
Violations	Corridor near Room 108 No violations recorded.
Deficiency	EPOXY FLOORING: CRACKS/SPALLING
Deficiency Location/Instance	Room 401
Deficiency Quantity	10
Quantity Uom	S.F.
Potential Action	REPLACE
Urgency of Action	PRIORITY 3

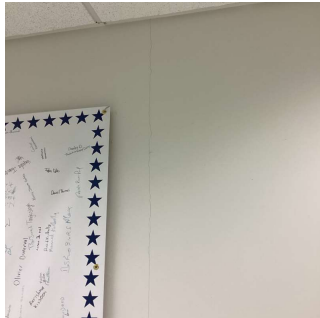
Room 401
Violations	No violations recorded.
Walls	
Condition	Inspected
Deficiency	2 - Between Good and Fair
Deficiency Location/Instance	GYPSUM BOARD: DETERIORATED
Deficiency Quantity	Corridor near Rooms B19, 103, 117, 313, Room 404, and others
Quantity Uom	60
Potential Action	S.F.
Urgency of Action	REPLACE
Purpose of Action	PRIORITY 3
Deficiency Photo1	LEVEL 2

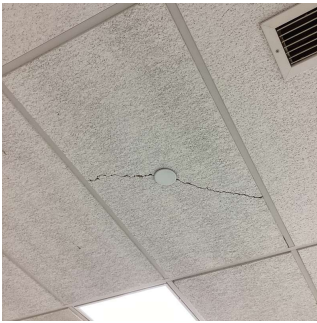
Violations	Corridor near Room B19 No violations recorded.
Specialties	Does not Exist
GYMNASIUM	
Instance on 1st Floor	Inspected
	Inspected
Ceiling	
Instance on 1st Floor	Inspected
Condition	2 - Between Good and Fair
Deficiency	ACOUSTIC TILES: DAMAGED/MISSING
Deficiency Location/Instance	Entrance
Deficiency Quantity	10
Quantity Uom	S.F.
Potential Action	REPLACE
Urgency of Action	PRIORITY 3
Purpose of Action	LEVEL 2

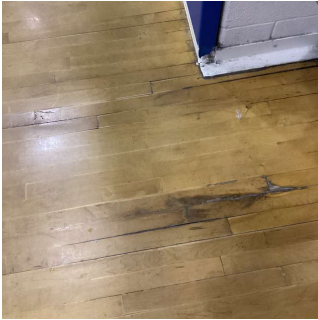
Violations	Near Toilet Rooms No violations recorded.
Deficiency	WOOD: DAMAGED/DETERIORATED
Deficiency Location/Instance	Near Drinking Fountain
Deficiency Quantity	10
Quantity Uom	S.F.
Potential Action	REPLACE
Urgency of Action	PRIORITY 3
Purpose of Action	LEVEL 2
Deficiency Photo1

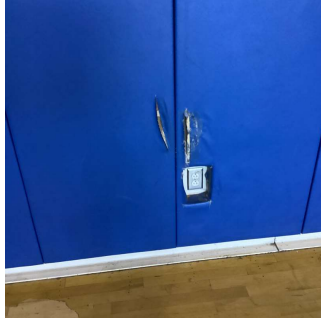
Violations	Near Drinking Fountain No violations recorded.
Seating	
Instance on 1st Floor	Inspected
Condition	2 - Between Good and Fair
Deficiency	No deficiencies recorded
Sliding-folding Partition	
Instance on 1st Floor	Inspected
Condition	2 - Between Good and Fair
Deficiency	No deficiencies recorded
Stage	
Instance on 1st Floor	Does not Exist
Walls	
Instance on 1st Floor	Inspected
Condition	2 - Between Good and Fair
Deficiency	WALL PADDING: DETERIORATED
Deficiency Location/Instance	Near Girls Locker Room, Near Room 125A
Deficiency Quantity	80
Quantity Uom	S.F.
Potential Action	REPLACE

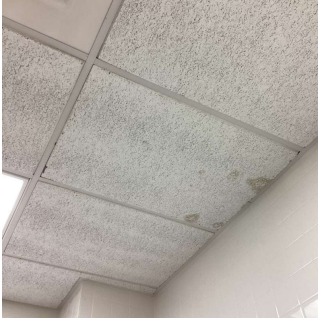
Question	Response
INTERIOR	
LOCKER ROOM	
Ceiling	
Condition	2 - Between Good and Fair
Deficiency	ACOUSTIC TILES: DAMAGED/MISSING
Deficiency Location/Instance	Center
Deficiency Quantity	10
Quantity Uom	S.F.
Potential Action	REPLACE
Urgency of Action	PRIORITY 3
Purpose of Action	LEVEL 2
Deficiency Photo1

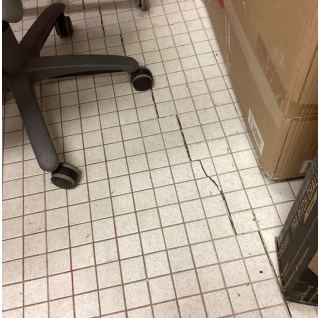
Center
Violations	No violations recorded.
Door(s)	
Instance on 1st Floor - Boys	Inspected
Condition	2 - Between Good and Fair
Deficiency	No deficiencies recorded
Instance on 1st Floor - Girls	Inspected
Condition	2 - Between Good and Fair
Deficiency	No deficiencies recorded
Floor Finish	
Instance on 1st Floor - Boys	Inspected
Condition	2 - Between Good and Fair
Deficiency	CERAMIC TILE: DETERIORATED SUBSTRATE
Deficiency Location/Instance	Center
Deficiency Quantity	10
Quantity Uom	S.F.
Potential Action	REPLACE
Urgency of Action	PRIORITY 3
Purpose of Action	LEVEL 2
Deficiency Photo1

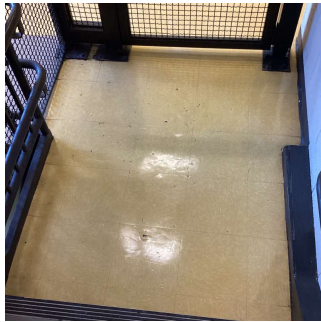
Stair A/Bulkhead	Stair A/Bulkhead

Question	Response
INTERIOR	
SCIENCE PREP ROOM	Inspected
Instance on Room 402	Inspected
Alternative use	No
Fixed Equipment	
Instance on Room 402	Inspected
Condition	2 - Between Good and Fair
Deficiency	No deficiencies recorded
SHOWER ROOM	Does not Exist
STAIRS/RAMPS: INTERIOR	Inspected
Do Letter Stair Signs Exist?	Yes
Ceiling	Inspected
Condition	2 - Between Good and Fair
Deficiency	No deficiencies recorded
Door(s)	Inspected
Condition	2 - Between Good and Fair
Deficiency	No deficiencies recorded
Partition	Does not Exist
Railings	Inspected
Condition	2 - Between Good and Fair
Deficiency	No deficiencies recorded
Stairs and Landings	Inspected
Condition	2 - Between Good and Fair
Deficiency	VINYL TILES: BROKEN/DETERIORATED/MISSING TILES
Deficiency Location/Instance	Stair A/Bulkhead
Deficiency Quantity	10
Quantity Uom	S.F.
Potential Action	REPLACE
Urgency of Action	PRIORITY 3
Purpose of Action	LEVEL 2
Deficiency Photo1

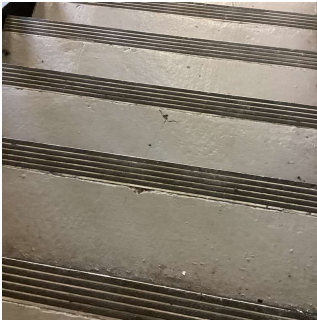
Violations	No violations recorded.
Deficiency	CONCRETE: CRACKS/SPALLING - MAJOR
Deficiency Location/Instance	Stair A/Bulkhead
Deficiency Quantity	10
Quantity Uom	S.F.
Potential Action	REPLACE
Urgency of Action	PRIORITY 3
Purpose of Action	LEVEL 2

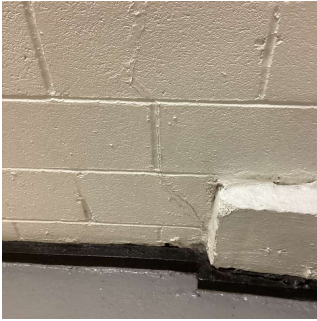
Violations	Stair A/Bulkhead No violations recorded.
Walls	Inspected
Condition	2 - Between Good and Fair
Deficiency	MASONRY: CRACKS/SPALLING
Deficiency Location/Instance	Stairs A/Basement,4, B/4
Deficiency Quantity	30
Quantity Uom	S.F.
Potential Action	REPLACE
Urgency of Action	PRIORITY 3
Purpose of Action	LEVEL 2
Deficiency Photo1

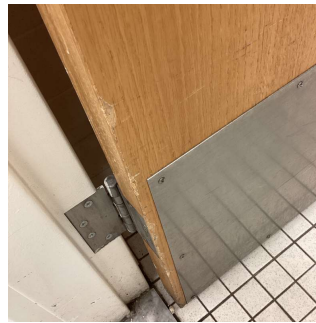
Violations	Stair A/Basement No violations recorded.
TOILET ROOMS - STAFF	
Ceiling	Inspected
Condition	2 - Between Good and Fair
Deficiency	No deficiencies recorded
Door(s)	Inspected
Condition	3 - Fair
Deficiency	WOOD: DETERIORATED DOOR
Deficiency Location/Instance	In Room 219
Deficiency Quantity	1
Quantity Uom	EACH
Potential Action	MAINTENANCE
Urgency of Action	PRIORITY 3
Purpose of Action	LEVEL 2

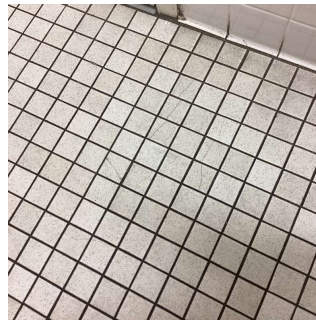
Room B19A

CERAMIC TILE: BROKEN/MISSING TILES

REPLACE

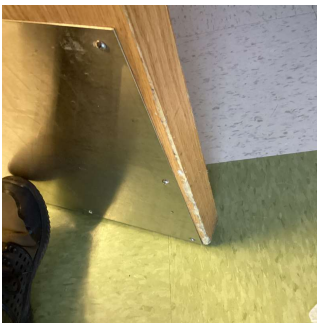
Question	Response
INTERIOR	
TOILET ROOMS - STUDENTS	
Door(s)	
Deficiency Photo1

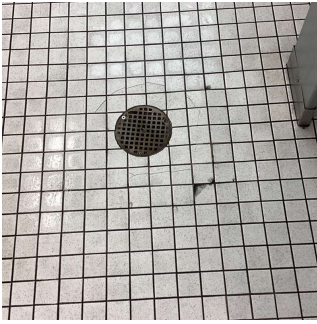
Violations	In Room 206 No violations recorded.
Floor Finish	Inspected
Condition	2 - Between Good and Fair
Deficiency	CERAMIC TILE: BROKEN/MISSING TILES
Deficiency Location/Instance	Rooms 215, 309
Deficiency Quantity	20
Quantity Uom	S.F.
Potential Action	REPLACE
Urgency of Action	PRIORITY 3
Purpose of Action	LEVEL 2
Deficiency Photo1

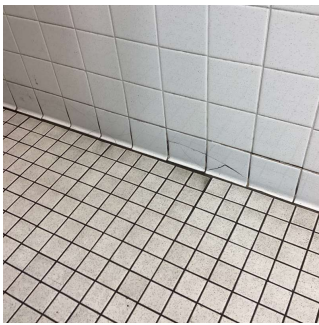
Violations	Room 309 No violations recorded.
Stalls	Inspected
Condition	2 - Between Good and Fair
Deficiency	No deficiencies recorded
Walls	Inspected
Condition	2 - Between Good and Fair
Deficiency	CERAMIC TILE: BROKEN/ MISSING
Deficiency Location/Instance	Room 409
Deficiency Quantity	10
Quantity Uom	S.F.
Potential Action	REPLACE
Urgency of Action	PRIORITY 3
Purpose of Action	LEVEL 2

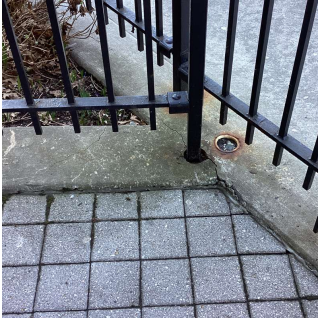
Deficiency	CONCRETE CURB: DAMAGED/DETERIORATED
Deficiency Location/Instance	Jamaica Avenue
Deficiency Quantity	35
Quantity Uom	S.F.
Potential Action	REPLACE
Urgency of Action	PRIORITY 3
Purpose of Action	LEVEL 2

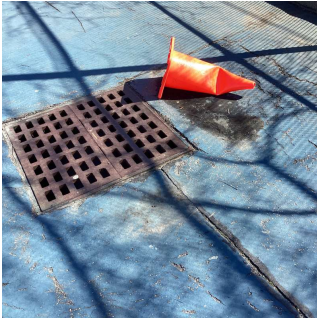
Question	Response
SITE	
PAVING	
Student Use	
Asphalt	
Deficiency Photo1	 
Violations	Schoolyard No violations recorded.
Deficiency	LOCALIZED SINK AREA
Deficiency Location/Instance	Schoolyard
Deficiency Quantity	100
Quantity Uom	S.F.
Potential Action	REPAIR
Urgency of Action	PRIORITY 3
Purpose of Action	LEVEL 2
Deficiency Photo1

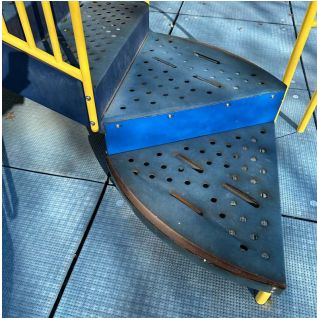
Question	Response
SITE	
PLAYGROUNDS	
Pavement	
Instance on Schoolyard	Does not Exist
Play Equipment	
Instance on Schoolyard	Inspected
Condition	5 - Poor
Deficiency	BROKEN/DETERIORATED/MISSING
Deficiency Location/Instance	East Side
Deficiency Quantity	1
Quantity Uom	EACH
Potential Action	REPLACE
Urgency of Action	PRIORITY 3
Purpose of Action	LEVEL 2
Deficiency Photo1

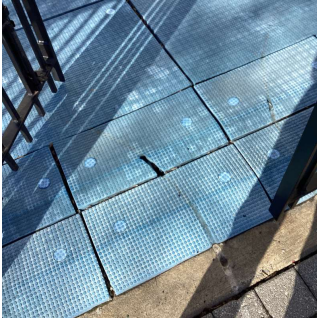
East Side
Violations	No violations recorded.
Safety Surfacing	
Instance on Schoolyard	Inspected
Condition	2 - Between Good and Fair
Deficiency	DETERIORATED/MISSING
Deficiency Location/Instance	East Side, West Side
Deficiency Quantity	20
Quantity Uom	S.F.
Potential Action	REPLACE
Urgency of Action	PRIORITY 3
Purpose of Action	LEVEL 2
Deficiency Photo1
