**NYC Department of Education**  
**Building Condition Assessment Survey 2023 - 2024**

Architectural Inspection

**Asset:** P.S./I.S. 266 - QUEENS, 74-10 COMMONWEALTH BLVD, New York, 11426

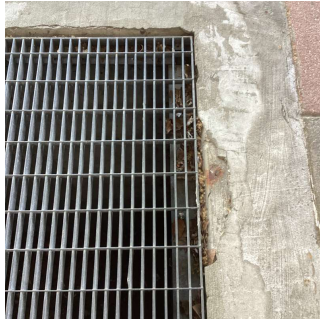
Question	Response
<b>Architectural</b>	
<b>EXTERIOR</b>	Inspected
<b>AREAWAY</b>	Inspected
Instance on AW1-AW10	Inspected
Instance Condition	3 - Fair
Instance Quantity	10
Instance Quantity Uom	EACH
Deficiency	AREAWAY WALLS: CRACKS AND SPALLING
Roof Plan reference	<b>Q266</b>

Deficiency Quantity	30
Quantity Uom	S.F.
Potential Action	REPAIR
Urgency of Action	PRIORITY 3
Purpose of Action	LEVEL 2

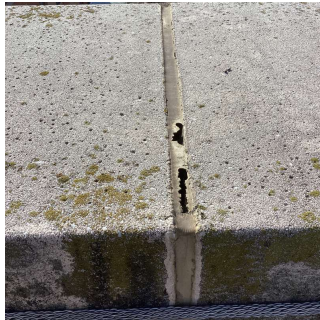
Violations	Roof 2 No violations recorded.
<b>CORNICE</b>	
	Does not Exist

Violations	Facade A - AW1 No violations recorded.
<b>AWNINGS AND CANOPIES</b>	
Condition	Inspected
Deficiency	2 - Between Good and Fair No deficiencies recorded
<b>CHIMNEY</b>	
Material Type(s)	Inspected Metal
Condition	2 - Between Good and Fair
Deficiency	No deficiencies recorded
<b>COPING</b>	
Condition	Inspected 3 - Fair
Deficiency	CAST STONE: DETERIORATED TRANSVERSE JOINTS
Roof Plan reference	Q266

Deficiency Quantity	50
Quantity Uom	L.F.
Potential Action	MAINTENANCE
Urgency of Action	PRIORITY 3
Purpose of Action	LEVEL 2
Deficiency Photo1

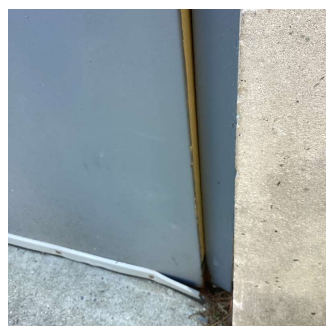
Question	Response
<b>EXTERIOR</b>	
<b>DOORS</b>	Inspected
<b>DOORS AND FRAMES</b>	Inspected
Condition	4 - Between Fair and Poor
Deficiency	METAL: DETERIORATED DOOR AND FRAME - MAJOR DETERIORATION
Roof Plan reference	<p><b>Q266</b></p>

Deficiency Quantity	3
Quantity Uom	EACH
Potential Action	REPLACE
Urgency of Action	PRIORITY 4
Purpose of Action	LEVEL 2
Deficiency Photo1

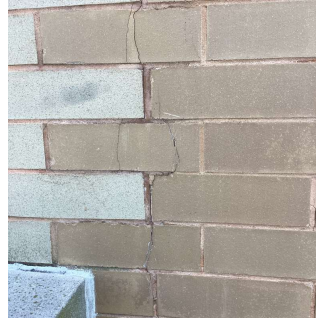
Facade C

BRICK: MINOR CRACKS AND SPALLING

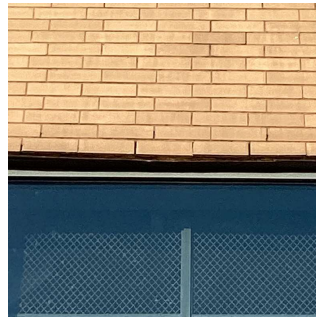
Facade F

**BRICK: RELIEVING ANGLES - MAJOR DETERIORATION**

REPLACE

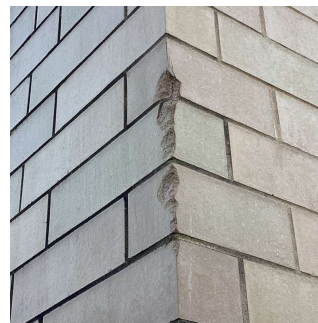
Facade B

BRICK: CRACKS/DISPLACED/SPALLED BRICK AT BUILDING CORNERS

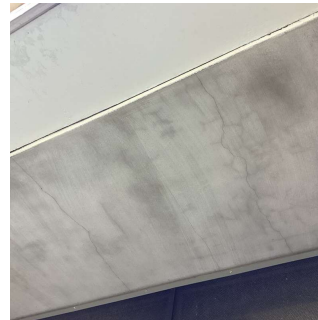
Facade E

CONCRETE: MINOR CRACKS/SPALLING

REPAIR

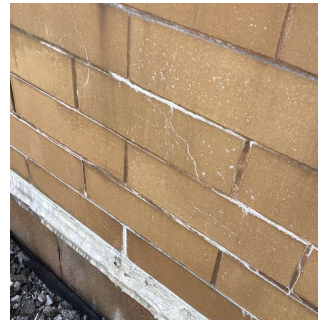
Roof 2

BRICK: MINOR CRACKS, SPALLING

REPAIR

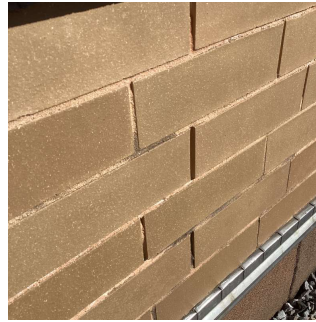
Roof 2

**BRICK: DETERIORATED JOINTS**

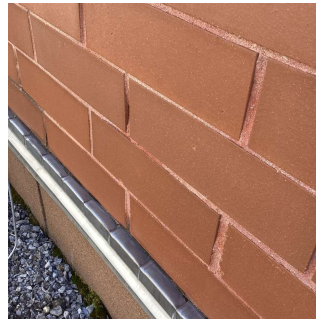
Roof 8

**BRICK: DETERIORATED JOINTS**

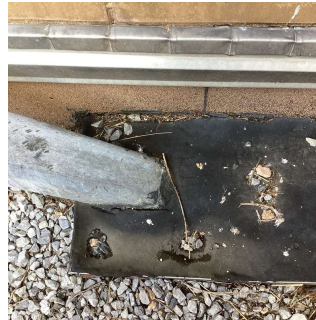
Roof 8

IRMA: FLASHING: PITCH POCKET DETERIORATED - MAJOR

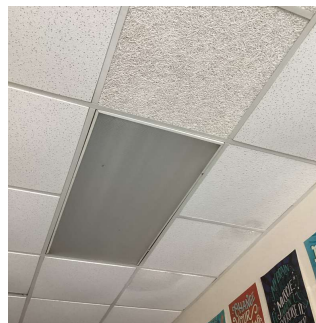
Roof 8 - Room 311, Stair C/3

**IRMA: ROOFING: MAJOR ACTIVE ROOF LEAKS IN INSTRUCTIONAL SPACE**

**REPLACE ROOFING WITHOUT MAJOR EQUIPMENT REMOVAL**

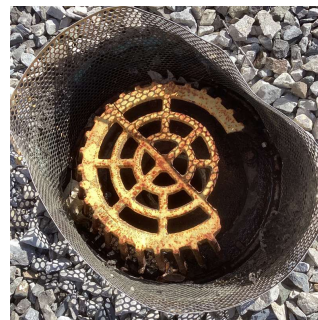
Roof 2

DETERIORATED

REPLACE

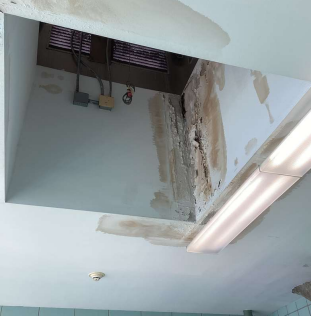
Question	Response
<b>EXTERIOR</b>	
<b>ROOF</b>	
<b>Specialties</b>	
<b>BULKHEAD/PENTHOUSE</b>	Inspected
Condition	3 - Fair
Deficiency	BULKHEAD/PENTHOUSE WALLS/INTERIOR: GYPSUM BOARD DAMAGED/DETERIORATED
Roof Plan reference	Q266

Deficiency Quantity	30
Quantity Uom	S.F.
Potential Action	REPLACE
Urgency of Action	PRIORITY 4
Purpose of Action	LEVEL 2
Deficiency Photo1

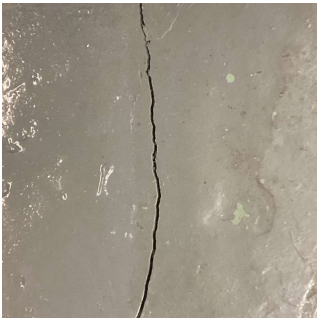
Mechanical Room 401
Violations	No violations recorded.
<b>FLOOR STRUCTURE</b>	
Condition	Inspected
	3 - Fair
Deficiency	CONCRETE SLAB ON GRADE: THRU CRACKS
Deficiency Location/Instance	Basement - Room C2
Deficiency Quantity	10
Quantity Uom	S.F.
Potential Action	REPAIR
Urgency of Action	PRIORITY 3
Purpose of Action	LEVEL 5
Deficiency Photo1

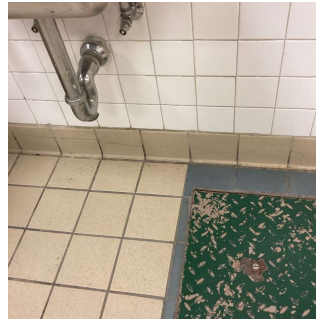
Serving Area

Instance on 1st Floor	Inspected
Condition	2 - Between Good and Fair
Deficiency	QUARRY TILE: BROKEN/MISSING TILES
Deficiency Location/Instance	Serving Area, Prep Area
Deficiency Quantity	30
Quantity Uom	S.F.
Potential Action	REPLACE
Urgency of Action	PRIORITY 3
Purpose of Action	LEVEL 2
Deficiency Photo1
