**NYC Department of Education**  
**Building Condition Assessment Survey 2023 - 2024**

Architectural Inspection

**Asset:** P.S. 268 - QUEENS, 92-07 175 STREET, New York, 11433

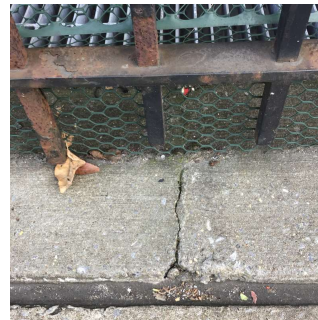
AW4  
No violations recorded.

Question	Response
<b>Architectural</b>	
<b>EXTERIOR</b>	Inspected
<b>AREAWAY</b>	Inspected
Instance on AW1-AW5	Inspected
Instance Condition	3 - Fair
Instance Quantity	5
Instance Quantity Uom	EACH
Deficiency	AREAWAY WALLS: CRACKS AND SPALLING

20  
S.F.  
REPAIR  
PRIORITY 3  
LEVEL 2

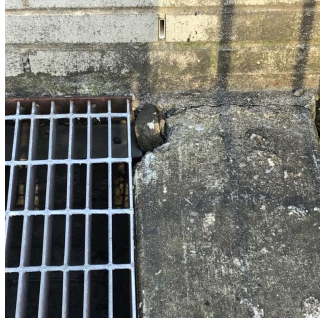
AW1
Violations	No violations recorded.
<b>AWNINGS AND CANOPIES</b>	
	Does not Exist
<b>CHIMNEY</b>	
Material Type(s)	Masonry
Condition	3 - Fair
Deficiency	BRICK: MAJOR / THRU CRACKS
Roof Plan reference	<p>Q268</p>

AREAWAY WALLS: CRACKS AND SPALLING

20  
S.F.  
REPLACE  
PRIORITY 4  
LEVEL 2

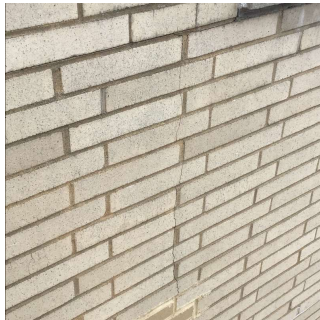
CH
Violations	No violations recorded.
<b>COPING</b>	
Condition	Inspected
Deficiency	3 - Fair
	CAST STONE: CRACKED/BROKEN PIECES

Deficiency Quantity	20
Quantity Uom	S.F.
Potential Action	REMOVE AND REBUILD
Urgency of Action	PRIORITY 4
Purpose of Action	LEVEL 2
Deficiency Photo1

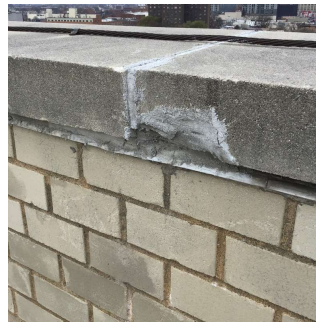
Roof 2  
No violations recorded.

20  
L.F.  
REPLACE-IN-KIND  
PRIORITY 4  
LEVEL 2

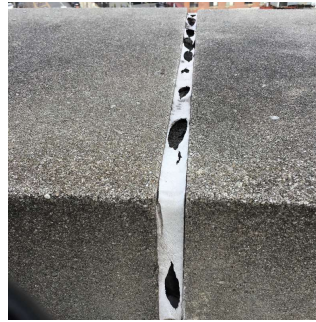
Roof 1

CAST STONE: DETERIORATED TRANSVERSE JOINTS

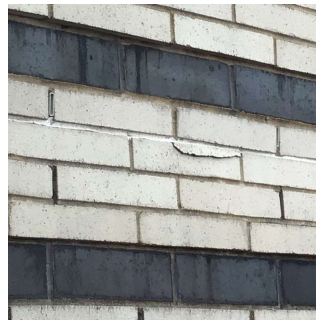
Facade C - between 3rd and 4th Floors

BRICK: MAJOR / THRU CRACKS

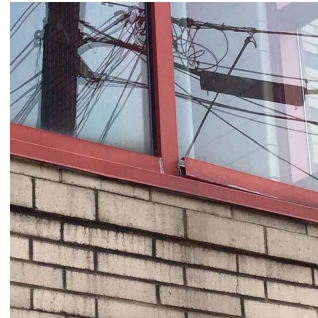
Facade A

METAL/GLASS CURT WALL: DAMAGED TRIM

PRIORITY 4  
LEVEL 2

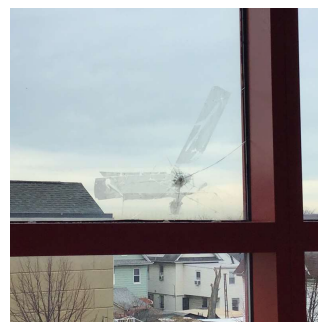
Facade C - Stair B/2-3 (Facade A - Stair A/3-4)

METAL/GLASS CURT WALL: BROKEN GLASS

120  
S.F.  
REPLACE  
PRIORITY 3  
LEVEL 4

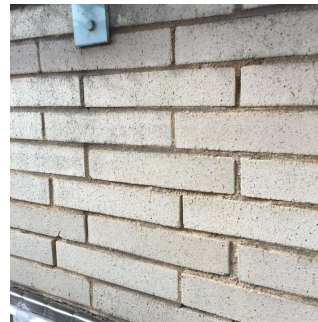
Violations	Roof 1 No violations recorded.
Deficiency	BRICK: DETERIORATED JOINTS

60  
S.F.  
REPOINT  
PRIORITY 3  
LEVEL 2

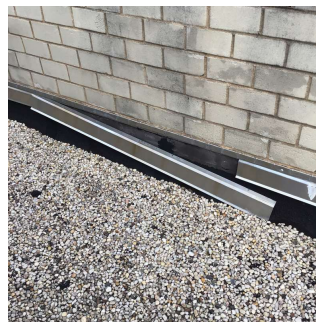
Roof 2

Deficiency BUILT-UP: FLASHING: CAP FLASHING DAMAGED

100  
L.F.  
REPLACE  
PRIORITY 4  
LEVEL 2

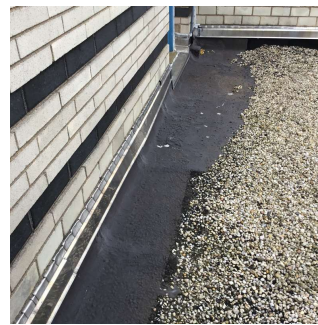
Roof 2  
No violations recorded.

Deficiency BUILT-UP: ROOFING: LOSS OF GRAVEL

50  
S.F.  
INSTALL NEW GRAVEL  
PRIORITY 3  
LEVEL 2

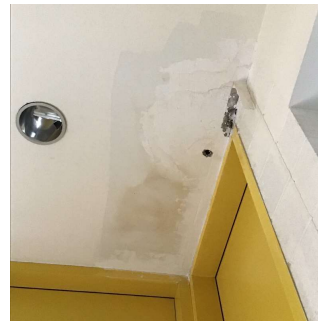
Roof 6 - Room 209 (Roof 6 - Room 211 similar)

SINGLE PLY, FULLY ADHERED ROOF: ROOFING: MAJOR ACTIVE ROOF LEAKS IN INSTRUCTIONAL SPACE

300  
S.F.  
REPLACE ROOFING WITHOUT MAJOR EQUIPMENT  
REMOVAL  
PRIORITY 5  
LEVEL 2

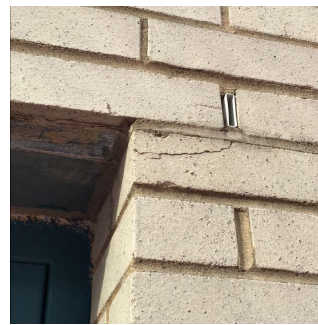
PH  
No violations recorded.

Violations	BH2 - Stair C/Roof No violations recorded.
Deficiency	BULKHEAD/PENTHOUSE WALLS/EXTERIOR: CRACKS/SPALLING - MINOR

20  
S.F.  
REPAIR  
PRIORITY 3  
LEVEL 2

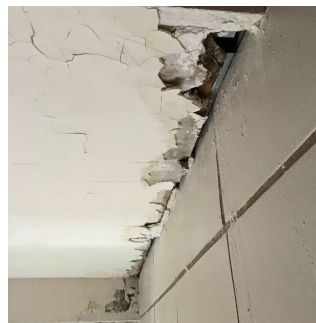
BH2 - Stair C

**BULKHEAD/PENTHOUSE CEILING: GYPSUM BOARD DAMAGED/DETERIORATED**

40  
 S.F.  
 REPLACE  
 PRIORITY 4  
 LEVEL 2

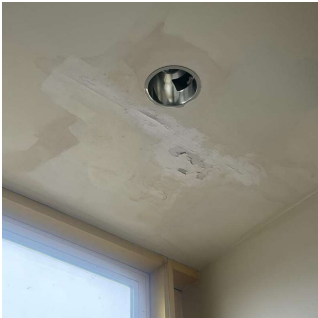
Question	Response
<b>INTERIOR</b>	
<b>CLASSROOMS/CORRIDORS/ADMIN SPACES</b>	
<b>Ceiling</b>	
Deficiency Quantity	100
Quantity Uom	S.F.
Potential Action	REPLACE
Urgency of Action	PRIORITY 5
Purpose of Action	LEVEL 2
Deficiency Photo1

Room 209
Violations	No violations recorded.
Deficiency	<b>GYPSUM BOARD: DAMAGED/DETERIORATED</b>
Deficiency Location/Instance	Corridor near Rooms 203, 109, 101, Main Entrance Lobby, Corridor near Auditorium and others
Deficiency Quantity	120
Quantity Uom	S.F.
Potential Action	REPLACE
Urgency of Action	PRIORITY 3
Purpose of Action	LEVEL 2
Deficiency Photo1

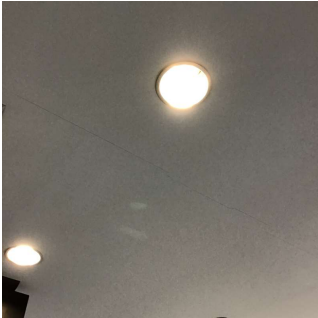
Corridor near Room 203
Violations	No violations recorded.
Deficiency	<b>ACOUSTIC TILES: DAMAGED/MISSING</b>
Deficiency Location/Instance	Rooms 409, 316, 312, 306, 304 and others
Deficiency Quantity	500
Quantity Uom	S.F.
Potential Action	REPLACE
Urgency of Action	PRIORITY 3
Purpose of Action	LEVEL 2

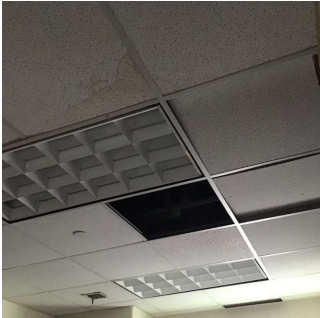
Center
Violations	No violations recorded.
Deficiency	ACOUSTIC TILES: DAMAGED/MISSING
Deficiency Location/Instance	Storage Room
Deficiency Quantity	20
Quantity Uom	S.F.
Potential Action	REPLACE
Urgency of Action	PRIORITY 3
Purpose of Action	LEVEL 2
Deficiency Photo1

Storage Room
Violations	No violations recorded.
Deficiency	TECTUM: DAMAGED/MISSING
Deficiency Location/Instance	Near Stair C/4
Deficiency Quantity	10
Quantity Uom	S.F.
Potential Action	REPLACE
Urgency of Action	PRIORITY 5
Purpose of Action	LEVEL 6

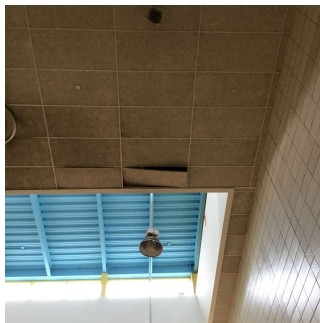
Yes	Potential Falling Debris	Loose tectum Ceiling tile is a potential safety hazard.	INTERIOR   GYMNASIUM   Ceiling	Near Stair C/4	Francisco Caceres	Cleaner

Violations	Near Stair C/4 No violations recorded.
<b>Door(s)</b>	
Instance on 4th Floor	Inspected
Condition	2 - Between Good and Fair
Deficiency	No deficiencies recorded
<b>Fixed Equipment</b>	
Instance on 4th Floor	Inspected
Condition	2 - Between Good and Fair
Deficiency	No deficiencies recorded
<b>Floor Finish</b>	
Instance on 4th Floor	Inspected
Condition	2 - Between Good and Fair
Deficiency	WOOD: DAMAGED/DETERIORATED
Deficiency Location/Instance	Near Drinking Fountain
Deficiency Quantity	20
Quantity Uom	S.F.
Potential Action	REPLACE
Urgency of Action	PRIORITY 3
Purpose of Action	LEVEL 2
Deficiency Photo1

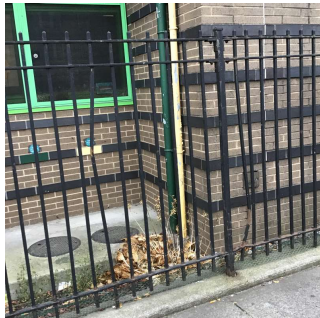
Violations	4th Floor Boys No violations recorded.
<b>LIFE SAFETY</b>	Inspected
<b>F.D. HOLDING AREA</b>	Does not Exist
<b>STEEL STAIRS</b>	Does not Exist
<b>SITE</b>	Inspected
<b>CONTAINERIZATION</b>	Does not Exist
<b>Drainage System for Asphalt</b>	Inspected
<b>Catch Basins/Manhole - Surrounded by asphalt</b>	Inspected
Condition	2 - Between Good and Fair
Deficiency	No deficiencies recorded
<b>Culverts - Asphalt Covering</b>	Does not Exist
<b>Drainage System for Concrete</b>	Inspected
<b>Catch Basins/Manhole - Surrounded by concrete</b>	Inspected
Condition	2 - Between Good and Fair
Deficiency	No deficiencies recorded
<b>Culverts - Concrete Covering</b>	Does not Exist
<b>Drainage System for Soil</b>	Does not Exist
<b>DRINKING FOUNTAINS</b>	Does not Exist
<b>FENCES</b>	Inspected
Condition	3 - Fair
Deficiency	WROUGHT IRON: DAMAGED/DETERIORATED

Deficiency Location/Instance	Jamaica Avenue, 176th Street
Deficiency Quantity	120
Quantity Uom	S.F.
Potential Action	REPLACE
Urgency of Action	PRIORITY 3
Purpose of Action	LEVEL 2
Deficiency Photo1

Question	Response
<b>SITE</b>	
<b>FENCES</b>	
Violations	Jamaica Avenue No violations recorded.
Deficiency	CONCRETE CURB: DAMAGED/DETERIORATED
Deficiency Location/Instance	Jamaica Avenue, 175th Street, 176th Street
Deficiency Quantity	30
Quantity Uom	S.F.
Potential Action	REPLACE
Urgency of Action	PRIORITY 3
Purpose of Action	LEVEL 2
Deficiency Photo1

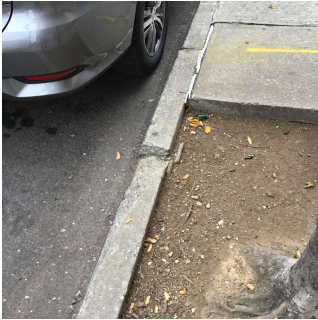
175th Street
Violations	No violations recorded.
Deficiency	DAMAGED CURBS
Deficiency Location/Instance	Jamaica Avenue, 175th Street, 176th Street
Deficiency Quantity	80
Quantity Uom	L.F.
Potential Action	REPLACE
Urgency of Action	PRIORITY 3
Purpose of Action	LEVEL 2
Deficiency Photo1

175th Street
Violations	No violations recorded.
Deficiency	DAMAGED/DETERIORATED/MISSING SECTIONS
Deficiency Location/Instance	Jamaica Avenue, 175th Street, 176th Street
Deficiency Quantity	950
Quantity Uom	S.F.
Potential Action	REPLACE
Urgency of Action	PRIORITY 3
