NYC Department of Education
Building Condition Assessment Survey 2023 - 2024

Architectural Inspection

Asset: P.S. 270 - QUEENS, 233-15 MERRICK BLVD, New York, 11422

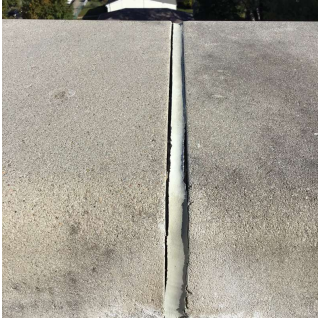
Question	Response
EXTERIOR	
COPING	
Potential Action	MAINTENANCE
Urgency of Action	PRIORITY 3
Purpose of Action	LEVEL 2
Deficiency Photo1

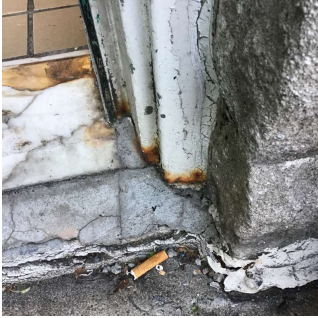
Violations	Roof 2 No violations recorded.
CORNICE	Does not Exist
DOORS	Inspected
DOORS AND FRAMES	Inspected
Condition	4 - Between Fair and Poor
Deficiency	METAL CLAD: DETERIORATED DOOR AND FRAME - MINOR DETERIORATION
Roof Plan reference

Deficiency Quantity	2
Quantity Uom	EACH
Potential Action	MAINTENANCE
Urgency of Action	PRIORITY 3
Purpose of Action	LEVEL 2
Deficiency Photo1

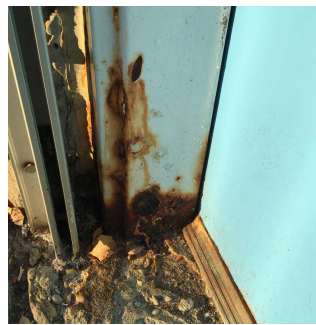
Facade J

Violations	Facade F No violations recorded.
Deficiency	METAL: DETERIORATED DOOR AND FRAME - MAJOR DETERIORATION

4
EACH
REPLACE
PRIORITY 4
LEVEL 2

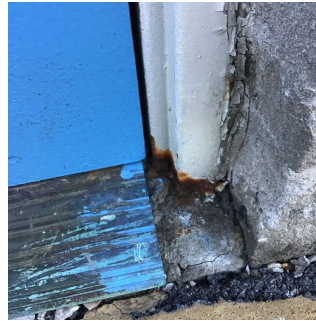
Facade B

METAL: DETERIORATED DOOR AND FRAME - MINOR DETERIORATION

10
EACH
MAINTENANCE
PRIORITY 3
LEVEL 2

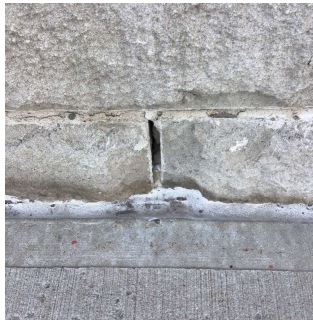
Facade A

STONE: DETERIORATED JOINTS

Deficiency Quantity

10

REPOINT

PRIORITY 4

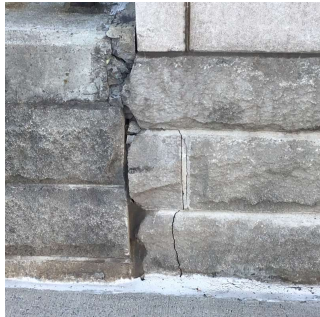
STONE: CRACKS AT BUILDING CORNERS

Deficiency Quantity

10

REPLACE

Question	Response
EXTERIOR	
EXTERIOR WALLS	
Urgency of Action	PRIORITY 4
Purpose of Action	LEVEL 2
Deficiency Photo1

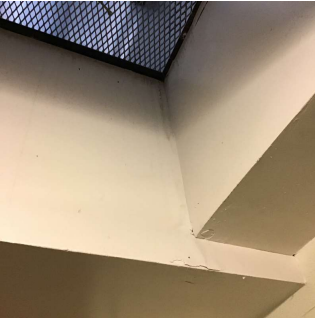
Question	Response
EXTERIOR	
ROOF	
Roofing	Inspected
Replacement Quantity	20,400
Replacement Uom	S.F.
ROOF HATCH/SMOKE HATCH	Inspected
Condition	5 - Poor
Deficiency	WATER INFILTRATION
Roof Plan reference

Deficiency Quantity	1
Quantity Uom	EACH
Potential Action	REPAIR
Urgency of Action	PRIORITY 5
Purpose of Action	LEVEL 2
Deficiency Photo1

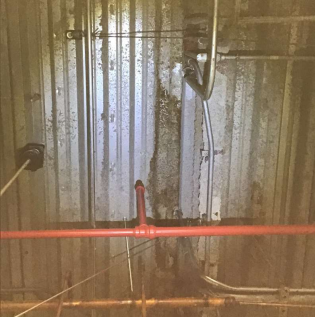
Question	Response
EXTERIOR	
ROOF	
Roofing	
ROOFING	
Deficiency Photo1	 
	Roof 7 - Gymnasium
Violations	No violations recorded.
ROOFING DRAINS	Inspected
Condition	2 - Between Good and Fair
Deficiency	No deficiencies recorded
Specialties	Inspected
BULKHEAD/PENTHOUSE	Inspected
Condition	3 - Fair
Deficiency	BULKHEAD/PENTHOUSE WALLS/INTERIOR: GYPSUM BOARD DAMAGED/DETERIORATED
Roof Plan reference	 
Deficiency Quantity	30
Quantity Uom	S.F.
Potential Action	REPLACE
Urgency of Action	PRIORITY 3
Purpose of Action	LEVEL 2
Deficiency Photo1	 
Violations	Roof 1 - Bulkhead
	No violations recorded.
Deficiency	BULKHEAD/PENTHOUSE ROOF: DETERIORATED

Deficiency Quantity	100
Quantity Uom	S.F.
Potential Action	REPAIR
Urgency of Action	PRIORITY 3
Purpose of Action	LEVEL 2
Deficiency Photo1

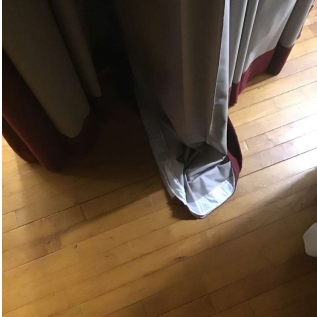
Deficiency	No deficiencies recorded
Stage Curtain Rigging	
Instance on Basement (298 Seats)	Inspected
Condition	2 - Between Good and Fair
Deficiency	No deficiencies recorded
Stage Curtains	
Instance on Basement (298 Seats)	Inspected
Condition	3 - Fair
Deficiency	WORN/DETERIORATED
Deficiency Location/Instance	Right Side

Question	Response
INTERIOR	
AUDITORIUM	
Stage	
Stage Curtains	
Deficiency Quantity	100
Quantity Uom	S.F.
Potential Action	REPLACE
Urgency of Action	PRIORITY 3
Purpose of Action	LEVEL 2
Deficiency Photo1

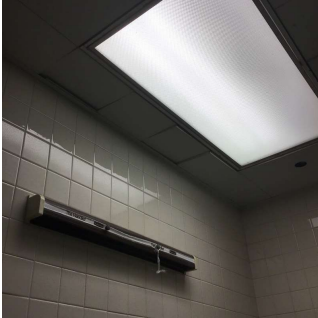
Room 125B

Deficiency	METAL PAN: DAMAGED/MISSING
------------	----------------------------

Deficiency Location/Instance	Room 125B, Near Cafeteria Exit
------------------------------	--------------------------------

Deficiency Quantity	20
---------------------	----

Potential Action	REPLACE
------------------	---------

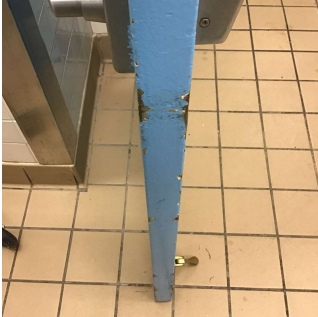
Deficiency	METAL: DETERIORATED DOOR
------------	--------------------------

Deficiency Location/Instance	Center
------------------------------	--------

Deficiency Quantity	1
---------------------	---

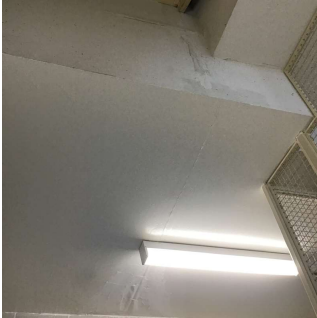
SHOWER ROOM	Does not Exist
STAIRS/RAMPS: INTERIOR	Inspected
Do Letter Stair Signs Exist?	Yes
Ceiling	
Condition	2 - Between Good and Fair
Deficiency	GYPSUM BOARD: DAMAGED/DETERIORATED

Question	Response
INTERIOR	
STAIRS/RAMPS: INTERIOR	
Ceiling	
Deficiency Location/Instance	Stair C/4
Deficiency Quantity	40
Quantity Uom	S.F.
Potential Action	REPLACE
Urgency of Action	PRIORITY 3
Purpose of Action	LEVEL 2
Deficiency Photo1

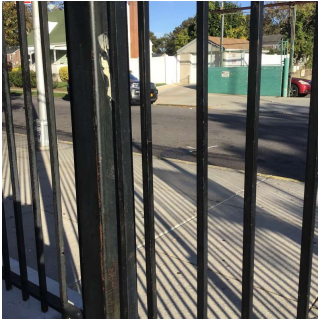
FENCES	Inspected
Condition	2 - Between Good and Fair
Deficiency	WROUGHT IRON: DAMAGED/DETERIORATED
Deficiency Location/Instance	Along 234 Street
Deficiency Quantity	40
Quantity Uom	S.F.
Potential Action	REPLACE
Urgency of Action	PRIORITY 3
Purpose of Action	LEVEL 2

Violations	Along 234 Street No violations recorded.
IRRIGATION SYSTEM	Does not Exist
PAVING	Inspected
Student Non-Use	Inspected
Gravel Exists?	No
Asphalt	Does not Exist
Concrete	Inspected
Condition	2 - Between Good and Fair
Deficiency	No deficiencies recorded
Pavers	Does not Exist
Student Use	Inspected
Gravel Exists?	No
Asphalt	Inspected
Condition	4 - Between Fair and Poor
Deficiency	CRACKS - MAJOR
Deficiency Location/Instance	Schoolyard along 233rd Street, 234 street, center courtyard,
Deficiency Quantity	700
Quantity Uom	S.F.
Potential Action	REPLACE
Urgency of Action	PRIORITY 3
Purpose of Action	LEVEL 2
Deficiency Photo1

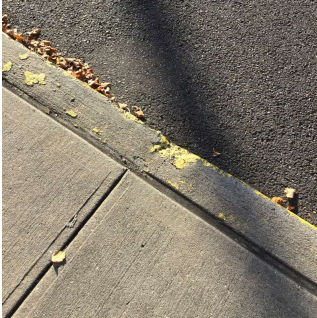
233rd Street
Violations	No violations recorded.
Deficiency	HEAVING
Deficiency Location/Instance	Merrick Boulevard, 233rd Street
Deficiency Quantity	100
Quantity Uom	S.F.
Potential Action	REPLACE
Urgency of Action	PRIORITY 3
Purpose of Action	LEVEL 2
Deficiency Photo1

Question	Response
SITE	
PAVING	
DOT Sidewalk	
Concrete	
Condition	4 - Between Fair and Poor
Deficiency	DAMAGED CURBS
Deficiency Location/Instance	Merrick Boulevard, 233rd Street, 234th Street
Deficiency Quantity	105
Quantity Uom	L.F.
Potential Action	REPLACE
Urgency of Action	PRIORITY 3
Purpose of Action	LEVEL 2
Deficiency Photo1

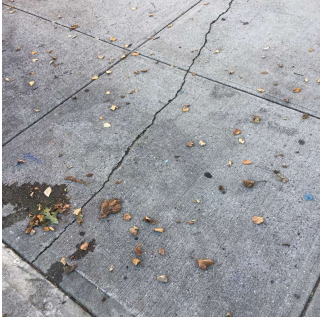
Merrick Boulevard
Violations	No violations recorded.
Deficiency	DAMAGED/DETERIORATED/MISSING SECTIONS
Deficiency Location/Instance	Along 234 Street
Deficiency Quantity	375
Quantity Uom	S.F.
Potential Action	REPLACE
Urgency of Action	PRIORITY 3
Purpose of Action	LEVEL 2

Violations	Along 234 Street, Merrick Boulevard No violations recorded.
Pavers	Inspected
Condition	2 - Between Good and Fair
Deficiency	HEAVING
Deficiency Location/Instance	Merrick Boulevard
Deficiency Quantity	10
Quantity Uom	S.F.
Potential Action	REPLACE
Urgency of Action	PRIORITY 3
Purpose of Action	LEVEL 2
Deficiency Photo1	 
Violations	Merrick Boulevard No violations recorded.
PLAYGROUNDS	Inspected
Instance on Along 233 Street	Inspected
Benches	
Instance on Along 233 Street	Does not Exist
Fence	
Instance on Along 233 Street	Does not Exist
Pavement	
Instance on Along 233 Street	Does not Exist
Play Equipment	
Instance on Along 233 Street	Inspected
Condition	2 - Between Good and Fair
Deficiency	No deficiencies recorded
Safety Surfacing	
Instance on Along 233 Street	Inspected
Condition	3 - Fair
