NYC Department of Education
Building Condition Assessment Survey 2023 - 2024

Architectural Inspection

Asset: P.S. 273 - QUEENS, 88-07 102ND STREET, New York, 11418

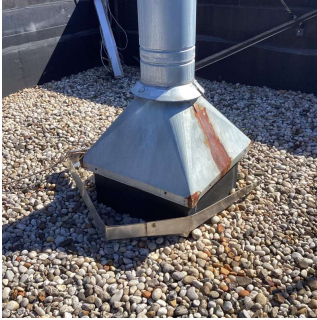
| Question | Response |
|---|---|
| Deficiency | METAL: DENTS, MAJOR RUSTING |

| Potential Action | REPLACE-UPGRADE |

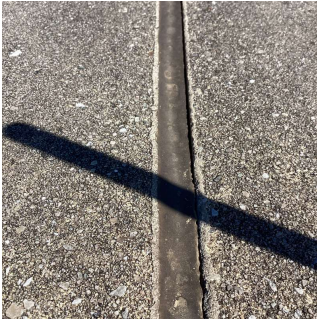
| Question | Response |
|---|--|
| Deficiency | CAST STONE: DETERIORATED TRANSVERSE JOINTS |

| Question | Response |
|---|--|
| Urgency of Action | PRIORITY 3 |

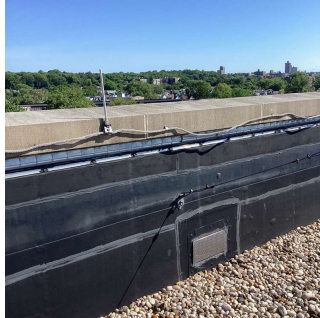
| Question | Response |
|---|--|
| Deficiency | IRMA: FLASHING: CAP FLASHING MISSING |

| Question | Response |
|---|--|
| Urgency of Action | PRIORITY 4 |

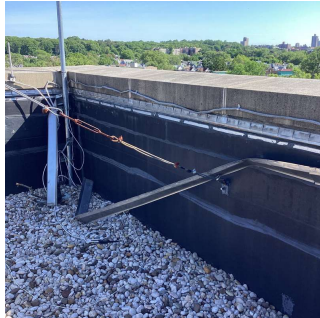
| Question | Response |
|---|--|
| Deficiency | IRMA: FLASHING: CAP FLASHING DAMAGED |

| Question | Response |
|---|--|
| Potential Action | REPLACE |
| Urgency of Action | PRIORITY 4 |

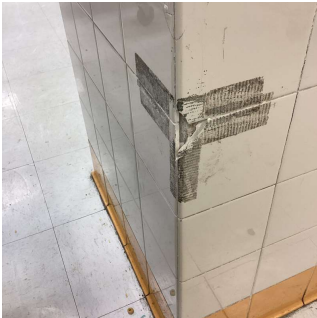
| Question | Response |
|--|--|
| | Column |

| Question | Response |
|---|--|
| Deficiency | CERAMIC TILE: BROKEN/ MISSING |
| Deficiency Location/Instance | Columns, Near center, Serving Area |

| Question | Response |
|--|--|
| Potential Action | REPLACE |
| Urgency of Action | PRIORITY 3 |

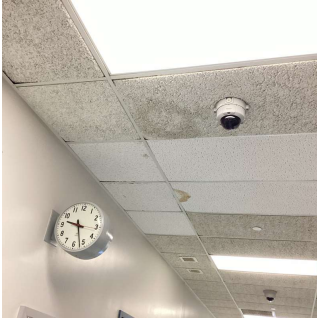
| Question | Response |
|--|--|
| | Corridor near Room 407 |

| Question | Response |
|--|--|
| Deficiency | ACOUSTIC TILES: DAMAGED/MISSING |
| Deficiency Location/Instance | Rooms 406, 407, Corridor near Room 407 |

| Question | Response |
|--|--|
| Potential Action | REPLACE |
| Urgency of Action | PRIORITY 3 |

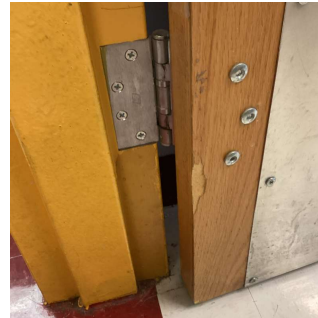
Room 306

| Question | Response |
|--|--|
| Deficiency | WOOD: DETERIORATED DOOR |
| Deficiency Location/Instance | Rooms 306, 404 |

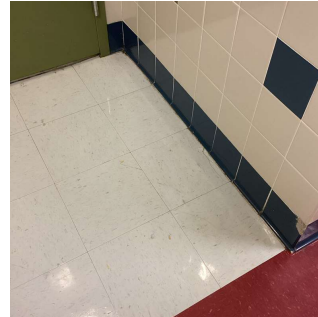
Corridor near Room C02

VINYL TILES: BROKEN/DETERIORATED/MISSING TILES

REPLACE

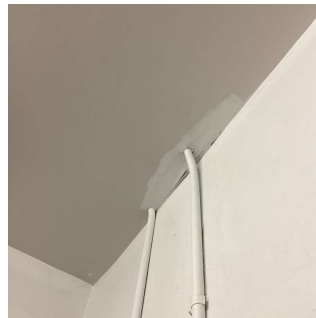
| Question | Response |
|---|--|
| Deficiency | GYPSUM BOARD: DAMAGED/DETERIORATED - ACTIVE LEAK |
| Deficiency Location/Instance | Stair A/Cellar |

| Question | Response |
|---|--|
| Potential Action | REPLACE |

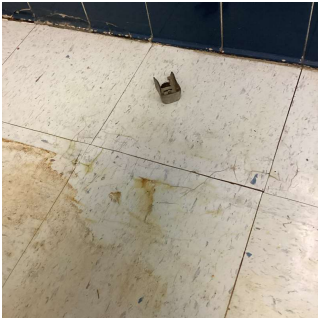
| | Stair A/1 |

| Deficiency | VINYL TILES: BROKEN/DETERIORATED/MISSING TILES |
| Deficiency Location/Instance | Stair A/1 |

| Potential Action | REPLACE |
| Urgency of Action | PRIORITY 3 |

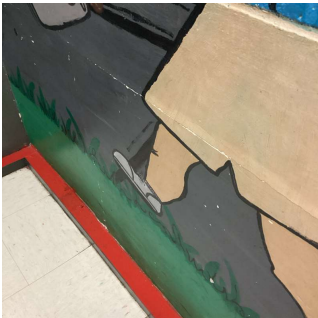
| Deficiency | PLASTER: CRACKS/SPALLING |
| Deficiency Location/Instance | Stair B/Cellar |

| Potential Action | REPLACE |
| Urgency of Action | PRIORITY 3 |

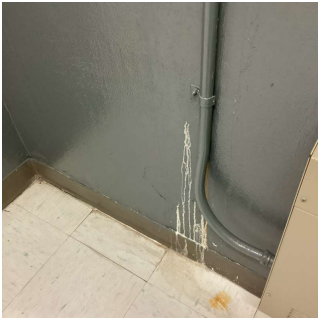
| Question | Response |
|---|--|
| Deficiency | PLASTER: CRACKS/SPALLING - ACTIVE LEAK |
| Deficiency Location/Instance | Stair A/Cellar |

| Question | Response |
|---|--|
| Potential Action | REPLACE |
| Urgency of Action | PRIORITY 5 |

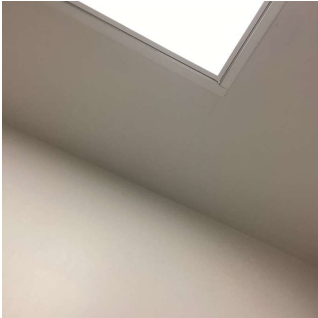
| Question | Response |
|---|--|
| Deficiency | GYPSUM BOARD: DAMAGED/DETERIORATED |
| Deficiency Location/Instance | Room 415 |

| Question | Response |
|---|--|
| Potential Action | REPLACE |
| Urgency of Action | PRIORITY 3 |

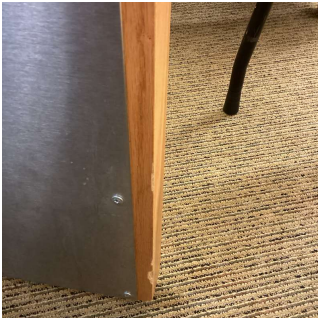
| Question | Response |
|---|---|
| Room 413A | |

| Question | Response |
|---|---|
| Condition | 5 - Poor |
| Deficiency | WOOD: DETERIORATED DOOR |
| Deficiency Location/Instance | Rooms 101/107, 307A, 402A,409A, 413A |

| Question | Response |
|---|---|
| Urgency of Action | PRIORITY 3 |

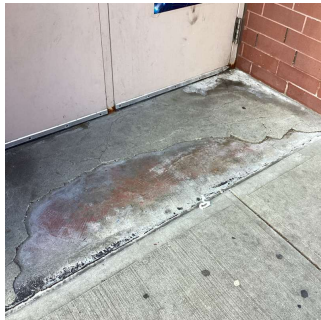
| Question | Response |
|---|--|
| Deficiency | DAMAGED/DETERIORATED/MISSING SECTIONS |
| Deficiency Location/Instance | Near Exit 2 |

| Question | Response |
|---|--|
| Potential Action | REPLACE |
| Urgency of Action | PRIORITY 3 |

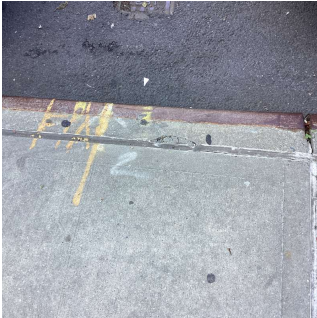
| Question | Response |
|---|--|
| | 102nd Street |

| Question | Response |
|---|--|
| Deficiency | DAMAGED CURBS |
| Deficiency Location/Instance | 102nd Street |

| Question | Response |
|---|--|
| Potential Action | REPLACE |
| Urgency of Action | PRIORITY 3 |

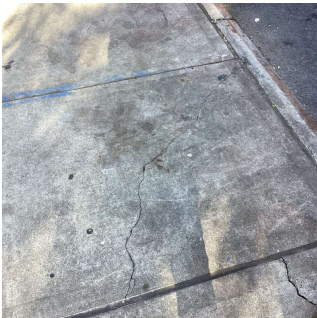
| Question | Response |
|---|--|
| | 88th Avenue |

| Question | Response |
|---|--|
| Deficiency | DAMAGED/DETERIORATED/MISSING SECTIONS |
| Deficiency Location/Instance | 88th Avenue, 102nd Street |

| Question | Response |
|---|--|
| Potential Action | REPLACE |
| Urgency of Action | PRIORITY 3 |

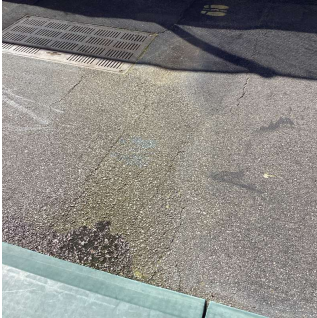
| Question | Response |
|---|--|
| Deficiency | ASPHALT: CRACKS - MAJOR |

| Question | Response |
|--|--|
| Deficiency Location/Instance | Near Exit 4 |

| Question | Response |
|--|--|
| Potential Action | REPLACE |
| Urgency of Action | PRIORITY 3 |

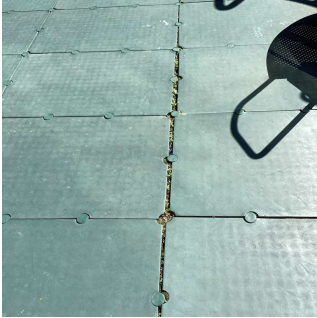
| Question | Response |
|--|--|
| Deficiency | DETERIORATED/MISSING |
| Deficiency Location/Instance | Near Exits 3, 4 |

| Question | Response |
|--|--|
| Potential Action | REPLACE |
| Urgency of Action | PRIORITY 3 |

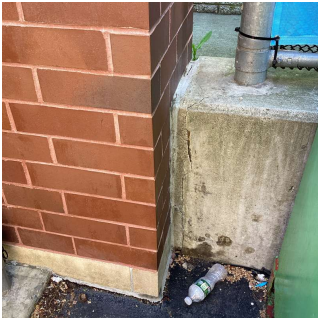
| Question | Response |
|---|--|
| Deficiency | CAST IN PLACE CONCRETE: CRACKS/SPALLING - MAJOR |
| Deficiency Location/Instance | Near Gas Meter Area, Exit 4 |

| Question | Response |
|---|--|
| Potential Action | REPLACE |
| Urgency of Action | PRIORITY 3 |

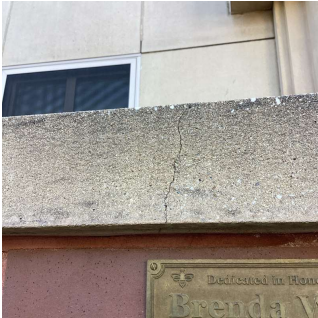
| Question | Response |
|---|--|
| Deficiency | BRICK: DETERIORATED COPING STONE |
| Deficiency Location/Instance | 102nd Street |

| Question | Response |
|---|--|
| Potential Action | REPLACE |
| Urgency of Action | PRIORITY 3 |

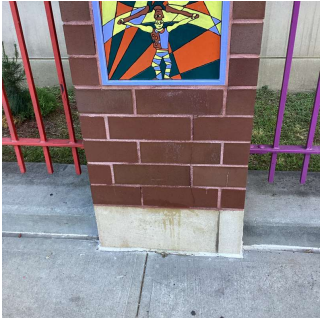
| Question | Response |
|---|--|
| Deficiency | BRICK: CRACKS/SPALLING - MAJOR |
| Deficiency Location/Instance | 102nd Street |

| Question | Response |
|---|--|
| Potential Action | REPLACE |
