**NYC Department of Education**  
**Building Condition Assessment Survey 2023 - 2024**

Architectural Inspection

Q276

**Asset: THE WILLIAM WORDSWORTH EDUCATIONAL COMPLEX - QUEENS, 108-29 155 STREET, New York, 11433**

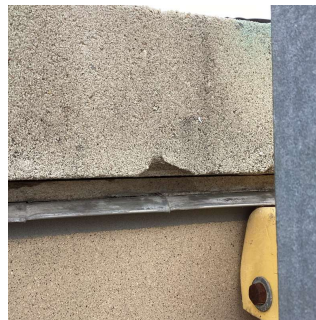
Roof 3

CAST STONE: DETERIORATED BED JOINT

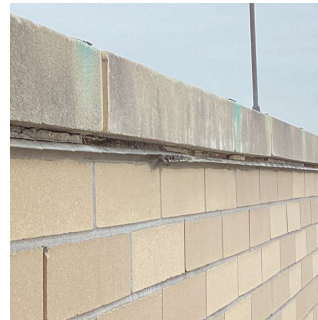
Roof 2

**CAST STONE: DETERIORATED TRANSVERSE JOINTS**

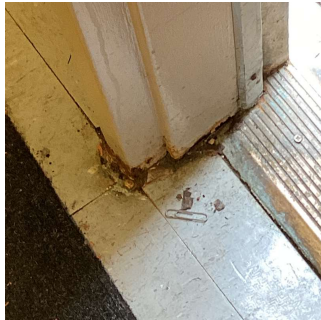
Violations	Roof 1 No violations recorded.
<b>CORNICE</b>	Does not Exist
<b>DOORS</b>	Inspected
<b>DOORS AND FRAMES</b>	Inspected
Condition	3 - Fair
Deficiency	METAL: DETERIORATED DOOR AND FRAME - MINOR DETERIORATION
Roof Plan reference	Q276

Deficiency Quantity	4
Quantity Uom	EACH
Potential Action	MAINTENANCE
Urgency of Action	PRIORITY 3
Purpose of Action	LEVEL 2
Deficiency Photo1

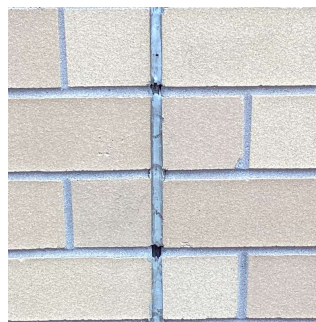
Facade D

Deficiency	<b>BRICK: DETERIORATED CONTROL/EXPANSION JOINTS</b>
------------	---

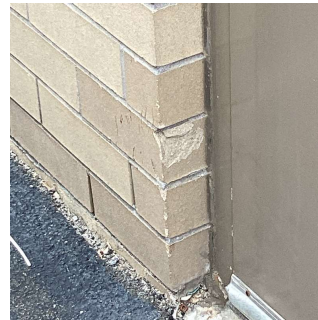
Facade D

**BRICK: MINOR CRACKS AND SPALLING**

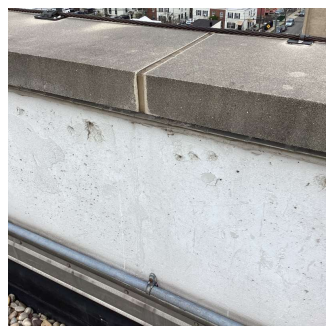
Deficiency Quantity	20
Quantity Uom	S.F.
Potential Action	REPAIR
Urgency of Action	PRIORITY 3
Purpose of Action	LEVEL 2
Deficiency Photo1

Violations	Roof 1 No violations recorded.
<b>PLAZA DECK</b>	Does not Exist
<b>ROOF</b>	Inspected
<b>Roofing</b>	Inspected
Replacement Quantity	22,000
Replacement Uom	S.F.
<b>ROOF HATCH/SMOKE HATCH</b>	Inspected
Condition	2 - Between Good and Fair
Deficiency	No deficiencies recorded
<b>LEADERS, GUTTERS, DOWNSPOUTS, SCUPPERS</b>	Inspected
Condition	2 - Between Good and Fair
Deficiency	No deficiencies recorded
<b>ROOF BARRIER/FENCE</b>	Inspected
Condition	2 - Between Good and Fair
Deficiency	No deficiencies recorded
<b>ROOF CAGE</b>	Does not Exist
<b>ROOFING</b>	Inspected
Instance on IRMA: All Roofs	Inspected
Instance Condition	4 - Between Fair and Poor

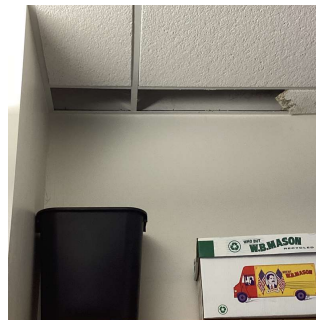
Roof 1 - Room 507 (Roof 1 - Room 505, Corridor near Rooms 502, 511, Roof 2 - Corridor near Room 403 similar)

Deficiency	IRMA: ROOFING: MAJOR ACTIVE ROOF LEAKS IN INSTRUCTIONAL SPACE
------------	---

Potential Action	REPLACE ROOFING WITHOUT MAJOR EQUIPMENT REMOVAL
------------------	---

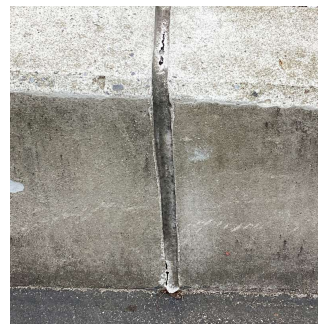
Facade E

10  
 L.F.  
 REPLACE  
 PRIORITY 3  
 LEVEL 2

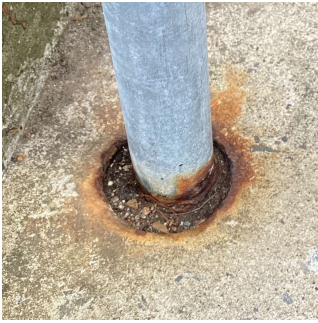
RUST - MAJOR

10  
 L.F.  
 REPLACE  
 PRIORITY 4  
 LEVEL 2

Violations	Facade E No violations recorded.
<b>STAIRS/RAMPS</b>	Inspected
Condition	2 - Between Good and Fair
Deficiency	No deficiencies recorded
<b>WINDOWS</b>	Inspected
Replacement Quantity	8,000
Replacement Uom	S.F.
<b>EXTERIOR GUARDS</b>	Inspected
Condition	2 - Between Good and Fair
Deficiency	No deficiencies recorded
<b>LINTELS</b>	Inspected
Condition	2 - Between Good and Fair
Deficiency	No deficiencies recorded
<b>WINDOWS</b>	Inspected
Material Type(s)	Aluminum
Instance on Aluminum - Other: All Facades	Inspected
Instance Condition	2 - Between Good and Fair
Instance Quantity	8,000
Instance Quantity Uom	S.F.
Are these windows insulated	Yes
Installation Year	2011
Source of Installation	Custodial Staff
Deficiency	ALUMINUM - OTHER: BROKEN PANE
Roof Plan reference	Q276

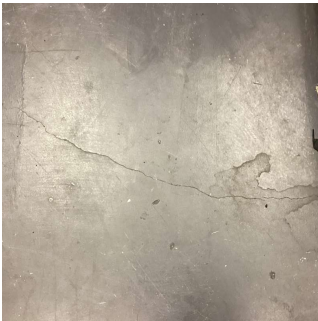
Violations	Room 135 (Rooms 141, 145 similar) No violations recorded.
Deficiency	CONCRETE: CRACKS/SPALLED/REINFORCEMENT EXPOSED
Deficiency Location/Instance	PH
Deficiency Quantity	40
Quantity Uom	S.F.
Potential Action	REPAIR
Urgency of Action	PRIORITY 3
Purpose of Action	LEVEL 5
Deficiency Photo1

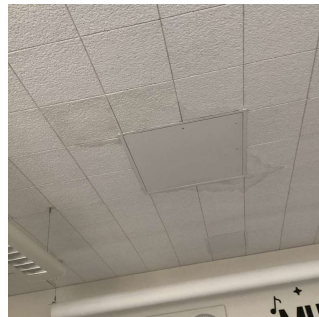
Violations	Room 401
Violations	No violations recorded.
Deficiency	ACOUSTIC TILES: DAMAGED/MISSING
Deficiency Location/Instance	Rooms 441,401 Corridor near 441
Deficiency Quantity	20
Quantity Uom	S.F.
Potential Action	REPLACE
Urgency of Action	PRIORITY 3
Purpose of Action	LEVEL 2
Deficiency Photo1

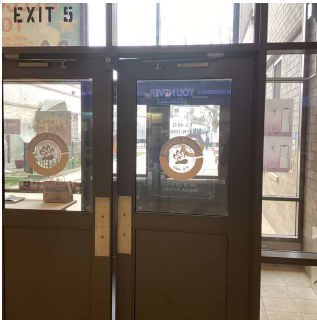
Violations	Room 512 No violations recorded.
Deficiency	METAL: DETERIORATED DOOR AND FRAME
Deficiency Location/Instance	Main Entrance Vestibule
Deficiency Quantity	1
Quantity Uom	EACH
Potential Action	MAINTENANCE
Urgency of Action	PRIORITY 3
Purpose of Action	LEVEL 2
Deficiency Photo1

Violations	Main Entrance Vestibule No violations recorded.
<b>Floor Finish</b>	Inspected
Condition	2 - Between Good and Fair
Deficiency	VINYL TILES: DETERIORATED SUBSTRATE
Deficiency Location/Instance	Rooms 401, 405
Deficiency Quantity	20

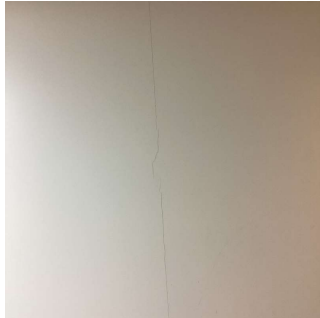
Violations	Room 401 No violations recorded.
<b>Walls</b>	
Condition	Inspected 2 - Between Good and Fair
Deficiency	GYPSON BOARD: DETERIORATED
Deficiency Location/Instance	Corridor near rooms 512, 511, 437, 436, 401 and others
Deficiency Quantity	120
Quantity Uom	S.F.
Potential Action	REPLACE
Urgency of Action	PRIORITY 3
Purpose of Action	LEVEL 2
Deficiency Photo1

Violations	Corridor near room 512 No violations recorded.
Deficiency	CERAMIC TILE: BROKEN/ MISSING
Deficiency Location/Instance	Main Lobby
Deficiency Quantity	10
Quantity Uom	S.F.
Potential Action	REPLACE
Urgency of Action	PRIORITY 3
Purpose of Action	LEVEL 2

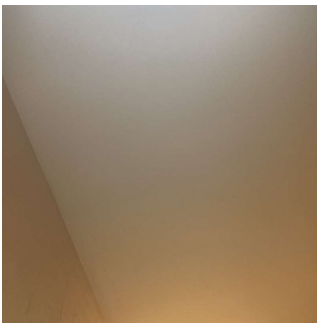
Do Letter Stair Signs Exist?	Yes
<b>Ceiling</b>	
Condition	2 - Between Good and Fair
Deficiency	GYP SUM BOARD: DAMAGED/DETERIORATED
Deficiency Location/Instance	Stair C/4
Deficiency Quantity	10
Quantity Uom	S.F.
Potential Action	REPLACE
Urgency of Action	PRIORITY 3
Purpose of Action	LEVEL 2

Violations	Stair C/4 No violations recorded.
<b>Door(s)</b>	Inspected
Condition	2 - Between Good and Fair
Deficiency	No deficiencies recorded
<b>Partition</b>	Does not Exist
<b>Railings</b>	Inspected
Condition	2 - Between Good and Fair
Deficiency	No deficiencies recorded
<b>Stairs and Landings</b>	Inspected
Condition	2 - Between Good and Fair
Deficiency	No deficiencies recorded
<b>Walls</b>	Inspected
Condition	2 - Between Good and Fair
Deficiency	No deficiencies recorded
<b>TOILET ROOMS - STAFF</b>	Inspected
<b>Ceiling</b>	Inspected
Condition	2 - Between Good and Fair
Deficiency	No deficiencies recorded
<b>Door(s)</b>	Inspected
Condition	2 - Between Good and Fair
Deficiency	No deficiencies recorded
<b>Floor Finish</b>	Inspected
Condition	2 - Between Good and Fair
Deficiency	No deficiencies recorded
<b>Stalls</b>	Inspected

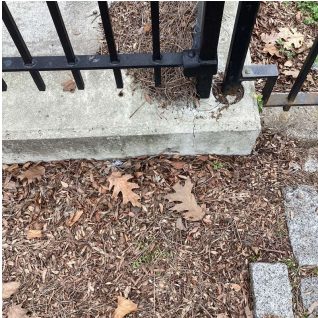
Question	Response
<b>SITE</b>	
<b>CONTAINERIZATION</b>	Inspected
Condition	4 - Between Fair and Poor
Deficiency	CONCRETE PAD MISSING
Deficiency Location/Instance	Along 155th Street
Deficiency Quantity	300
Quantity Uom	S.F.
Potential Action	INSTALL NEW
Urgency of Action	PRIORITY 3
Purpose of Action	LEVEL 2
Deficiency Photo1	 
Violations	Along 155th Street No violations recorded.
Deficiency	FENCING DAMAGED
Deficiency Location/Instance	Along 155th Street
Deficiency Quantity	50
Quantity Uom	S.F.
Potential Action	REPAIR
Urgency of Action	PRIORITY 3
Purpose of Action	LEVEL 2
Deficiency Photo1	 
Violations	Along 155th Street No violations recorded.
<b>Drainage System for Asphalt</b>	Inspected
<b>Catch Basins/Manhole - Surrounded by asphalt</b>	Inspected
Condition	2 - Between Good and Fair
Deficiency	No deficiencies recorded
<b>Culverts - Asphalt Covering</b>	Does not Exist
<b>Drainage System for Concrete</b>	Inspected
<b>Catch Basins/Manhole - Surrounded by concrete</b>	Inspected

Violations	Along 155th Street No violations recorded.
<b>IRRIGATION SYSTEM</b>	Does not Exist
<b>PAVING</b>	Inspected
<b>Student Non-Use</b>	Inspected
Gravel Exists?	No
<b>Asphalt</b>	Inspected
Condition	4 - Between Fair and Poor
Deficiency	CRACKS - MAJOR
Deficiency Location/Instance	Containerization area, Parking Lot
Deficiency Quantity	900
Quantity Uom	S.F.

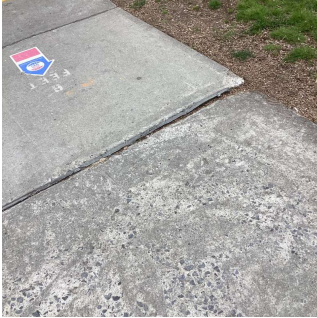
Along 155th Street
Violations	No violations recorded.
Deficiency	DAMAGED/DETERIORATED/MISSING SECTIONS
Deficiency Location/Instance	Along 155th Street
Deficiency Quantity	300
Quantity Uom	S.F.
