NYC Department of Education
Building Condition Assessment Survey 2023 - 2024

Architectural Inspection

Asset: PS 182 SAMANTHA SMITH - QUEENS, 153-27 88TH AVENUE, New York, 11432

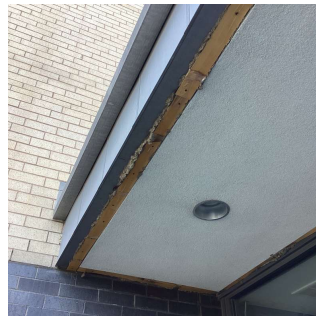
Question	Response
Architectural	
EXTERIOR	Inspected
AREAWAY	Does not Exist
AWNINGS AND CANOPIES	Inspected
Condition	4 - Between Fair and Poor
Deficiency	CONCRETE: DETERIORATED
Roof Plan reference

100
S.F.
REPLACE
PRIORITY 4
LEVEL 2

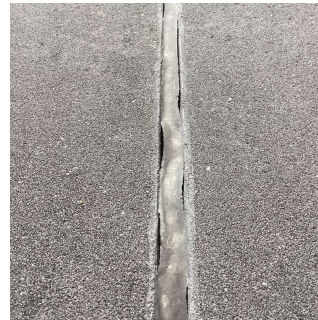
2 - Between Good and Fair

CAST STONE: DETERIORATED TRANSVERSE JOINTS

30
 L.F.
 MAINTENANCE
 PRIORITY 3
 LEVEL 2

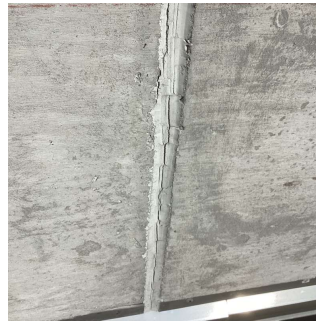
Roof 1
No violations recorded.

Condition	2 - Between Good and Fair
Deficiency	No deficiencies recorded
PARAPETS	
	Inspected
Material Type(s)	Masonry, Concrete
Replacement Quantity	3,100
Replacement Uom	C.F.
Instance on All Facades	Inspected
Instance Condition	3 - Fair
Instance Quantity	3,100
Instance Quantity Uom	C.F.
Deficiency	CONCRETE: DETERIORATED CONTROL/EXPANSION JOINT

50
L.F.
MAINTENANCE
PRIORITY 3
LEVEL 2

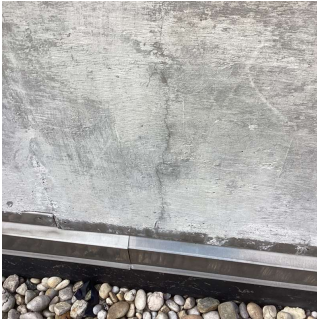
CONCRETE: MINOR CRACKS, SPALLING

50
S.F.
REPAIR
PRIORITY 3
LEVEL 2

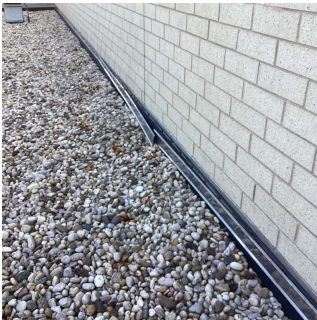
Roof 2
Violations	No violations recorded.
ROOFING DRAINS	Inspected
Condition	5 - Poor
Deficiency	CLOGGED

Roof 1
Instance Quantity	24,000
Instance Quantity Uom	S.F.
Does the roof have major mechanical equipment sitting on Dunnage Steel less than 18" above the Roofing?	No
Does this roof instance have a Sustainable Roof System?	No
Do solar panels exist on these roofs?	No
Is/Are the roof(s) suitable for Solar Panel installation?	No
Installation Year	2012
Source of Installation	Custodial Staff
Deficiency	IRMA: FLASHING: CAP FLASHING DAMAGED
Roof Plan reference

Deficiency Quantity	30
Quantity Uom	L.F.
Potential Action	REPLACE
Urgency of Action	PRIORITY 4
Purpose of Action	LEVEL 2
Deficiency Photo1

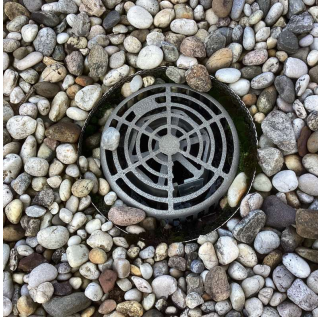
DETERIORATED

5
 EACH
 REPLACE
 PRIORITY 4
 LEVEL 2

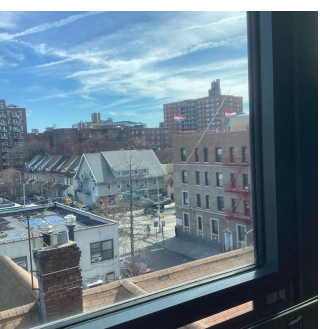
Are these windows insulated	Yes
Installation Year	2012
Source of Installation	Custodial Staff
Deficiency	ALUMINUM - OTHER: BROKEN PANE

Deficiency Quantity	30
Quantity Uom	S.F.
Potential Action	MAINTENANCE
Urgency of Action	PRIORITY 3
Purpose of Action	LEVEL 2
Deficiency Photo1

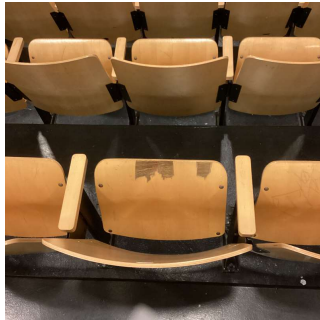
Question	Response
INTERIOR	
STRUCTURAL	
FOUNDATION WALLS	Inspected
Deficiency	No deficiencies recorded
ROOF STRUCTURE	Inspected
Condition	2 - Between Good and Fair
Deficiency	No deficiencies recorded
VAULTS-BUNKERS	Does not Exist
AUDITORIUM	Inspected
Instance on 1st Floor (350 Seats)	Inspected
Ceiling	
Instance on 1st Floor (350 Seats)	Inspected
Condition	2 - Between Good and Fair
Deficiency	No deficiencies recorded
Door(s)	
Instance on 1st Floor (350 Seats)	Inspected
Condition	2 - Between Good and Fair
Deficiency	No deficiencies recorded
Fixed H/C Lift	
Instance on 1st Floor (350 Seats)	Does not Exist
Fixed Seating	
Instance on 1st Floor (350 Seats)	Inspected
Condition	2 - Between Good and Fair
Deficiency	DAMAGED/BROKEN/INOPERABLE
Deficiency Location/Instance	Seats D/60, G/123, H/145
Deficiency Quantity	3
Quantity Uom	EACH
Potential Action	REPLACE
Urgency of Action	PRIORITY 3
Purpose of Action	LEVEL 2
Deficiency Photo1

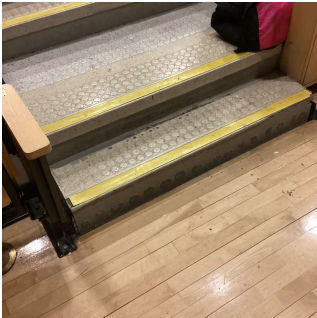
Seat G/123
Violations	No violations recorded.
Floor Finish	
Instance on 1st Floor (350 Seats)	Inspected
Condition	2 - Between Good and Fair
Deficiency	RUBBER NOSING: DETERIORATED
Deficiency Location/Instance	Left Aisle
Deficiency Quantity	10
Quantity Uom	L.F.
Potential Action	MAINTENANCE
Urgency of Action	PRIORITY 3

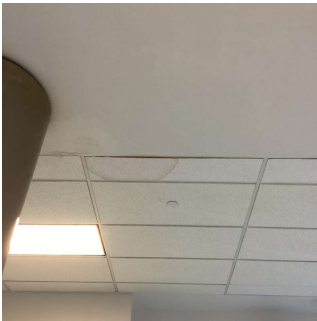
Condition	2 - Between Good and Fair
Deficiency	ACOUSTIC TILES: DAMAGED/MISSING - ACTIVE LEAK
Deficiency Location/Instance	Near stair C
Deficiency Quantity	10
Quantity Uom	S.F.
Potential Action	REPLACE
Urgency of Action	PRIORITY 5
Purpose of Action	LEVEL 2

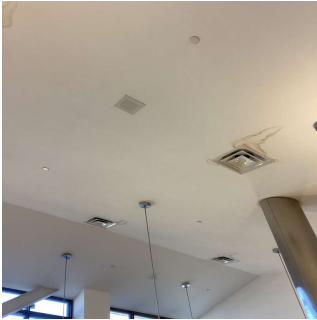
Violations	Near stair C No violations recorded.
Deficiency	GYPSUM BOARD: DAMAGED/DETERIORATED
Deficiency Location/Instance	Near center
Deficiency Quantity	40
Quantity Uom	S.F.
Potential Action	REPLACE
Urgency of Action	PRIORITY 3
Purpose of Action	LEVEL 2
Deficiency Photo1

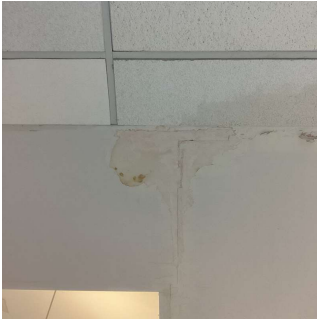
Violations	Near center No violations recorded.
Deficiency	GYPSUM BOARD: DAMAGED/DETERIORATED - ACTIVE LEAK
Deficiency Location/Instance	Near Stair C
Deficiency Quantity	30
Quantity Uom	S.F.
Potential Action	REPLACE
Urgency of Action	PRIORITY 5
Purpose of Action	LEVEL 2
Deficiency Photo1

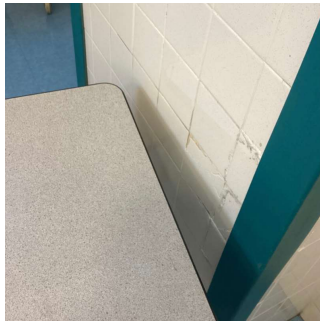
Violations	Near Windows No violations recorded.
Deficiency	CERAMIC TILE: BROKEN/ MISSING
Deficiency Location/Instance	Near Serving Area
Deficiency Quantity	10
Quantity Uom	S.F.
Potential Action	REPLACE
Urgency of Action	PRIORITY 3
Purpose of Action	LEVEL 2
Deficiency Photo1

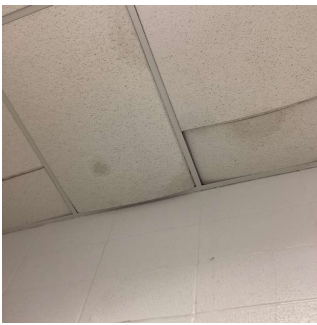
Question	Response
INTERIOR	
GYMNASIUM	
Ceiling	
Deficiency Photo1

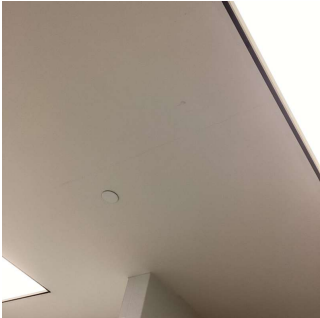
Question	Response
INTERIOR	
LOCKER ROOM	
Instance on 3rd Floor - Room 325	Inspected
Alternative use	Yes
Ceiling	
Instance on 3rd Floor - Room 325	Inspected
Condition	2 - Between Good and Fair
Deficiency	GYP SUM BOARD: DAMAGED/DETERIORATED
Deficiency Location/Instance	Near center
Deficiency Quantity	10
Quantity Uom	S.F.
Potential Action	REPLACE
Urgency of Action	PRIORITY 3
Purpose of Action	LEVEL 2
Deficiency Photo1

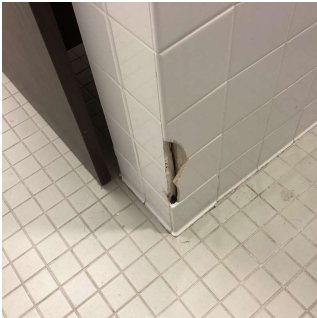
Question	Response
INTERIOR	
LOCKER ROOM	
Door(s)	
Condition	2 - Between Good and Fair
Deficiency	No deficiencies recorded
Floor Finish	
Instance on 3rd Floor - Room 325	Inspected
Condition	2 - Between Good and Fair
Deficiency	No deficiencies recorded
Instance on 3rd Floor - Room 321	Inspected
Condition	2 - Between Good and Fair
Deficiency	No deficiencies recorded
Locker Room Lockers	
Instance on 3rd Floor - Room 321	Does not Exist
Instance on 3rd Floor - Room 325	Does not Exist
Walls	
Instance on 3rd Floor - Room 325	Inspected
Condition	2 - Between Good and Fair
Deficiency	CERAMIC TILE: BROKEN/ MISSING
Deficiency Location/Instance	Near Entrance
Deficiency Quantity	10
Quantity Uom	S.F.
Potential Action	REPLACE
Urgency of Action	PRIORITY 3
Purpose of Action	LEVEL 2
Deficiency Photo1

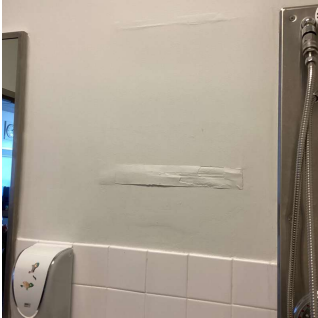
Question	Response
INTERIOR	
TOILET ROOMS - STUDENTS	
Door(s)	Inspected
Condition	2 - Between Good and Fair
Deficiency	No deficiencies recorded
Floor Finish	Inspected
Condition	2 - Between Good and Fair
Deficiency	No deficiencies recorded
Stalls	Inspected
Condition	2 - Between Good and Fair
Deficiency	No deficiencies recorded
Walls	Inspected
Condition	2 - Between Good and Fair
Deficiency	GYPSUM BOARD: DETERIORATED
Deficiency Location/Instance	Room 202A
Deficiency Quantity	10
Quantity Uom	S.F.
Potential Action	REPLACE
Urgency of Action	PRIORITY 3
Purpose of Action	LEVEL 2
Deficiency Photo1

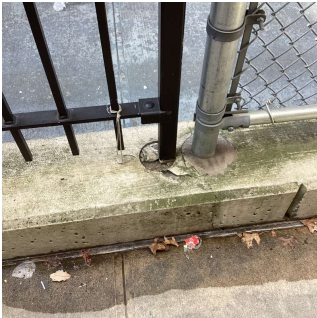
Question	Response
SITE	
FENCES	
Condition	3 - Fair
Deficiency	CONCRETE CURB: DAMAGED/DETERIORATED
Deficiency Location/Instance	Near Exit Playground
Deficiency Quantity	20
Quantity Uom	S.F.
Potential Action	REPLACE
Urgency of Action	PRIORITY 3
Purpose of Action	LEVEL 2
Deficiency Photo1

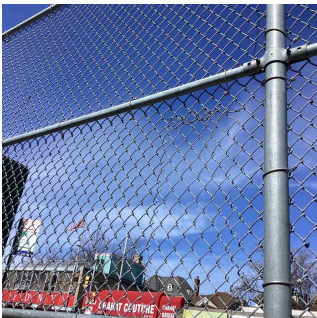
Violations	Near Exit Playground No violations recorded.
Deficiency	CHAIN LINK: DAMAGED/DETERIORATED
Deficiency Location/Instance	Hillside Avenue
Deficiency Quantity	50
Quantity Uom	S.F.
Potential Action	REPLACE
Urgency of Action	PRIORITY 3
Purpose of Action	LEVEL 2
Deficiency Photo1

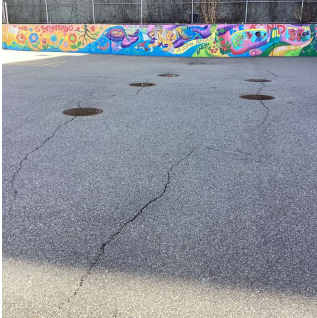
Question	Response
SITE	
PAVING	
Student Use	
Asphalt	Inspected
Condition	3 - Fair
Deficiency	CRACKS - MAJOR
Deficiency Location/Instance	Near center
Deficiency Quantity	400
Quantity Uom	S.F.
Potential Action	REPLACE
Urgency of Action	PRIORITY 3
Purpose of Action	LEVEL 2
Deficiency Photo1

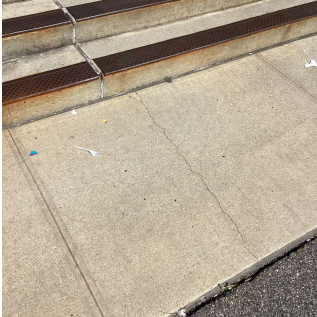
Violations	Near center No violations recorded.
Concrete	Inspected
Condition	3 - Fair
Deficiency	DAMAGED/DETERIORATED/MISSING SECTIONS
Deficiency Location/Instance	Near Stairs
Deficiency Quantity	50
Quantity Uom	S.F.
Potential Action	REPLACE
Urgency of Action	PRIORITY 3
Purpose of Action	LEVEL 2
Deficiency Photo1

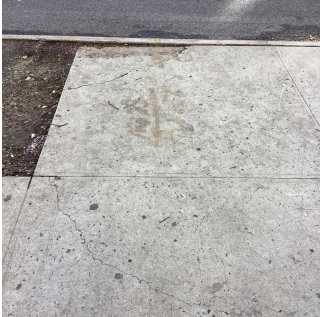
Question	Response
SITE	
PAVING	
Site Sidewalks & Walkways	
Concrete	
Deficiency Quantity	225
Quantity Uom	S.F.
Potential Action	REPLACE
Urgency of Action	PRIORITY 3
Purpose of Action	LEVEL 2
Deficiency Photo1	 
	88th Avenue
Violations	No violations recorded.
Pavers	Does not Exist
DOT Sidewalk	Inspected
Asphalt	Does not Exist
Concrete	Inspected
Condition	3 - Fair
Deficiency	HEAVING
Deficiency Location/Instance	88th Avenue
Deficiency Quantity	25
Quantity Uom	S.F.
Potential Action	REPLACE
Urgency of Action	PRIORITY 5
Purpose of Action	LEVEL 6
Deficiency Photo1	 
	88th Avenue
Violations	No violations recorded.
Deficiency	DAMAGED/DETERIORATED/MISSING SECTIONS
Deficiency Location/Instance	88th Avenue, Hillside
Deficiency Quantity	50
Quantity Uom	S.F.
Potential Action	REPLACE
Urgency of Action	PRIORITY 3
Purpose of Action	LEVEL 2

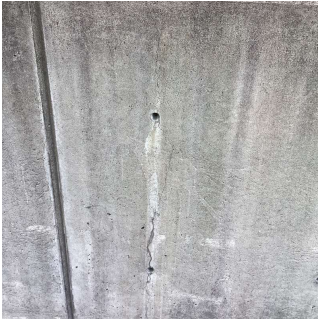
Violations	88th Avenue No violations recorded.
Pavers	Does not Exist
PLAYGROUNDS	Inspected
Instance on West Side of Building	Inspected
Benches	
Instance on West Side of Building	Does not Exist
Fence	
Instance on West Side of Building	Does not Exist
Pavement	
Instance on West Side of Building	Does not Exist
Play Equipment	
Instance on West Side of Building	Inspected
Condition	2 - Between Good and Fair
Deficiency	No deficiencies recorded
Safety Surfacing	
Instance on West Side of Building	Inspected
Condition	2 - Between Good and Fair
Deficiency	No deficiencies recorded
Unpaved Area	
Instance on West Side of Building	Does not Exist
PLAYING SURFACE	Does not Exist
RETAINING WALLS	Inspected
Are there any Retaining Walls 6' OR higher facing public street/sidewalk?	No
Condition	3 - Fair
Deficiency	CAST IN PLACE CONCRETE: CRACKS/SPALLING - MAJOR
Deficiency Location/Instance	Near Entrance, ramp area, exit schoolyard

Deficiency Quantity	50
Quantity Uom	S.F.
Potential Action	REPLACE
Urgency of Action	PRIORITY 3
Purpose of Action	LEVEL 2

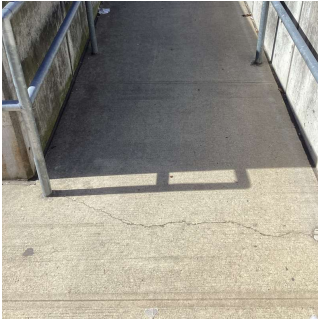
Violations	Near Entrance No violations recorded.
SEATING	Does not Exist
SITE WALLS (NOT RETAINING WALLS)	Inspected
Condition	2 - Between Good and Fair
Deficiency	No deficiencies recorded
STAIRS/RAMPS: EXTERIOR	Inspected
Railings	Inspected
Condition	2 - Between Good and Fair
Deficiency	No deficiencies recorded
Site Cheek/flank Walls	Inspected
Condition	2 - Between Good and Fair
Deficiency	No deficiencies recorded
Stairs/ramps	Inspected
Condition	2 - Between Good and Fair
Deficiency	CAST IN PLACE CONCRETE: CRACKS/SPALLING - MAJOR
Deficiency Location/Instance	End Of the Ramp
Deficiency Quantity	30
Quantity Uom	S.F.
Potential Action	REPLACE
Urgency of Action	PRIORITY 3
Purpose of Action	LEVEL 2
Deficiency Photo1
