NYC Department of Education
Building Condition Assessment Survey 2023 - 2024

Architectural Inspection

Asset: PS 182 ANNEX - QUEENS, 88-13 PARSONS BOULEVARD, New York, 11432

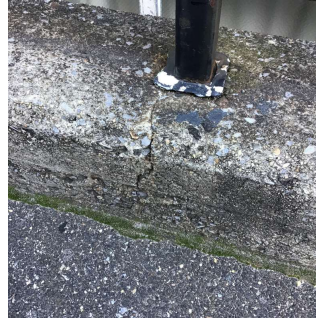
AW1
No violations recorded.

Question	Response
Architectural	
EXTERIOR	Inspected
AREAWAY	Inspected
Instance on AW1-AW3	Inspected
Instance Condition	3 - Fair
Instance Quantity	3
Instance Quantity Uom	EACH
Deficiency	AREAWAY WALLS: CRACKS AND SPALLING
Roof Plan reference	
Deficiency Quantity	40
Quantity Uom	S.F.
Potential Action	REPAIR
Urgency of Action	PRIORITY 3
Purpose of Action	LEVEL 2

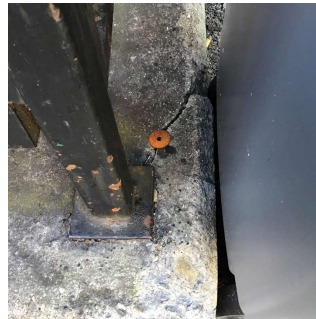
AW3
No violations recorded.

AREAWAY WALLS: CRACKS AND SPALLING

20
S.F.
REPLACE
PRIORITY 4
LEVEL 2

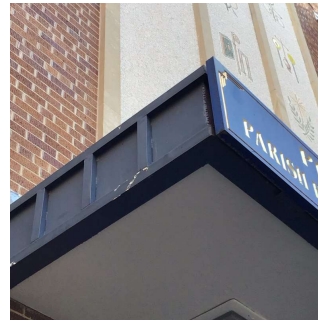
Facade A

METAL: DETERIORATION/DAMAGED/MISSING PIECES

10
S.F.
REPLACE
PRIORITY 4
LEVEL 2

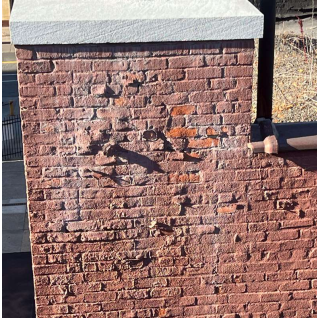
BRICK: MAJOR / THRU CRACKS

40
S.F.
REMOVE AND REBUILD
PRIORITY 4
LEVEL 2

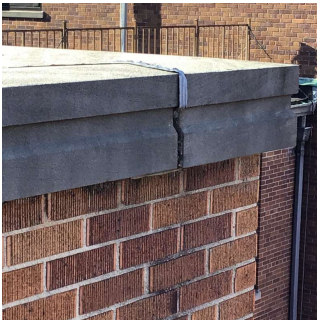
Violations	CH No violations recorded.
COPING	
Condition	Inspected 2 - Between Good and Fair
Deficiency	CAST STONE: DETERIORATED TRANSVERSE JOINTS
Roof Plan reference

Deficiency Quantity	10
Quantity Uom	L.F.
Potential Action	MAINTENANCE
Urgency of Action	PRIORITY 3
Purpose of Action	LEVEL 2
Deficiency Photo1

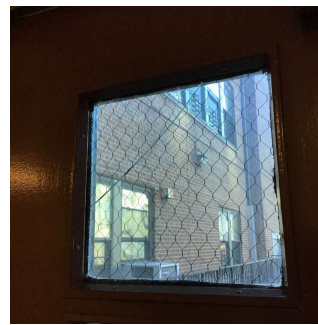
Facade A

Violations	Roof 1 No violations recorded.
CORNICE	
	Does not Exist
DOORS	
	Inspected
DOORS AND FRAMES	
	Inspected
Condition	3 - Fair
Deficiency	METAL: DETERIORATED DOOR - MINOR DETERIORATION

1
EACH
MAINTENANCE
PRIORITY 3
LEVEL 2

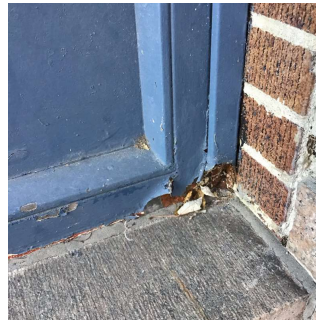
Facade C

METAL: DENTED, MAJOR RUSTING

10
S.F.
REPLACE
PRIORITY 4
LEVEL 2

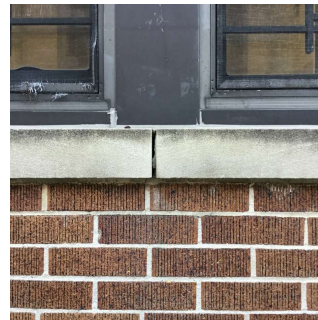
Facade E

BRICK: MASONRY SILLS - DETERIORATED JOINTS

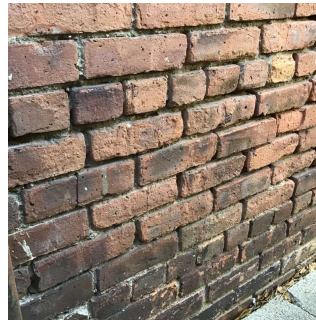
Facade H

BRICK: DETERIORATED JOINTS

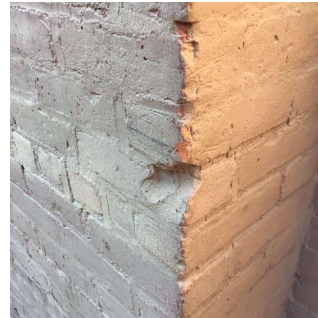
Facade G

BRICK: MAJOR / THRU CRACKS

PRIORITY 4
LEVEL 2

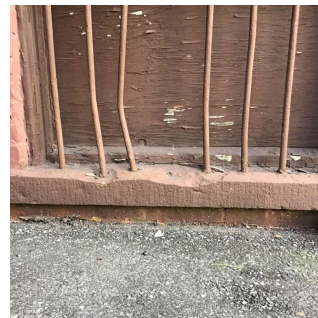
Facade J

BRICK: DETERIORATED MASONRY SILLS - MAJOR

REMOVE AND REPLACE

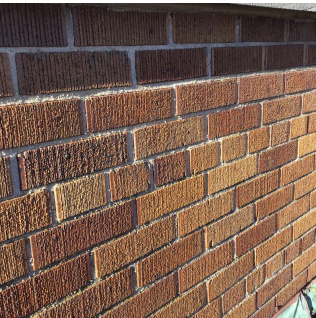
Question	Response
EXTERIOR	
PARAPETS	
Instance Condition	3 - Fair
Instance Quantity	600
Instance Quantity Uom	C.F.
Deficiency	BRICK: DETERIORATED JOINTS
Roof Plan reference

Deficiency Quantity	80
Quantity Uom	S.F.
Potential Action	REPOINT
Urgency of Action	PRIORITY 3
Purpose of Action	LEVEL 2
Deficiency Photo1

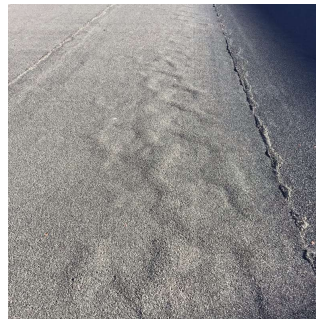
Roof 1
No violations recorded.

Deficiency Quantity	20
Quantity Uom	S.F.
Potential Action	REPLACE
Urgency of Action	PRIORITY 4
Purpose of Action	LEVEL 2
Deficiency Photo1	 
	Roof 1
Violations	No violations recorded.
Deficiency	MODIFIED BITUMEN: ROOFING: DELAMINATION

20
S.F.
REPLACE ROOFING WITHOUT MAJOR EQUIPMENT
REMOVAL
PRIORITY 4
LEVEL 2

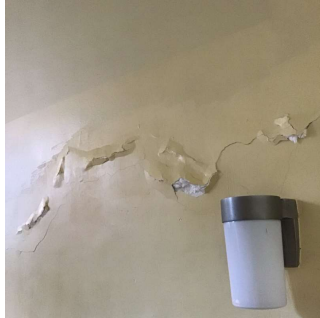
BULKHEAD/PENTHOUSE WALLS/INTERIOR: PLASTER
CRACKS/SPALLING

50
S.F.
REPLACE
PRIORITY 4

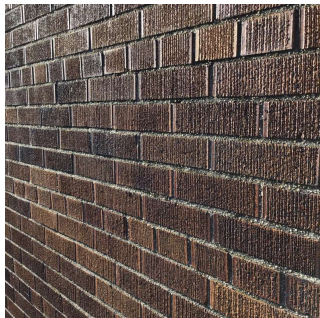
Violations	BH2 No violations recorded.
Deficiency	BULKHEAD/PENTHOUSE WALLS/EXTERIOR: DETERIORATED JOINTS
Roof Plan reference

Deficiency Quantity	200
Quantity Uom	S.F.
Potential Action	REPOINT
Urgency of Action	PRIORITY 3
Purpose of Action	LEVEL 2
Deficiency Photo1

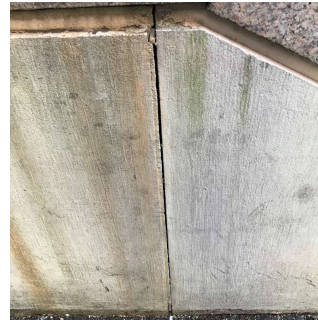
Facade A

STONE: DETERIORATED JOINTS

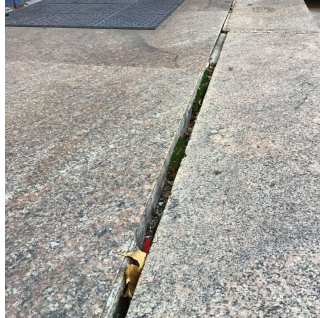
Violations	Facade A No violations recorded.
RAILINGS	Inspected
Condition	2 - Between Good and Fair
Deficiency	No deficiencies recorded
STAIRS/RAMPS	Inspected
Condition	5 - Poor
Deficiency	STONE: DETERIORATED JOINTS
Roof Plan reference

Deficiency Quantity	20
Quantity Uom	L.F.
Potential Action	REPOINT
Urgency of Action	PRIORITY 4
Purpose of Action	LEVEL 2
Deficiency Photo1

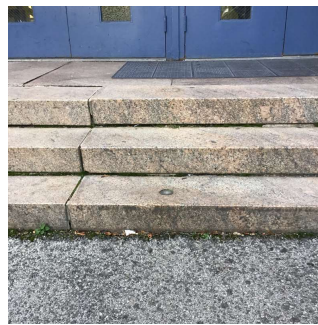
Violations	Facade A No violations recorded.
Deficiency	STONE: DETERIORATED SUBSTRATE

20
S.F.
REPLACE SUBSTRATE AND RESET
PRIORITY 5
LEVEL 6

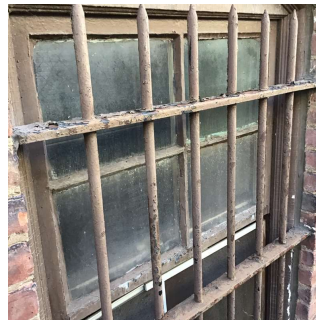
Facade H - Boiler Room

Question	Response
EXTERIOR	
WINDOWS	
EXTERIOR GUARDS	
Elevation	 
Deficiency Quantity	30
Quantity Uom	S.F.
Potential Action	REPLACE
Urgency of Action	PRIORITY 4
Purpose of Action	LEVEL 2
Deficiency Photo1	 
Violations	Facade J No violations recorded.
LINTELS	Inspected
Condition	2 - Between Good and Fair
Deficiency	No deficiencies recorded
WINDOWS	Inspected
Material Type(s)	Aluminum, Steel, Solid Wood
Instance on Wood: Basement - Boiler Room - O'Brien Hall	Inspected
Instance Condition	5 - Poor
Instance Quantity	30
Instance Quantity Uom	S.F.
Are these windows insulated	No
Installation Year	1965
Source of Installation	Inspector Estimate
Deficiency	WOOD: DETERIORATED

30
S.F.
REPLACE WINDOW
PRIORITY 4
LEVEL 2

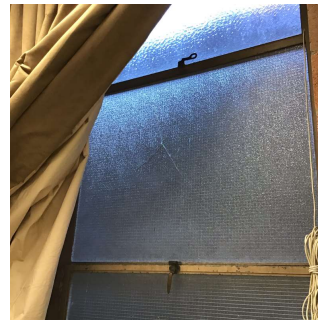
Facade F - Multipurpose Room (Facade C similar)
No violations recorded.

Instance on Steel: Basement - Main Building	Inspected
Instance Condition	5 - Poor
Instance Quantity	500
Instance Quantity Uom	S.F.
Are these windows insulated	No
Installation Year	1965
Source of Installation	Inspector Estimate
Deficiency	STEEL: BROKEN PANE

90
S.F.
MAINTENANCE
PRIORITY 3
LEVEL 2

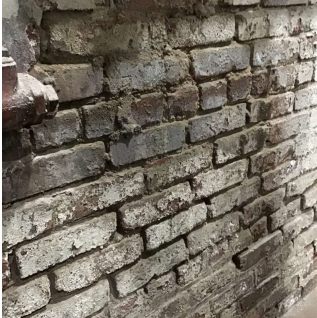
Basement - Sump Pump
Violations	No violations recorded.
Deficiency	BRICK: DETERIORATED JOINTS
Deficiency Location/Instance	Boiler Room

Question	Response
INTERIOR	
STRUCTURAL	
FOUNDATION WALLS	
Quantity Uom	S.F.
Potential Action	REPOINT
Urgency of Action	PRIORITY 4
Purpose of Action	LEVEL 5
Deficiency Photo1

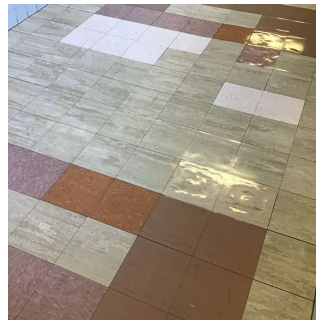
Corridor near Room 301

VINYL TILES: BROKEN/DETERIORATED/MISSING TILES

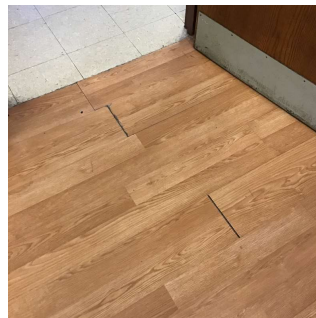
SHEET VINYL: BROKEN/DETERIORATED

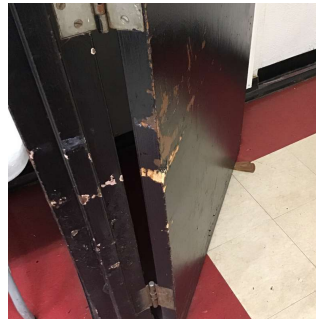
Right Entrance near Pantry

Instance on Basement - O'Brien Hall	Inspected
Condition	5 - Poor
Deficiency	WOOD: DETERIORATED DOOR
Deficiency Location/Instance	Right and Left Entrance near Pantry, Entrance near Boys Toilet Room
Deficiency Quantity	3
Quantity Uom	EACH
Potential Action	MAINTENANCE
Urgency of Action	PRIORITY 3
Purpose of Action	LEVEL 2
Deficiency Photo1

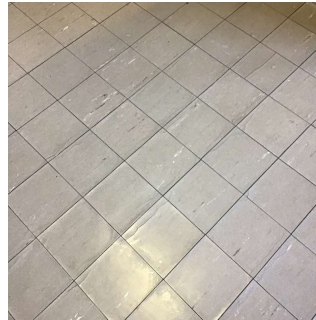
Stair B/3

VINYL TILES: BROKEN/DETERIORATED/MISSING TILES

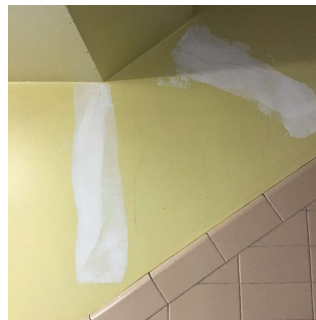
PLASTER: CRACKS/SPALLING

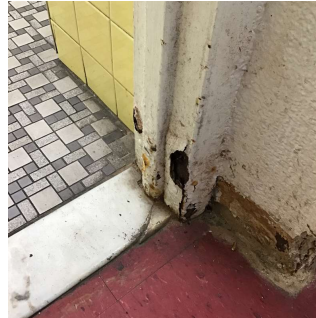
Violations	Basement - Boys OBrien Hall No violations recorded.
Deficiency	PLASTER: CRACKS/SPALLING
Deficiency Location/Instance	3rd Floor - Boys, 1st Floor - Girls, Boys
Deficiency Quantity	30
Quantity Uom	S.F.
Potential Action	REPLACE
Urgency of Action	PRIORITY 3
Purpose of Action	LEVEL 2
Deficiency Photo1	 
Violations	3rd Floor - Boys No violations recorded.
Door(s)	Inspected
Condition	5 - Poor
Deficiency	METAL: DETERIORATED DOOR AND FRAME

Deficiency Location/Instance	Basement - Boys OBrien Hall
Deficiency Quantity	1

Quantity Uom	EACH
Potential Action	MAINTENANCE
Urgency of Action	PRIORITY 3
Purpose of Action	LEVEL 2
Deficiency Photo1

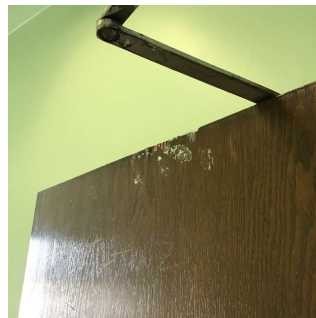
3rd Floor - Boys

Deficiency	WOOD: DETERIORATED DOOR
Deficiency Location/Instance	3rd Floor - Boys, Girls, 2nd Floor - Boys, Girls, 1st Floor - Boys and others
Deficiency Quantity	8
Quantity Uom	EACH
Potential Action	MAINTENANCE
Urgency of Action	PRIORITY 3
Purpose of Action	LEVEL 2
Deficiency Photo1

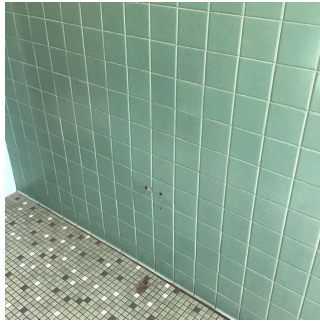
CERAMIC TILE: BROKEN/ MISSING
