NYC Department of Education
Building Condition Assessment Survey 2023 - 2024

Architectural Inspection

Q280

Asset: P.S. 280 - QUEENS, 34-20 94TH STREET, New York, 11372

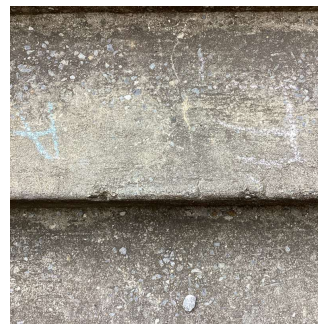
AW6

AREAWAY STAIRS: DETERIORATED TREADS/RISERS/NOSINGS

REPAIR

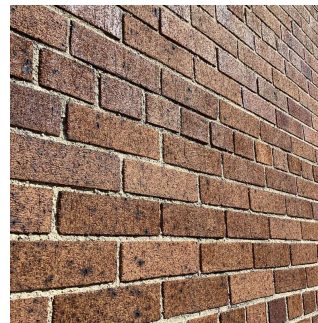
BH5

BULKHEAD/PENTHOUSE WALLS/EXTERIOR: DETERIORATED JOINTS

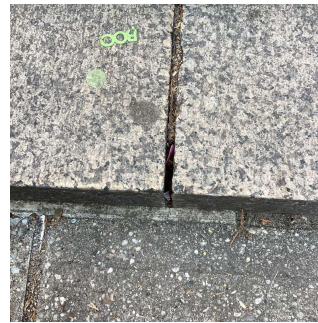
Facade A

STONE: DETERIORATED JOINTS

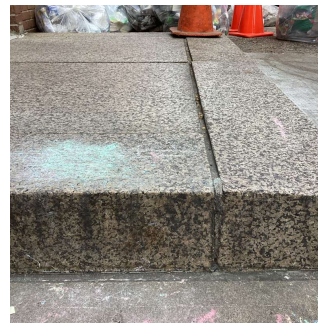
Facade A

STONE: DETERIORATED SUBSTRATE

REPLACE SUBSTRATE AND RESET

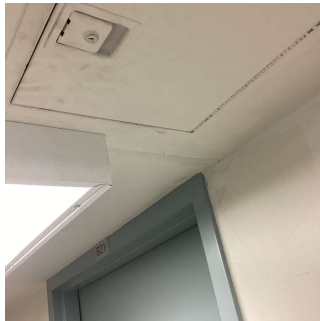
Question	Response
INTERIOR	
KITCHEN	
Ceiling	
Deficiency Photo1

Violations	Corridor near Room B21 No violations recorded.
Door(s)	
Instance on Basement	Inspected
Condition	2 - Between Good and Fair
Deficiency	No deficiencies recorded
Floor Finish	
Instance on Basement	Inspected
Condition	2 - Between Good and Fair
Deficiency	CERAMIC TILE: BROKEN/MISSING TILES
Deficiency Location/Instance	Room B22
Deficiency Quantity	10
Quantity Uom	S.F.
Potential Action	REPLACE
Urgency of Action	PRIORITY 3
Purpose of Action	LEVEL 2
Deficiency Photo1

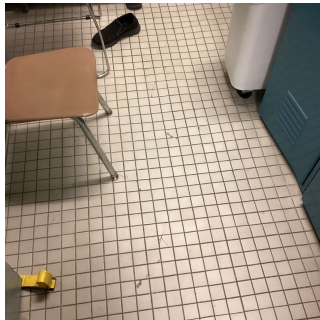
Violations	Room B22 No violations recorded.
Walls	
Instance on Basement	Inspected
Condition	3 - Fair
Deficiency	MASONRY: CRACKS/SPALLING
Deficiency Location/Instance	Near Room B16
Deficiency Quantity	10
Quantity Uom	S.F.
Potential Action	REPLACE
Urgency of Action	PRIORITY 3
Purpose of Action	LEVEL 2

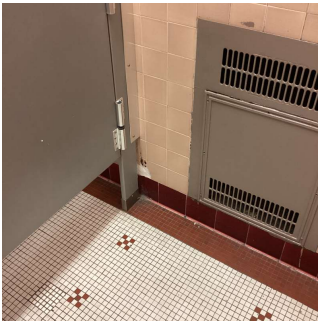
Question	Response
INTERIOR	
TOILET ROOMS - STAFF	
Floor Finish	
Deficiency Photo1	 
Violations	Room 104 No violations recorded.
Stalls	Inspected
Condition	2 - Between Good and Fair
Deficiency	No deficiencies recorded
Walls	Inspected
Condition	2 - Between Good and Fair
Deficiency	CERAMIC TILE: BROKEN/ MISSING
Deficiency Location/Instance	Rooms 107, 104, M12, M13
Deficiency Quantity	40
Quantity Uom	S.F.
Potential Action	REPLACE
Urgency of Action	PRIORITY 3
Purpose of Action	LEVEL 2
Deficiency Photo1

Violations	Room 104 No violations recorded.
TOILET ROOMS - STUDENTS	
Ceiling	Inspected
Condition	2 - Between Good and Fair
Deficiency	PLASTER: CRACKS/SPALLING - ACTIVE LEAK
Deficiency Location/Instance	Room 216
Deficiency Quantity	20
Quantity Uom	S.F.
Potential Action	REPLACE
Urgency of Action	PRIORITY 5
Purpose of Action	LEVEL 2

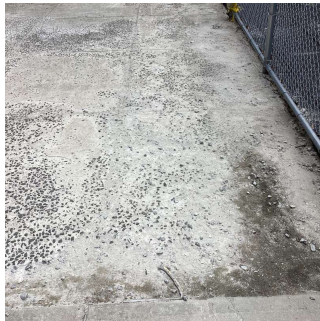
Violations	94th Street No violations recorded.
Pavers	Does not Exist
Student Use	Inspected
Gravel Exists?	No
Asphalt	Inspected
Condition	1 - Good
Deficiency	No deficiencies recorded
Concrete	Does not Exist
Pavers	Does not Exist
Site Sidewalks & Walkways	Inspected
Asphalt	Does not Exist
Concrete	Inspected
Condition	4 - Between Fair and Poor
Deficiency	CRACKS - MAJOR
Deficiency Location/Instance	Near Playground, Exits 12, 11, 5, 3 and others
Deficiency Quantity	600
Quantity Uom	S.F.
Potential Action	REPLACE
Urgency of Action	PRIORITY 3
Purpose of Action	LEVEL 2
Deficiency Photo1

Violations	Near Playground No violations recorded.
Pavers	Does not Exist
DOT Sidewalk	Inspected
Asphalt	Does not Exist
Concrete	Inspected
