**NYC Department of Education
Building Condition Assessment Survey 2023 - 2024**

Architectural Inspection

Q287

Asset: P.S. 330 - QUEENS, 110-08 NORTHERN BOULEVARD, New York, 11368

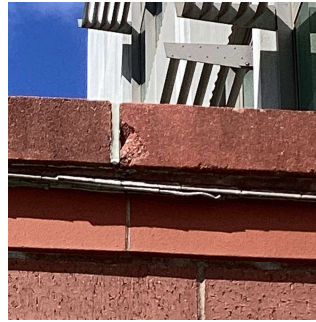
Facade C

Question	Response
Architectural	
EXTERIOR	Inspected
AREAWAY	Does not Exist
AWNINGS AND CANOPIES	Inspected
Condition	2 - Between Good and Fair
Deficiency	No deficiencies recorded
CHIMNEY	Inspected
Material Type(s)	Metal
Condition	2 - Between Good and Fair
Deficiency	No deficiencies recorded
COPING	Inspected
Condition	3 - Fair
Deficiency	CAST STONE: CRACKED/BROKEN PIECES
Roof Plan reference

15
 L.F.
 REPLACE-IN-KIND
 PRIORITY 4
 LEVEL 2

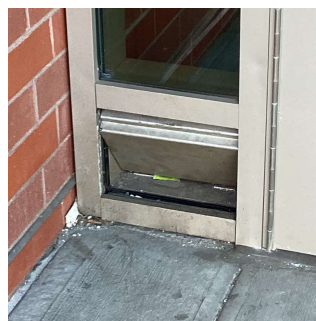
Facade A

METAL: DENTED, MAJOR RUSTING

REPLACE

PRIORITY 4

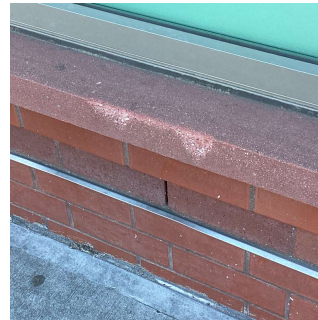
Question	Response
EXTERIOR	
DOORS	Inspected
TRANSOM/SIDE LIGHT	
Violations	No violations recorded.
EXTERIOR WALLS	Inspected
Material Type(s)	Concrete, Masonry
Replacement Quantity	21,000
Replacement Uom	S.F.
Instance on All Facades	Inspected
Instance Condition	3 - Fair
Instance Quantity	21,000
Instance Quantity Uom	S.F.
Deficiency	BRICK: DETERIORATED MASONRY SILLS - MAJOR
Roof Plan reference	 
Elevation	 
Deficiency Quantity	10
Quantity Uom	L.F.
Potential Action	REMOVE AND REPLACE
Urgency of Action	PRIORITY 4
Purpose of Action	LEVEL 2
Deficiency Photo1	 
Violations	Facade A No violations recorded.
Deficiency	BRICK: DETERIORATED MASONRY SILLS - MINOR

REPAIR

PRIORITY 3

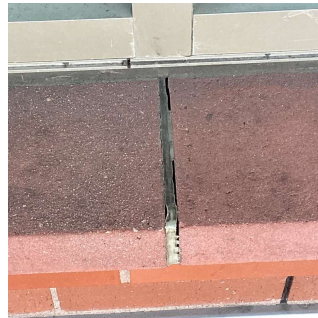
Facade A

BRICK: MASONRY SILLS - DETERIORATED JOINTS

REPOINT

PRIORITY 3

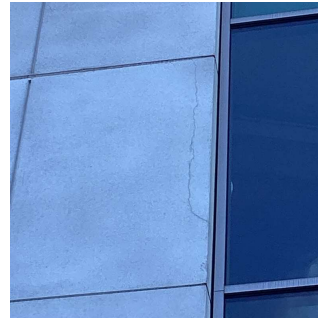
Facade A

CAST IN PLACE / PRE-CAST CONCRETE: MAJOR
CRACKS/SPALLING

REPLACE

PRIORITY 4
LEVEL 2

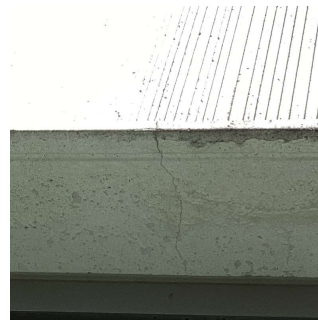
Facade C

CAST IN PLACE / PRE-CAST CONCRETE: MINOR
CRACKS/SPALLING

270
S.F.
REPAIR
PRIORITY 3
LEVEL 2

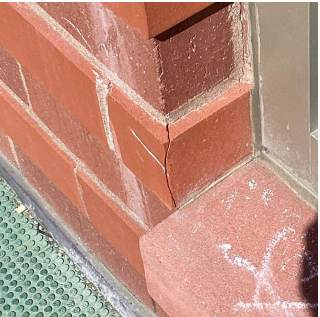
Question	Response
EXTERIOR	
EXTERIOR WALLS	
Deficiency	BRICK: MINOR CRACKS AND SPALLING
Roof Plan reference

Deficiency Quantity	60
Quantity Uom	S.F.
Potential Action	RESTITCH
Urgency of Action	PRIORITY 3
Purpose of Action	LEVEL 2
Deficiency Photo1

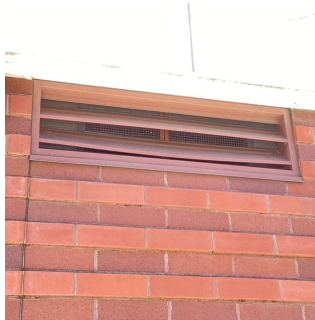
Facade B
 No violations recorded.

Violations	Facade C No violations recorded.
EXTERIOR SOFFITS	
Condition	Inspected
Deficiency	2 - Between Good and Fair
LOADING DOCK	
Condition	Does not Exist
LOUVER	
Condition	Inspected
Deficiency	3 - Fair BROKEN/ DENTED BLADES

20
 S.F.
 REPLACE
 PRIORITY 4
 LEVEL 2

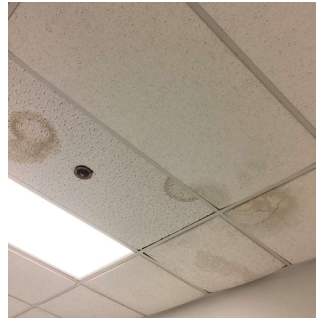
Roof 2 - Corridor near Room 406 (Roof 2 - Corridor near Room 405, Room 402 similar)

Roof 1
Instance Quantity	13,000
Instance Quantity Uom	S.F.
Does the roof have major mechanical equipment sitting on Dunnage Steel less than 18" above the Roofing?	No
Does this roof instance have a Sustainable Roof System?	No
Do solar panels exist on these roofs?	No
Is/Are the roof(s) suitable for Solar Panel installation?	Yes
Installation Year	2013
Source of Installation	Custodial Staff
Deficiency	IRMA: ROOFING: MAJOR ACTIVE ROOF LEAKS IN INSTRUCTIONAL SPACE
Roof Plan reference

Deficiency Quantity	300
Quantity Uom	S.F.
Potential Action	REPLACE ROOFING WITHOUT MAJOR EQUIPMENT REMOVAL
Urgency of Action	PRIORITY 5
Purpose of Action	LEVEL 2

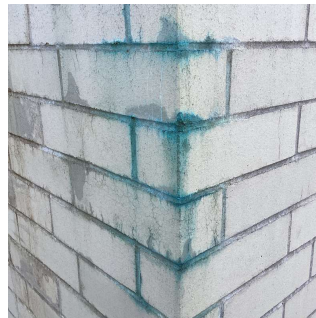
BH

BULKHEAD/PENTHOUSE WALLS/EXTERIOR:
CRACKS/SPALLING - MAJOR

REPLACE

PRIORITY 4

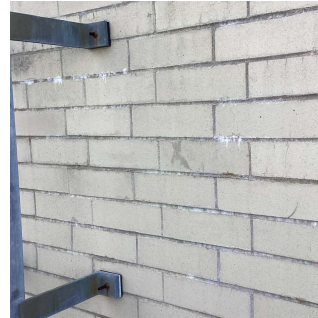
BH
 No violations recorded.

BULKHEAD/PENTHOUSE WALLS/EXTERIOR:
EFFLORESCENCE

45
 S.F.
 MAINTENANCE
 PRIORITY 1
 LEVEL 1

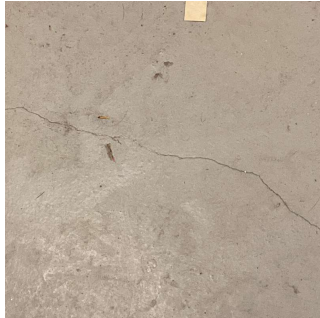
Room C02 (Room C23 similar)
Violations	No violations recorded.
Deficiency	CONCRETE: CRACKS/SPALLED/REINFORCEMENT EXPOSED
Deficiency Location/Instance	2nd, 3rd, 4th Floors
Deficiency Quantity	75
Quantity Uom	S.F.
Potential Action	REPAIR
Urgency of Action	PRIORITY 3
Purpose of Action	LEVEL 5

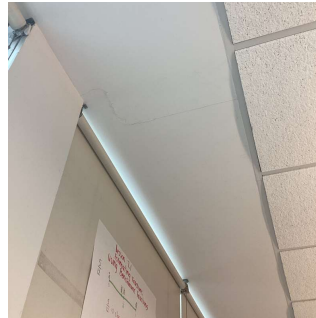
Room 410

GYPSUM BOARD: DAMAGED/DETERIORATED

REPLACE

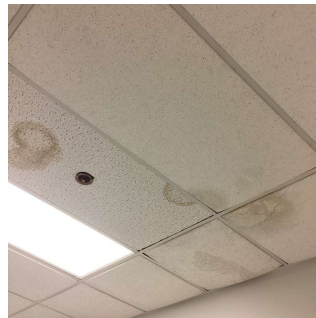
Corridor near room 406

ACOUSTIC TILES: DAMAGED/MISSING - ACTIVE LEAK

REPLACE

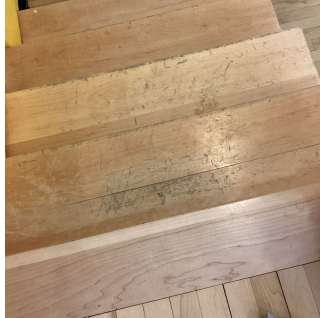
Deficiency	DAMAGED STEPS
Deficiency Location/Instance	Left Side
Deficiency Quantity	10
Quantity Uom	S.F.
Potential Action	REPLACE
Urgency of Action	PRIORITY 3

Left Side
Violations	No violations recorded.
Stage Curtain Rigging	Inspected
Instance on Basement	Inspected
Condition	2 - Between Good and Fair
Deficiency	No deficiencies recorded
Stage Curtains	Inspected
Instance on Basement	Inspected
Condition	1 - Good
Deficiency	No deficiencies recorded
Walls	
Instance on Basement	Inspected
Condition	2 - Between Good and Fair
Deficiency	WALL PADDING: DETERIORATED
Deficiency Location/Instance	Near Entrance
Deficiency Quantity	20
Quantity Uom	S.F.
Potential Action	REPLACE
Urgency of Action	PRIORITY 3
Purpose of Action	LEVEL 2
Deficiency Photo1

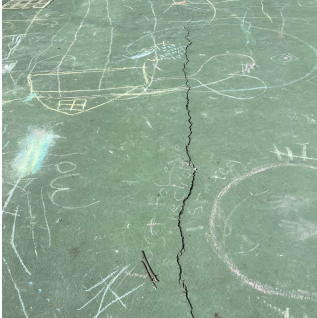
Deficiency	No deficiencies recorded
IRRIGATION SYSTEM	Does not Exist
PAVING	Inspected
Student Non-Use	Does not Exist
Student Use	Inspected
Gravel Exists?	No
Asphalt	Inspected
Condition	3 - Fair
Deficiency	CRACKS - MAJOR
Deficiency Location/Instance	Schoolyard
Deficiency Quantity	300
Quantity Uom	S.F.
Potential Action	REPLACE
Urgency of Action	PRIORITY 3
Purpose of Action	LEVEL 2

Violations	Schoolyard No violations recorded.
Concrete	Inspected
Condition	2 - Between Good and Fair
Deficiency	No deficiencies recorded
Pavers	Does not Exist
Site Sidewalks & Walkways	Inspected
Asphalt	Does not Exist
Concrete	Inspected
Condition	2 - Between Good and Fair
Deficiency	No deficiencies recorded
Pavers	Does not Exist
DOT Sidewalk	Inspected
Asphalt	Does not Exist
Concrete	Inspected
Condition	3 - Fair
Deficiency	HEAVING
Deficiency Location/Instance	Northern Boulevard
Deficiency Quantity	25
Quantity Uom	S.F.
Potential Action	REPLACE
Urgency of Action	PRIORITY 3
Purpose of Action	LEVEL 2
Deficiency Photo1

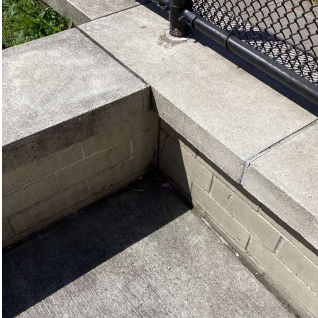
Are there any Retaining Walls 6' OR higher facing public street/sidewalk?	No
Condition	2 - Between Good and Fair
Deficiency	BRICK: CRACKS/SPALLING - MINOR
Deficiency Location/Instance	Schoolyard

Near ramp
Violations	No violations recorded.
SEATING	Does not Exist
SITE WALLS (NOT RETAINING WALLS)	Does not Exist
STAIRS/RAMPS: EXTERIOR	Inspected
Railings	Inspected
Condition	2 - Between Good and Fair
Deficiency	No deficiencies recorded
Site Cheek/flank Walls	Inspected
Condition	2 - Between Good and Fair
Deficiency	BRICK: CRACKS/SPALLING - MAJOR
Deficiency Location/Instance	Playground Steps
Deficiency Quantity	10
Quantity Uom	S.F.
Potential Action	REPLACE
Urgency of Action	PRIORITY 3
Purpose of Action	LEVEL 2
Deficiency Photo1

Question	Response
SITE	
RETAINING WALLS	
Deficiency Quantity	10
Quantity Uom	S.F.
Potential Action	REPAIR
Urgency of Action	PRIORITY 3
Purpose of Action	LEVEL 2
Deficiency Photo1

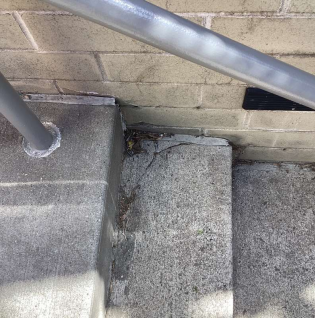
Playground Step
Violations	No violations recorded.
ARTWORK	
Instance	Inspected
Instance Photo	Interior - Main Entrance Vestibule - 10062

Playground Steps
Violations	No violations recorded.
Stairs/ramps	Inspected
Condition	2 - Between Good and Fair
Deficiency	CAST IN PLACE CONCRETE: CRACKS/SPALLING - MAJOR
Deficiency Location/Instance	Playground Step

Question	Response
SITE	
STAIRS/RAMPS: EXTERIOR	
Stairs/ramps	
Potential Action	REPLACE
Urgency of Action	PRIORITY 3
Purpose of Action	LEVEL 2
Deficiency Photo1
