NYC Department of Education
Building Condition Assessment Survey 2023 - 2024

Architectural Inspection

Q292

Asset: P.S. 92 - QUEENS, 99-01 34TH AVENUE, New York, 11368

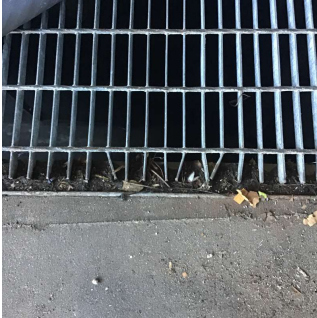
Question	Response
Architectural	
EXTERIOR	Inspected
AREAWAY	Inspected
Instance on AW1 - AW2	Inspected
Instance Condition	3 - Fair
Instance Quantity	2
Instance Quantity Uom	EACH
Deficiency	AREAWAY GRATINGS: MAJOR RUSTING / OR BROKEN
Roof Plan reference	
Deficiency Quantity	20
Quantity Uom	S.F.

Question	Response
EXTERIOR	
AREAWAY	
Potential Action	REPLACE
Urgency of Action	PRIORITY 4
Purpose of Action	LEVEL 2
Deficiency Photo1

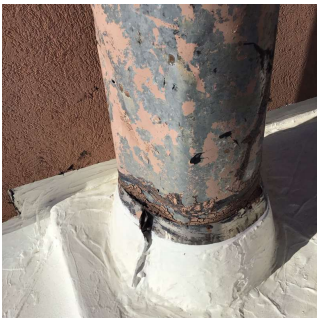
Violations	AW1 No violations recorded.
AWNINGS AND CANOPIES	
	Does not Exist
CHIMNEY	
Material Type(s)	Inspected Metal
Condition	3 - Fair
Deficiency	METAL: DENTS, MAJOR RUSTING
Roof Plan reference

Deficiency Quantity	10
Quantity Uom	S.F.
Potential Action	REPLACE-UPGRADE
Urgency of Action	PRIORITY 4
Purpose of Action	LEVEL 2
Deficiency Photo1

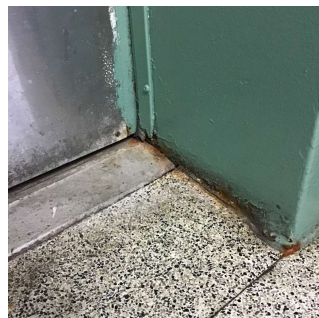
Question	Response
EXTERIOR	
CORNICE	Does not Exist
DOORS	Inspected
DOORS AND FRAMES	Inspected
Condition	5 - Poor
Deficiency	METAL: DETERIORATED DOOR AND FRAME - MINOR DETERIORATION
Roof Plan reference

Deficiency Quantity	6
Quantity Uom	EACH
Potential Action	MAINTENANCE
Urgency of Action	PRIORITY 3
Purpose of Action	LEVEL 2
Deficiency Photo1

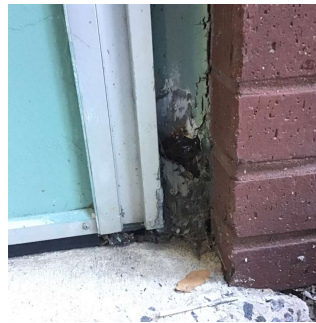
Facade L - Exit 14

Violations	Facade J - Exit 8 No violations recorded.
Deficiency	METAL: DETERIORATED DOOR AND FRAME - MAJOR DETERIORATION
Roof Plan reference

Deficiency Quantity	8
Quantity Uom	EACH
Potential Action	REPLACE
Urgency of Action	PRIORITY 4
Purpose of Action	LEVEL 2

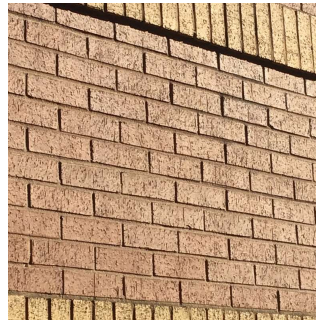
Facade D

BRICK: DETERIORATED JOINTS

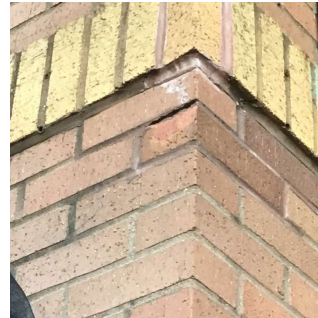
Facade K

BRICK: MINOR CRACKS AND SPALLING

PRIORITY 3
LEVEL 2

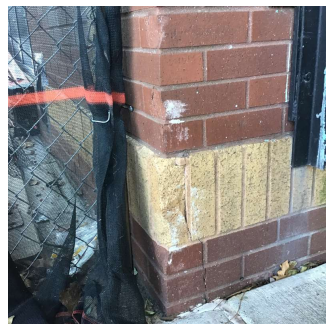
Question	Response
EXTERIOR	
EXTERIOR WALLS	
Violations	No violations recorded.
Deficiency	BRICK: MAJOR / THRU CRACKS
Roof Plan reference

Deficiency Quantity	20
Quantity Uom	S.F.
Potential Action	REMOVE AND REBUILD
Urgency of Action	PRIORITY 4
Purpose of Action	LEVEL 2
Deficiency Photo1

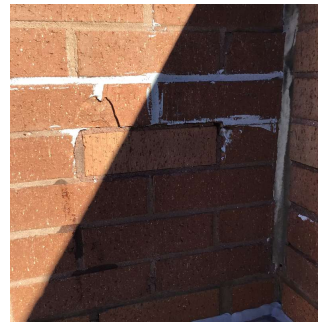
Roof 1

BRICK: MAJOR DETERIORATION/CRACKS

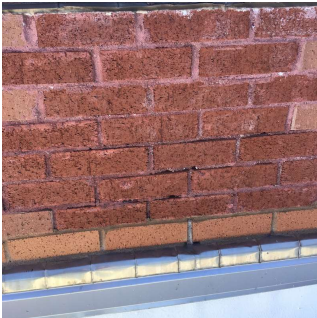
Violations	Roof 1 - Facade L No violations recorded.
Deficiency	BRICK: DETERIORATED JOINTS
Roof Plan reference	Q292

Deficiency Quantity	10
Quantity Uom	S.F.
Potential Action	REPOINT
Urgency of Action	PRIORITY 3
Purpose of Action	LEVEL 2
Deficiency Photo1

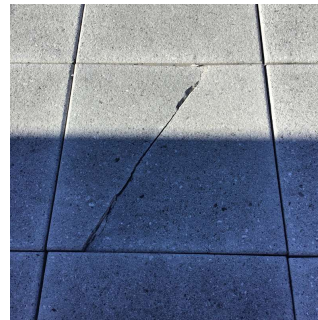
Roof 6

Does the roof have major mechanical equipment sitting on Dunnage Steel less than 18" above the Roofing?	No
Does this roof instance have a Sustainable Roof System?	No
Do solar panels exist on these roofs?	No
Is/Are the roof(s) suitable for Solar Panel installation?	No
Installation Year	2016
Source of Installation	Custodial Staff
Deficiency	IRMA: ROOFING: DETERIORATED PAVERS WITH INTEGRAL INSULATION

20
S.F.
REPLACE
PRIORITY 4
LEVEL 2

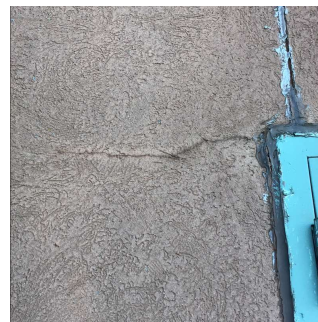
BULKHEAD/PENTHOUSE	Inspected
Condition	3 - Fair
Deficiency	BULKHEAD/PENTHOUSE WALLS/EXTERIOR: CRACKS/SPALLING - MINOR

20
S.F.
REPAIR
PRIORITY 3
LEVEL 2

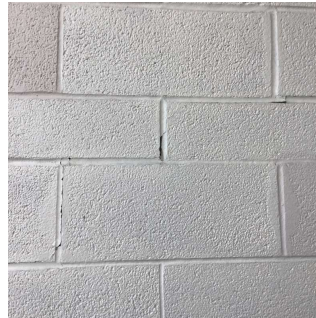
BH

Deficiency **BULKHEAD/PENTHOUSE WALLS/INTERIOR: CMU DETERIORATED JOINTS**

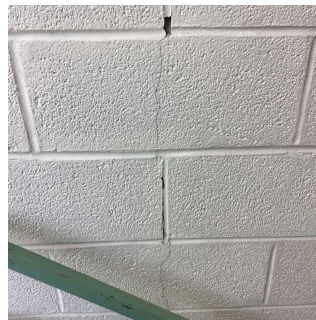
BH

**BULKHEAD/PENTHOUSE WALLS/INTERIOR: CMU
CRACKS/SPALLING**

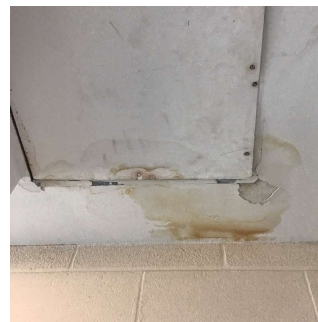
PH1 - Stair A

BULKHEAD/PENTHOUSE ROOF: MINOR LEAKAGE

50
S.F.
MAINTENANCE
PRIORITY 3
LEVEL 2

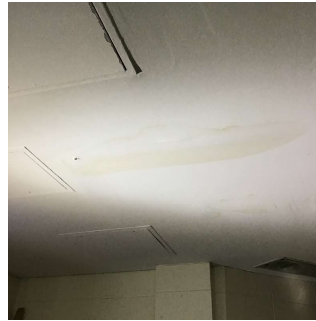
Center near Skylight
Violations	No violations recorded.
<hr/>	
Window Curtains/Shades/Blinds	
Instance on 1st Floor	Does not Exist
<hr/>	
CLASSROOMS/CORRIDORS/ADMIN SPACES	
Ceiling	Inspected
Condition	2 - Between Good and Fair
Deficiency	GYPSUM BOARD: DAMAGED/DETERIORATED - ACTIVE LEAK
Deficiency Location/Instance	Room 404
Deficiency Quantity	20
Quantity Uom	S.F.
Potential Action	REPLACE
Urgency of Action	PRIORITY 5
Purpose of Action	LEVEL 2

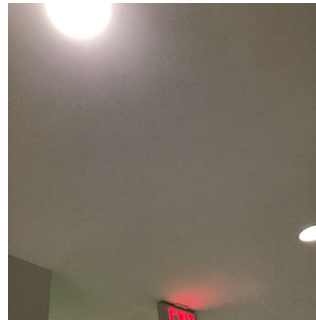
Main Entrance Lobby

GYPSUM BOARD: DAMAGED/DETERIORATED

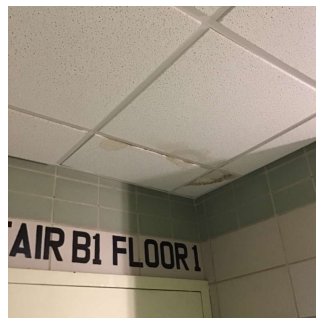
Corridor near Stair B/1

ACOUSTIC TILES: DAMAGED/MISSING

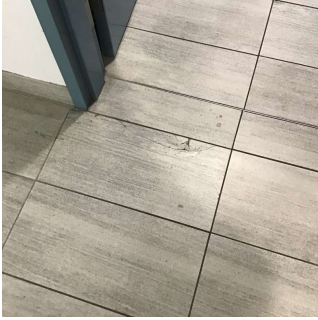
Violations	Room 408 No violations recorded.
Floor Finish	Inspected
Condition	2 - Between Good and Fair
Deficiency	CERAMIC TILE: BROKEN/MISSING TILES
Deficiency Location/Instance	Corridor near Main Entrance
Deficiency Quantity	10
Quantity Uom	S.F.
Potential Action	REPLACE
Urgency of Action	PRIORITY 3
Purpose of Action	LEVEL 2
Deficiency Photo1

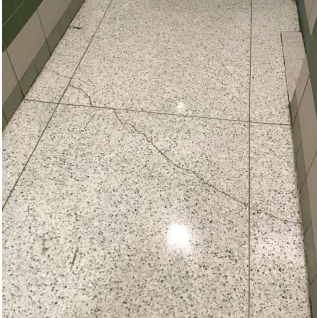
Violations	Corridor near Main Entrance No violations recorded.
Deficiency	TERRAZZO: CRACKS
Deficiency Location/Instance	Corridor near Rooms 120, 122, Corridor near Gymnasium, Exit 5 Vestibule, Corridor near Stair B/1 and others

Deficiency Quantity	120
Quantity Uom	S.F.
Potential Action	REPLACE

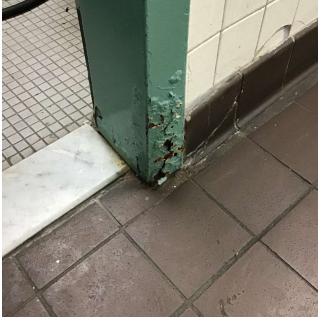
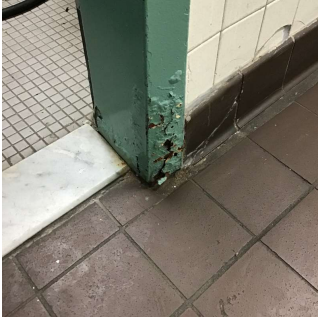
Condition	3 - Fair
Deficiency	METAL: DETERIORATED DOOR
Deficiency Location/Instance	Mop Room
Deficiency Quantity	1
Quantity Uom	EACH
Potential Action	MAINTENANCE
Urgency of Action	PRIORITY 3
Purpose of Action	LEVEL 2
Deficiency Photo1

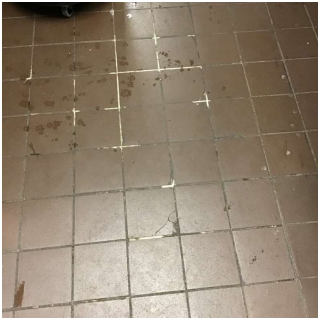
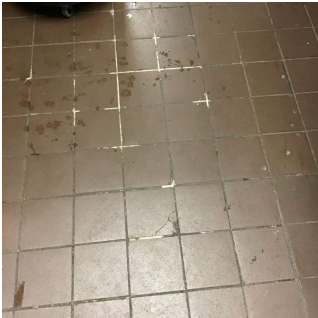
Instance on 1st Floor	Inspected
Condition	2 - Between Good and Fair
Deficiency	QUARRY TILE: BROKEN/MISSING TILES
Deficiency Location/Instance	Near prep area, Near Room 120E
Deficiency Quantity	20
Quantity Uom	S.F.
Potential Action	REPLACE
Urgency of Action	PRIORITY 3
Purpose of Action	LEVEL 2
Deficiency Photo1

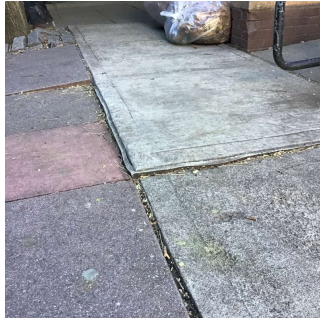
Violations	Schoolyard No violations recorded.
Concrete	Does not Exist
Pavers	Does not Exist
Site Sidewalks & Walkways	Inspected
Asphalt	Does not Exist
Concrete	Inspected
Condition	3 - Fair
Deficiency	HEAVING
Deficiency Location/Instance	Near 99th Street
Deficiency Quantity	50
Quantity Uom	S.F.
Potential Action	REPLACE
Urgency of Action	PRIORITY 3
Purpose of Action	LEVEL 2
Deficiency Photo1

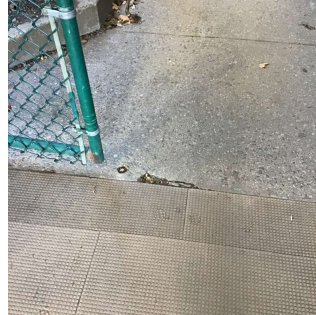
Rear of building near Playground

Violations	Near 99th Street No violations recorded.
Deficiency	CRACKS - MAJOR
Deficiency Location/Instance	Rear of building near Playground, Near exit 3
Deficiency Quantity	50
Quantity Uom	S.F.
Potential Action	REPLACE
Urgency of Action	PRIORITY 3
Purpose of Action	LEVEL 2

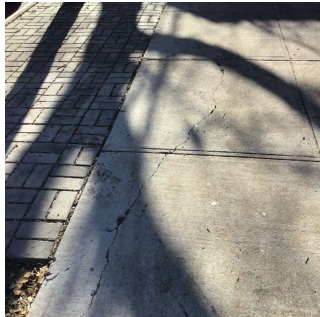
34th Avenue
Violations	No violations recorded.
Deficiency	DAMAGED/DETERIORATED/MISSING SECTIONS
Deficiency Location/Instance	100th Street
Deficiency Quantity	75
Quantity Uom	S.F.
Potential Action	REPLACE
Urgency of Action	PRIORITY 3
Purpose of Action	LEVEL 2

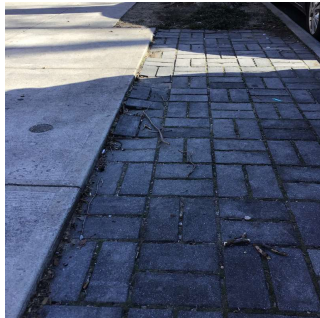
100th Street
Violations	No violations recorded.
Pavers	Inspected
Condition	2 - Between Good and Fair
Deficiency	HEAVING
Deficiency Location/Instance	34th Avenue
Deficiency Quantity	20
Quantity Uom	S.F.
Potential Action	REPLACE
Urgency of Action	PRIORITY 3
Purpose of Action	LEVEL 2
Deficiency Photo1
