NYC Department of Education
Building Condition Assessment Survey 2023 - 2024

Architectural Inspection

Q297

Asset: I.S. 230 ANNEX - QUEENS, 74-03 34TH AVENUE, New York, 11372

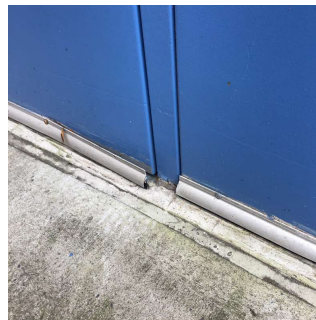
Facade C

METAL: DETERIORATED DOOR - MINOR DETERIORATION

2
EACH
MAINTENANCE
PRIORITY 3
LEVEL 2

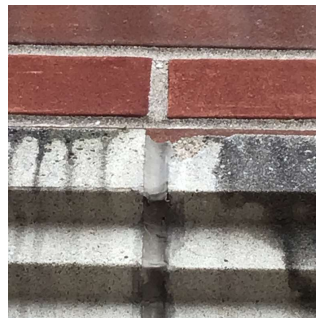
Facade C

CAST IN PLACE / PRE-CAST CONCRETE: MINOR
CRACKS/SPALLING

REPAIR

PRIORITY 3

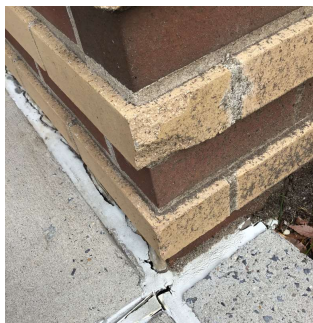
Facade A

BRICK: CRACKS/DISPLACED/SPALLED BRICK AT BUILDING CORNERS

REMOVE AND REBUILD

PRIORITY 4

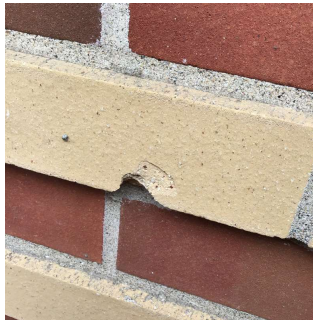
Facade A

BRICK: MINOR CRACKS AND SPALLING

RESTITCH

PRIORITY 3

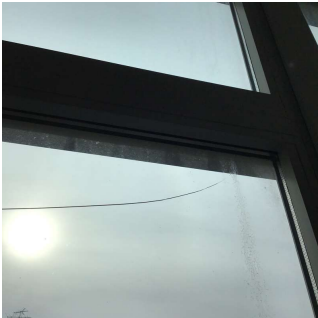
METAL/GLASS CURT WALL: BROKEN GLASS

Violations	Facade A No violations recorded.
EXTERIOR SOFFITS	
Condition	Inspected
Deficiency	2 - Between Good and Fair
LOADING DOCK	
Condition	Does not Exist
LOUVER	
Condition	Inspected
Deficiency	2 - Between Good and Fair
PARAPETS	
Material Type(s)	Inspected
Replacement Quantity	Concrete
Replacement Uom	1,500
Instance on All Facades	C.F.
Instance Condition	Inspected
Instance Quantity	2 - Between Good and Fair
Instance Quantity Uom	1,500
Deficiency	C.F.
PLAZA DECK	
Condition	Does not Exist
ROOF	
Condition	Inspected
Roofing	
Replacement Quantity	Inspected
Replacement Uom	8,000
ROOF HATCH/SMOKE HATCH	
Condition	Inspected
Deficiency	2 - Between Good and Fair
LEADERS, GUTTERS, DOWNSPOUTS, SCUPPERS	
Condition	Inspected
Deficiency	2 - Between Good and Fair
ROOF BARRIER/FENCE	
Condition	Inspected
Deficiency	2 - Between Good and Fair

REPLACE

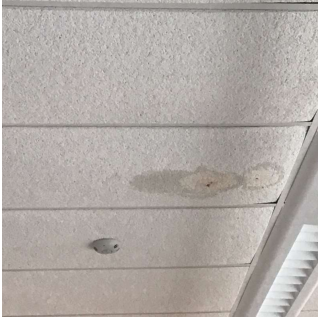
Source of Installation	Custodial Staff
Deficiency	IRMA: ROOFING: MAJOR ACTIVE ROOF LEAKS IN INSTRUCTIONAL SPACE
Roof Plan reference	Q297

Question	Response
EXTERIOR	
ROOF	
Roofing	
ROOFING	
Quantity Uom	S.F.
Potential Action	REPLACE ROOFING WITHOUT MAJOR EQUIPMENT REMOVAL
Urgency of Action	PRIORITY 5
Purpose of Action	LEVEL 2
Deficiency Photo1

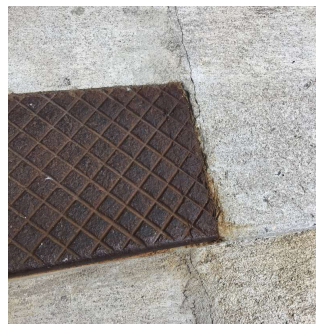
Facade B

Deficiency	CONCRETE: CRACKS/SPALLING - MINOR

15
S.F.
REPAIR
PRIORITY 3
LEVEL 2

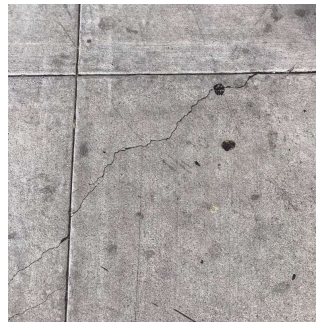
Facade A

CONCRETE: CRACKS/SPALLING - MAJOR

20
S.F.
REPLACE
PRIORITY 4
LEVEL 2

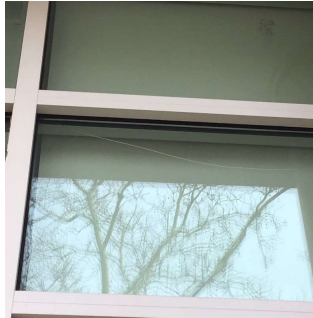
Facade B
No violations recorded.

ALUMINUM - OTHER: BROKEN PANE

60
S.F.
MAINTENANCE
PRIORITY 3
LEVEL 2

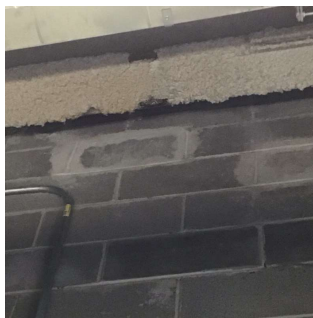
STEEL COLUMNS/BEAMS: DETERIORATED/MISSING SPRAY-ON FIREPROOFING

Electrical Room, Elevator Room

REPLACE

PRIORITY 3

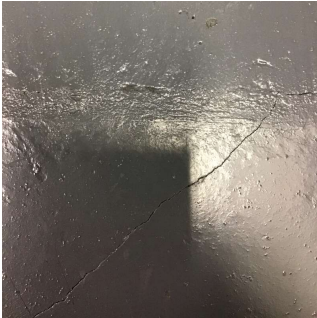
Question	Response
INTERIOR	
STRUCTURAL	
COLUMNS/BEAMS/BEARING WALLS	Inspected
	Room 106
Violations	No violations recorded.
FLOOR STRUCTURE	Inspected
Condition	3 - Fair
Deficiency	CONCRETE SLAB ON GRADE: THRU CRACKS
Deficiency Location/Instance	Electrical Room, Room 102A
Deficiency Quantity	20
Quantity Uom	S.F.
Potential Action	REPLACE
Urgency of Action	PRIORITY 4
Purpose of Action	LEVEL 5
Deficiency Photo1

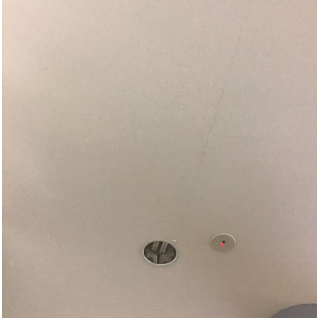
Question	Response
INTERIOR	
LIBRARY	
Ceiling	
Condition	2 - Between Good and Fair
Deficiency	GYPSUM BOARD: DAMAGED/DETERIORATED
Deficiency Location/Instance	Near Entrance
Deficiency Quantity	10
Quantity Uom	S.F.
Potential Action	REPLACE
Urgency of Action	PRIORITY 3
Purpose of Action	LEVEL 2
Deficiency Photo1

Violations	Near Entrance No violations recorded.
Door(s)	
Instance on Room 211	Inspected
Condition	2 - Between Good and Fair
Deficiency	No deficiencies recorded
Floor Finish	
Instance on Room 211	Inspected
Condition	2 - Between Good and Fair
Deficiency	CARPET: WORN/DETERIORATED
Deficiency Location/Instance	Near Windows
Deficiency Quantity	10
Quantity Uom	S.F.
Potential Action	REPLACE
Urgency of Action	PRIORITY 3
Purpose of Action	LEVEL 2
Deficiency Photo1

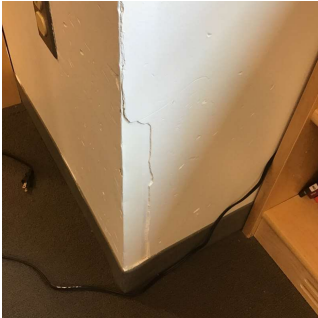
Question	Response
INTERIOR	
LIBRARY	
Walls	
Deficiency	GYP SUM BOARD: DETERIORATED
Deficiency Location/Instance	Near Windows
Deficiency Quantity	10
Quantity Uom	S.F.
Potential Action	REPLACE
Urgency of Action	PRIORITY 3
Purpose of Action	LEVEL 2
Deficiency Photo1

Violations	Near Windows No violations recorded.
LOCKER ROOM	Does not Exist
MULTI-PURPOSE ROOM	Does not Exist
SCIENCE DEMO ROOM	Does not Exist
SCIENCE LAB	Inspected
Instance on Rooms 401, 414	Inspected
Alternative use	No
Fixed Equipment	
Instance on Rooms 401, 414	Inspected
Condition	2 - Between Good and Fair
Deficiency	No deficiencies recorded
SCIENCE PREP ROOM	Inspected
Instance on Room 402	Inspected
Alternative use	No
Fixed Equipment	
Instance on Room 402	Inspected
Condition	2 - Between Good and Fair
Deficiency	No deficiencies recorded
SHOWER ROOM	Does not Exist
STAIRS/RAMPS: INTERIOR	Inspected
Do Letter Stair Signs Exist?	Yes
Ceiling	Inspected
Condition	2 - Between Good and Fair

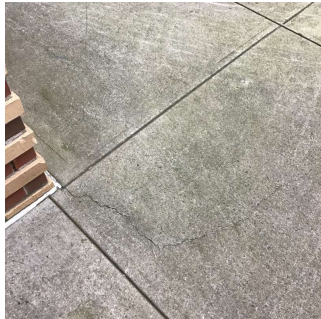
Question	Response
SITE	
IRRIGATION SYSTEM	Does not Exist
PAVING	Inspected
Student Non-Use	Inspected
Gravel Exists?	No
Asphalt	Does not Exist
Concrete	Inspected
Condition	2 - Between Good and Fair
Deficiency	No deficiencies recorded
Pavers	Does not Exist
Student Use	Does not Exist
Site Sidewalks & Walkways	Inspected
Asphalt	Does not Exist
Concrete	Inspected
Condition	3 - Fair
Deficiency	DAMAGED/DETERIORATED/MISSING SECTIONS
Deficiency Location/Instance	Near Exits 2, 3
Deficiency Quantity	100
Quantity Uom	S.F.
Potential Action	REPLACE
Urgency of Action	PRIORITY 3
Purpose of Action	LEVEL 2
Deficiency Photo1

Near Exit 2	
Violations	No violations recorded.
Pavers	Does not Exist
DOT Sidewalk	Inspected
Asphalt	Does not Exist
Concrete	Inspected
Condition	3 - Fair
Deficiency	DAMAGED/DETERIORATED/MISSING SECTIONS
Deficiency Location/Instance	34th Avenue, 74th Street
Deficiency Quantity	225
Quantity Uom	S.F.
Potential Action	REPLACE

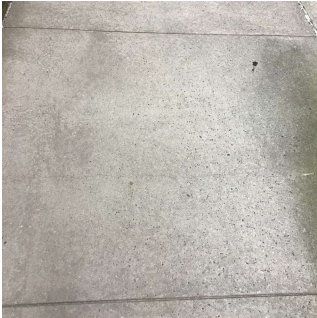
Question	Response
SITE	
STAIRS/RAMPS: EXTERIOR	
Site Cheek/flank Walls	Inspected
Condition	2 - Between Good and Fair
Deficiency	No deficiencies recorded
Stairs/ramps	Inspected
Condition	2 - Between Good and Fair
Deficiency	CAST IN PLACE CONCRETE: CRACKS/SPALLING - MAJOR
Deficiency Location/Instance	Near Exit 2
Deficiency Quantity	10
Quantity Uom	S.F.
Potential Action	REPLACE
Urgency of Action	PRIORITY 3
Purpose of Action	LEVEL 2
Deficiency Photo1

Violations	Near Exit 2 No violations recorded.
ARTWORK	
Instance	Inspected
Instance Photo	Interior - Cafeteria - 10064
