**NYC Department of Education**  
**Building Condition Assessment Survey 2023 - 2024**

Architectural Inspection

**Asset:** P.S. 298 - QUEENS, 50-51 98TH STREET, 11368

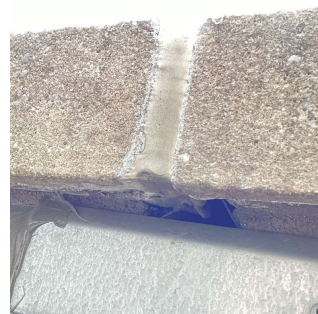
Roof 4  
No violations recorded.

**CAST STONE: DETERIORATED BED JOINT**

20  
L.F.  
REPOINT  
PRIORITY 3  
LEVEL 2

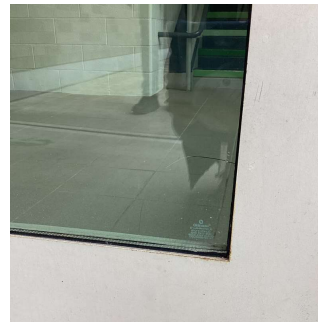
Facade C

METAL: DETERIORATED DOOR - MINOR DETERIORATION

MAINTENANCE

PRIORITY 3

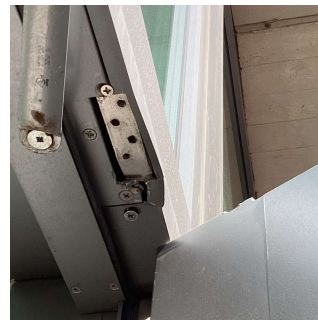
Facade E

METAL: DETERIORATED DOOR AND FRAME - MAJOR DETERIORATION

REPLACE

PRIORITY 4

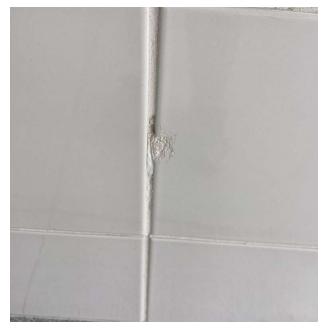
Facade A

CERAMIC TILE: CHIPPED, SPALLED, BROKEN PIECES

REPLACE

PRIORITY 3

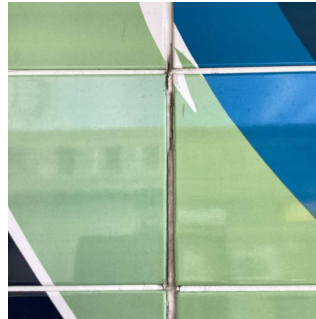
Facade A

CERAMIC TILE: DETERIORATED JOINTS

REPOINT

PRIORITY 3

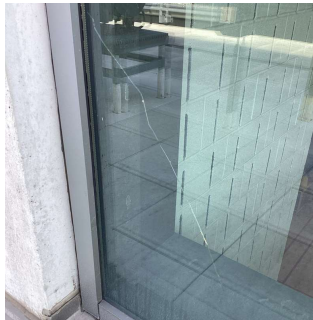
METAL/GLASS CURT WALL: BROKEN GLASS

REPLACE

Facade A - Gymnasium (Shown), Facade E - Cafeteria

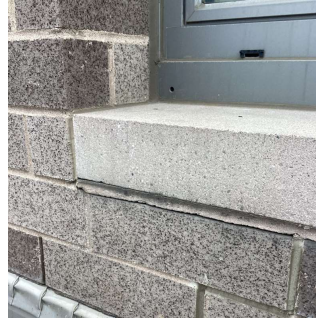
Facade A

**BRICK: MASONRY SILLS - DETERIORATED JOINTS**

REPOINT

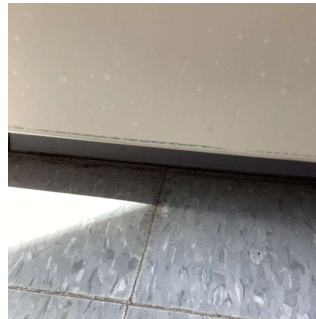
**BRICK: WATER INFILTRATION IN INSTRUCTIONAL SPACE**

REPAIR

PRIORITY 5

Facade F - Corridor near Stair C/2

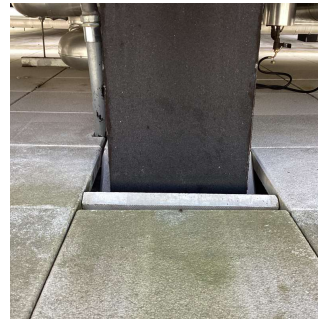
Roof 6

Roof 1
Instance Quantity	32,000
Instance Quantity Uom	S.F.
Does the roof have major mechanical equipment sitting on Dunnage Steel less than 18" above the Roofing?	No
Does this roof instance have a Sustainable Roof System?	No
Do solar panels exist on these roofs?	No
Is/Are the roof(s) suitable for Solar Panel installation?	Yes
Installation Year	2017
Source of Installation	Custodial Staff
Deficiency	IRMA: ROOFING: DETERIORATED PAVERS WITH INTEGRAL INSULATION

REPLACE

PRIORITY 4

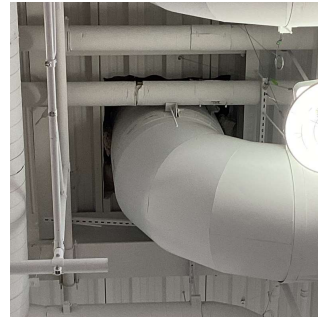
Roof 6 - Gymnasium

IRMA: ROOFING: MAJOR ACTIVE ROOF LEAKS IN INSTRUCTIONAL SPACE

REPLACE ROOFING WITHOUT MAJOR EQUIPMENT REMOVAL

PRIORITY 5

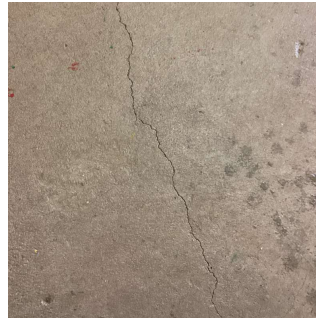
PH1

CONCRETE: CRACKS/SPALLED/REINFORCEMENT EXPOSED

REPAIR

PRIORITY 3

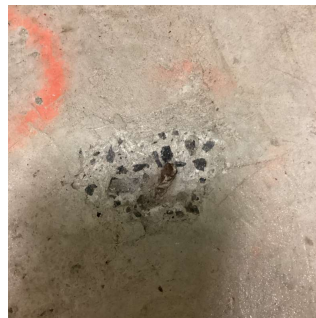
CONCRETE: CRACKS/SPALLED/REINFORCEMENT EXPOSED

REPAIR

PRIORITY 4

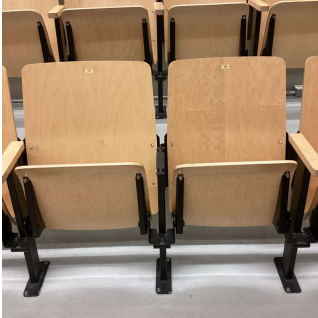
Question	Response
<b>INTERIOR</b>	
<b>STRUCTURAL</b>	
<b>FLOOR STRUCTURE</b>	Inspected
	PH1
Violations	No violations recorded.
<b>FOUNDATION WALLS</b>	Inspected
Material Type(s)	Concrete
Condition	2 - Between Good and Fair
Deficiency	No deficiencies recorded
<b>ROOF STRUCTURE</b>	Inspected
Condition	2 - Between Good and Fair
Deficiency	No deficiencies recorded
<b>VAULTS-BUNKERS</b>	Does not Exist
<b>AUDITORIUM</b>	Inspected
Instance on 2nd Floor (389 Seats)	Inspected
<b>Ceiling</b>	
Instance on 2nd Floor (389 Seats)	Inspected
Condition	2 - Between Good and Fair
Deficiency	No deficiencies recorded
<b>Door(s)</b>	
Instance on 2nd Floor (389 Seats)	Inspected
Condition	2 - Between Good and Fair
Deficiency	No deficiencies recorded
<b>Fixed H/C Lift</b>	
Instance on 2nd Floor (389 Seats)	Does not Exist
<b>Fixed Seating</b>	
Instance on 2nd Floor (389 Seats)	Inspected
Condition	2 - Between Good and Fair
Deficiency	DAMAGED/BROKEN/INOPERABLE

Deficiency Location/Instance	Seat B/15
Deficiency Quantity	1
Quantity Uom	EACH
Potential Action	REPLACE
Urgency of Action	PRIORITY 5
Purpose of Action	LEVEL 6
Deficiency Photo1

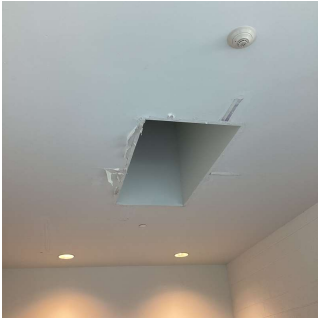
Deficiency	GYPSUM BOARD: DAMAGED/DETERIORATED
Deficiency Location/Instance	Stairs A/4, B/4, C/2
Deficiency Quantity	30
Quantity Uom	S.F.
Potential Action	REPLACE
Urgency of Action	PRIORITY 3
Purpose of Action	LEVEL 2
Deficiency Photo1

Violations	Stair A/4 No violations recorded.
<b>Door(s)</b>	Inspected
Condition	2 - Between Good and Fair
Deficiency	No deficiencies recorded
<b>Partition</b>	Does not Exist

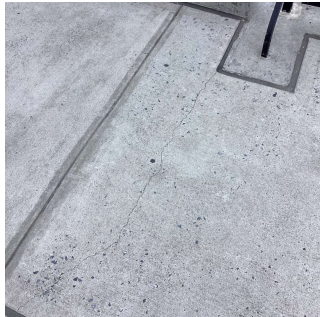
<b>Concrete</b>	Inspected
Condition	2 - Between Good and Fair
Deficiency	CRACKS - MAJOR
Deficiency Location/Instance	Exit 5
Deficiency Quantity	25
Quantity Uom	S.F.
Potential Action	REPLACE
Urgency of Action	PRIORITY 3
Purpose of Action	LEVEL 2

Violations	Exit 5 No violations recorded.
<b>Pavers</b>	Does not Exist
<b>DOT Sidewalk</b>	Inspected
<b>Asphalt</b>	Does not Exist
<b>Concrete</b>	Inspected
Condition	3 - Fair
Deficiency	DAMAGED/DETERIORATED/MISSING SECTIONS
Deficiency Location/Instance	98th Street, Christie Avenue
Deficiency Quantity	200
Quantity Uom	S.F.
Potential Action	REPLACE
Urgency of Action	PRIORITY 3
Purpose of Action	LEVEL 2
Deficiency Photo1

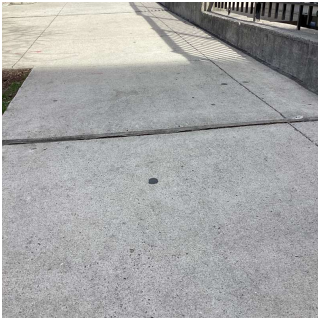
Violations	98th Street No violations recorded.
Deficiency	HEAVING
Deficiency Location/Instance	98th Street
Deficiency Quantity	50
Quantity Uom	S.F.
Potential Action	REPLACE
Urgency of Action	PRIORITY 3
Purpose of Action	LEVEL 2

Violations	98th Street No violations recorded.
<b>Pavers</b>	Does not Exist
<b>PLAYGROUNDS</b>	Inspected
Instance on North Side of the Building	Inspected
<b>Benches</b>	
Instance on North Side of the Building	Does not Exist
<b>Fence</b>	
Instance on North Side of the Building	Inspected
Condition	2 - Between Good and Fair
Deficiency	No deficiencies recorded
<b>Pavement</b>	
Instance on North Side of the Building	Inspected
Condition	2 - Between Good and Fair
Deficiency	No deficiencies recorded
<b>Play Equipment</b>	
Instance on North Side of the Building	Inspected
Condition	2 - Between Good and Fair
Deficiency	No deficiencies recorded
<b>Safety Surfacing</b>	
Instance on North Side of the Building	Inspected
Condition	2 - Between Good and Fair
Deficiency	No deficiencies recorded
<b>Unpaved Area</b>	
Instance on North Side of the Building	Inspected
