NYC Department of Education
Building Condition Assessment Survey 2023 - 2024

Architectural Inspection

Asset: GABRIELA MISTRAL CAMPUS - QUEENS, 98-11 44TH AVENUE, New York, 11368

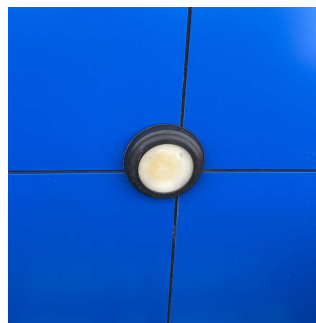
Facade A - Main Entrance

Question	Response
Architectural	
EXTERIOR	Inspected
AREAWAY	Does not Exist
AWNINGS AND CANOPIES	Inspected
Condition	3 - Fair
Deficiency	METAL: WATER PENETRATION
Roof Plan reference

50
S.F.
REPLACE
PRIORITY 5
LEVEL 2

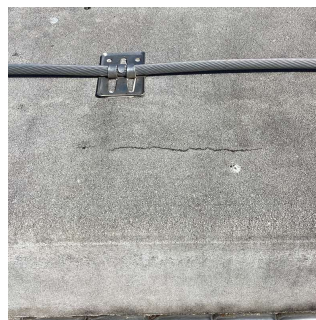
Deficiency	CAST STONE: CRACKED/BROKEN PIECES
------------	-----------------------------------

Deficiency Quantity	20
Quantity Uom	L.F.
Potential Action	REPLACE-IN-KIND
Urgency of Action	PRIORITY 4
Purpose of Action	LEVEL 2

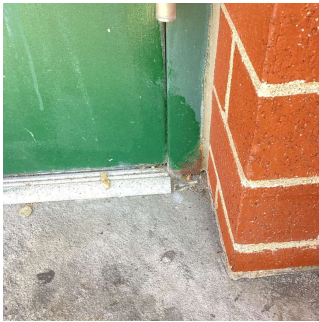
Question	Response
EXTERIOR	
COPING	Inspected
Violations	Roof 1 No violations recorded.
CORNICE	Does not Exist
DOORS	Inspected
DOORS AND FRAMES	Inspected
Condition	3 - Fair
Deficiency	METAL: DETERIORATED DOOR AND FRAME - MINOR DETERIORATION
Roof Plan reference

<p align="center">Q311</p> <p align="center">44th Avenue</p>
Deficiency Quantity	4
Quantity Uom	EACH
Potential Action	MAINTENANCE
Urgency of Action	PRIORITY 3
Purpose of Action	LEVEL 2
Deficiency Photo1

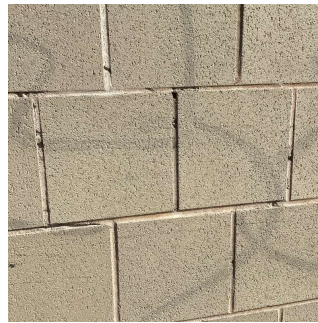
Facade A

BRICK: DETERIORATED JOINTS

Deficiency Quantity	10
Quantity Uom	S.F.
Potential Action	REPOINT
Urgency of Action	PRIORITY 3

LEVEL 2

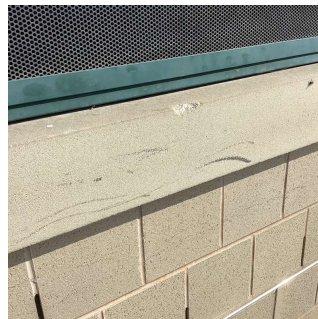
Facade A

BRICK: DETERIORATED MASONRY SILLS - MINOR

Deficiency Quantity

20

Potential Action

REPAIR

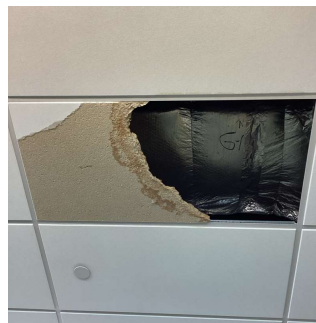
Roof 1 - Room 508 (Roof 1 - Room 506, Gymnasium similar)

IRMA: ROOFING: MAJOR ACTIVE ROOF LEAKS IN INSTRUCTIONAL SPACE

300

REPLACE ROOFING WITHOUT MAJOR EQUIPMENT REMOVAL

PRIORITY 5

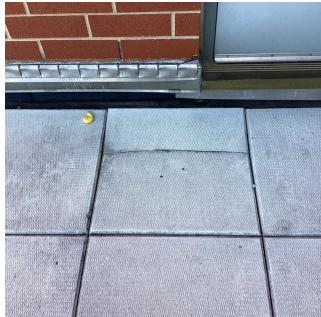
IRMA: ROOFING: DETERIORATED PAVERS WITH INTEGRAL INSULATION

30

REPLACE

PRIORITY 4

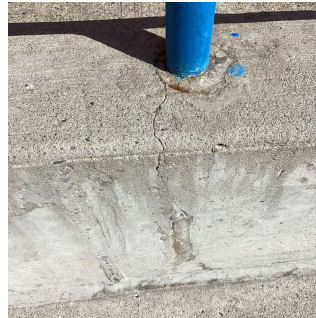
Facade A

Deficiency Quantity	10
Quantity Uom	S.F.
Potential Action	MAINTENANCE
Urgency of Action	PRIORITY 1
Purpose of Action	LEVEL 1
Deficiency Photo1	No photo recorded
Violations	No violations recorded.
CUPOLA/ SPIRES/ TOWERS	Does not Exist
DORMER	Does not Exist
DUNNAGE STEEL	Inspected
Condition	2 - Between Good and Fair
Deficiency	No deficiencies recorded
SKYLIGHT/ROOF VENT	Does not Exist
ROOF/GRAVITY TANK	Does not Exist
STAIRS/RAMPS: EXTERIOR	Inspected
BUILDING CHEEK/FLANK WALLS	Inspected
Condition	2 - Between Good and Fair
Deficiency	CAST IN PLACE CONCRETE: CRACKS/SPALLING - MINOR

10
S.F.
REPAIR
PRIORITY 3
LEVEL 2

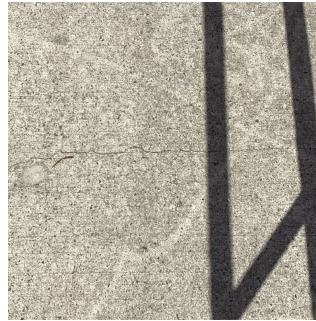
Facade A

CONCRETE: CRACKS/SPALLING - MINOR

20
S.F.
REPAIR
PRIORITY 3
LEVEL 2

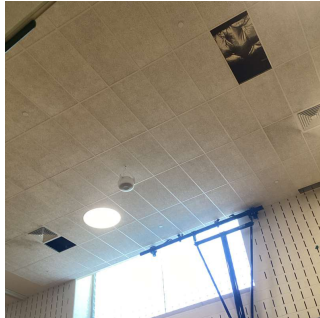
Along Windows
Violations	No violations recorded.
Deficiency	TECTUM: DAMAGED/MISSING - ACTIVE LEAK
Deficiency Location/Instance	Center
Deficiency Quantity	30
Quantity Uom	S.F.
Potential Action	REPLACE
Urgency of Action	PRIORITY 5
Purpose of Action	LEVEL 2

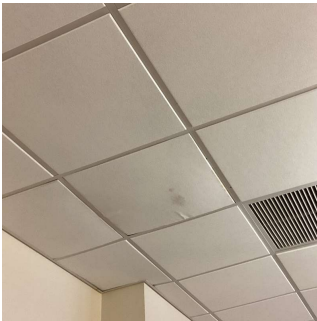
Deficiency	No deficiencies recorded
LIBRARY	
Instance on Room 520	Inspected
Built-in Furnishing	
Instance on Room 520	Does not Exist
Ceiling	
Instance on Room 520	Inspected
Condition	2 - Between Good and Fair
Deficiency	ACOUSTIC TILES: DAMAGED/MISSING
Deficiency Location/Instance	Near Circulation Desk
Deficiency Quantity	10
Quantity Uom	S.F.
Potential Action	REPLACE
Urgency of Action	PRIORITY 3
Purpose of Action	LEVEL 2

Violations	Near Circulation Desk No violations recorded.
Door(s)	
Instance on Room 520	Inspected
Condition	2 - Between Good and Fair
Deficiency	No deficiencies recorded
Floor Finish	
Instance on Room 520	Inspected
Condition	2 - Between Good and Fair
Deficiency	No deficiencies recorded
Walls	
Instance on Room 520	Inspected
Condition	2 - Between Good and Fair
Deficiency	No deficiencies recorded
LOCKER ROOM	
Instance on Room 424 (222 Lockers)	Inspected
Alternative use	Yes
Instance on Room 426 (222 Lockers)	Inspected
Alternative use	Yes
Ceiling	
Instance on Room 424 (222 Lockers)	Inspected
Condition	2 - Between Good and Fair
Deficiency	No deficiencies recorded
Instance on Room 426 (222 Lockers)	Inspected
Condition	2 - Between Good and Fair
Deficiency	No deficiencies recorded
Door(s)	
Instance on Room 424 (222 Lockers)	Inspected
Condition	2 - Between Good and Fair

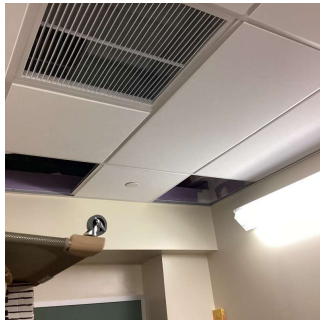
Question	Response
INTERIOR	
LOCKER ROOM	
Floor Finish	
Condition	2 - Between Good and Fair
Deficiency	No deficiencies recorded
Locker Room Lockers	
Instance on Room 426 (222 Lockers)	Inspected
Condition	2 - Between Good and Fair
Deficiency	No deficiencies recorded
Instance on Room 424 (222 Lockers)	Inspected
Condition	2 - Between Good and Fair
Deficiency	No deficiencies recorded
Walls	
Instance on Room 424 (222 Lockers)	Inspected
Condition	2 - Between Good and Fair
Deficiency	No deficiencies recorded
Instance on Room 426 (222 Lockers)	Inspected
Condition	2 - Between Good and Fair
Deficiency	No deficiencies recorded
MULTI-PURPOSE ROOM	
Instance on 2nd Floor	Inspected
Ceiling	
Instance on 2nd Floor	Inspected
Condition	2 - Between Good and Fair
Deficiency	ACOUSTIC TILES: DAMAGED/MISSING
Deficiency Location/Instance	Room 213C
Deficiency Quantity	10
Quantity Uom	S.F.
Potential Action	REPLACE
Urgency of Action	PRIORITY 3
Purpose of Action	LEVEL 2

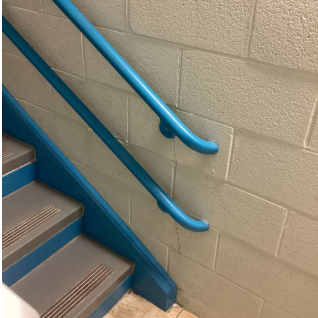
Stair B/Basement
Violations	No violations recorded.
TOILET ROOMS - STAFF	Inspected

Question	Response
INTERIOR	
SCIENCE LAB	Inspected
Fixed Equipment	
Instance on Rooms 504, 508	Inspected
Condition	2 - Between Good and Fair
Deficiency	No deficiencies recorded
SCIENCE PREP ROOM	Inspected
Instance on Room 506	Inspected
Alternative use	Yes
Fixed Equipment	
Instance on Room 506	Inspected
Condition	2 - Between Good and Fair
Deficiency	No deficiencies recorded
SHOWER ROOM	Does not Exist
STAIRS/RAMPS: INTERIOR	Inspected
Do Letter Stair Signs Exist?	Yes
Ceiling	
Condition	2 - Between Good and Fair
Deficiency	No deficiencies recorded
Door(s)	
Condition	2 - Between Good and Fair
Deficiency	No deficiencies recorded
Partition	
	Does not Exist
Railings	
Condition	2 - Between Good and Fair
Deficiency	No deficiencies recorded
Stairs and Landings	
Condition	2 - Between Good and Fair
Deficiency	No deficiencies recorded
Walls	
Condition	2 - Between Good and Fair
Deficiency	MASONRY: CRACKS/SPALLING
Deficiency Location/Instance	Stair B/Basement

Deficiency Quantity	10
Quantity Uom	S.F.
Potential Action	REPLACE
Urgency of Action	PRIORITY 3
Purpose of Action	LEVEL 2
Deficiency Photo1

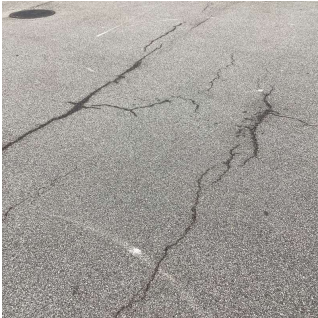
Question	Response
SITE	
FENCES	Inspected
Condition	2 - Between Good and Fair
Deficiency	No deficiencies recorded
IRRIGATION SYSTEM	Does not Exist
PAVING	Inspected
Student Non-Use	Inspected
Gravel Exists?	No
Asphalt	Does not Exist
Concrete	Inspected
Condition	2 - Between Good and Fair
Deficiency	No deficiencies recorded
Pavers	Does not Exist
Student Use	Inspected
Gravel Exists?	No
Asphalt	Inspected
Condition	3 - Fair
Deficiency	CRACKS - MAJOR
Deficiency Location/Instance	Schoolyard
Deficiency Quantity	150
Quantity Uom	S.F.
Potential Action	REPLACE
Urgency of Action	PRIORITY 3
Purpose of Action	LEVEL 2
Deficiency Photo1

Violations	Schoolyard No violations recorded.
Concrete	Does not Exist
Pavers	Does not Exist
Site Sidewalks & Walkways	Inspected
Asphalt	Does not Exist
Concrete	Inspected
Condition	2 - Between Good and Fair
Deficiency	CRACKS - MAJOR
Deficiency Location/Instance	Near Exit 2
Deficiency Quantity	25
Quantity Uom	S.F.
