NYC Department of Education
Building Condition Assessment Survey 2023 - 2024

Architectural Inspection

Asset: P.S./I.S. 78 - QUEENS, 46-08 5TH STREET, New York, 11101

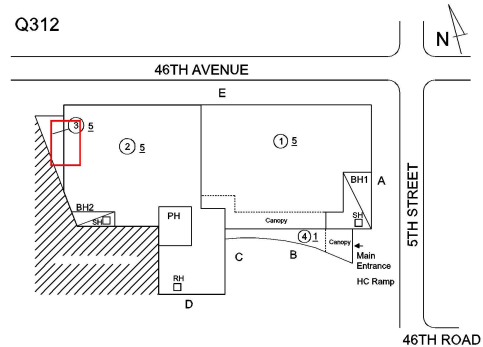
Roof Plan reference

Deficiency CAST STONE: DETERIORATED BED JOINT

20
L.F.
REPOINT
PRIORITY 3
LEVEL 2

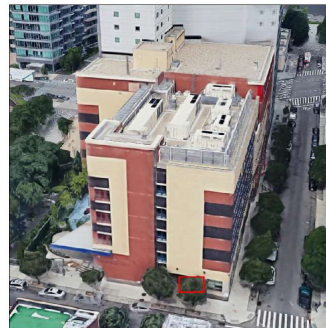
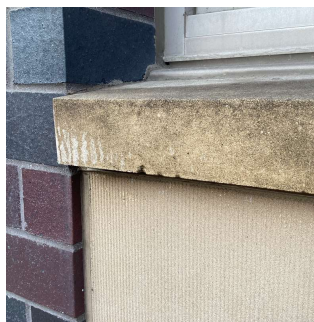
Facade A

BRICK: DETERIORATED MASONRY SILLS - MINOR

10
L.F.
REPAIR
PRIORITY 3
LEVEL 2

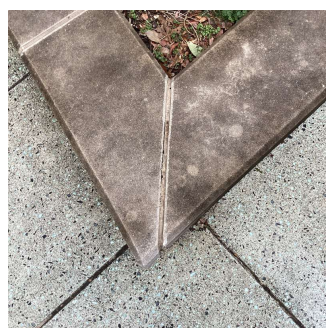
<p>Main Entrance</p> <p>No violations recorded.</p>
<p>Deficiency</p> <p>Roof Plan reference</p> <p>Deficiency Quantity</p> <p>Quantity Uom</p> <p>Potential Action</p> <p>Urgency of Action</p> <p>Purpose of Action</p> <p>Deficiency Photo1</p> <p>Violations</p>	<p>CAST IN PLACE CONCRETE: CRACKS/SPALLING - MINOR</p> <p>Q312</p>

<p>15</p> <p>S.F.</p> <p>REPAIR</p> <p>PRIORITY 3</p> <p>LEVEL 2</p>

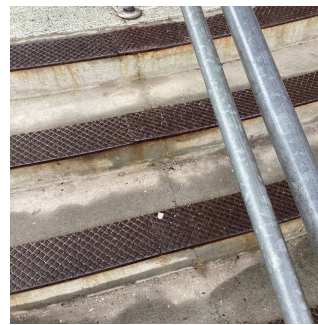
Main Entrance

<p>Main Entrance</p> <p>No violations recorded.</p>
RAILINGS	
Condition	Inspected
Deficiency	2 - Between Good and Fair
STAIRS/RAMPS	
Condition	Inspected
Deficiency	3 - Fair
Deficiency	CONCRETE: CRACKS/SPALLING - MINOR

10
S.F.
REPAIR
PRIORITY 3
LEVEL 2

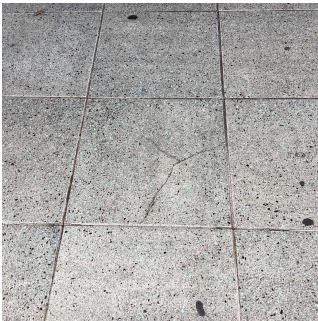
CONCRETE: CRACKS/SPALLING - MAJOR

10
S.F.
REPLACE
PRIORITY 4
LEVEL 2

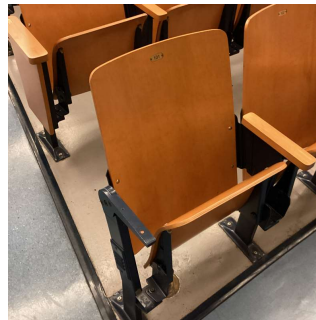
Deficiency	DAMAGED/BROKEN/INOPERABLE
------------	---------------------------

Deficiency Location/Instance	Seat B/101
------------------------------	------------

Potential Action	REPLACE
------------------	---------

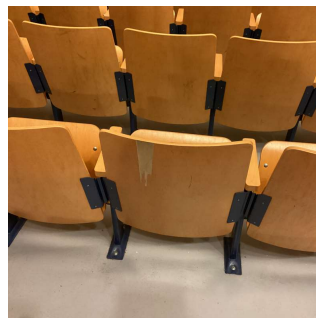
Deficiency	DAMAGED/BROKEN/INOPERABLE
------------	---------------------------

Deficiency Location/Instance	Seats B/4, 115, D/114, H/113, L/7 and others
------------------------------	--

Potential Action	REPLACE
------------------	---------

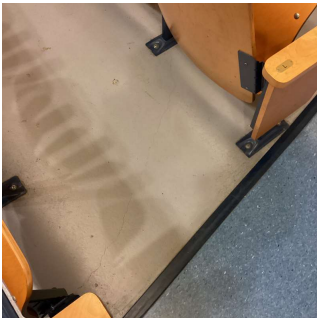
Question	Response
INTERIOR	
AUDITORIUM	
Fixed Seating	
	Seat L/7
Violations	No violations recorded.
Floor Finish	
Instance on 1st Floor (349 Seats)	Inspected
Condition	2 - Between Good and Fair
Deficiency	CONCRETE: CRACKS
Deficiency Location/Instance	Near Seats D/105, M/1
Deficiency Quantity	35
Quantity Uom	S.F.
Potential Action	REPLACE
Urgency of Action	PRIORITY 3
Purpose of Action	LEVEL 2
Deficiency Photo1

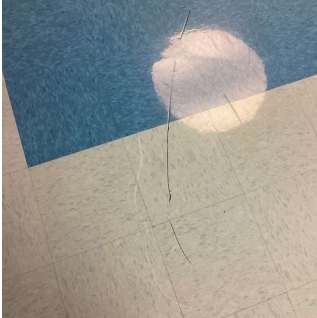
Question	Response
INTERIOR	
CAFETERIA	
Door(s)	
Deficiency	No deficiencies recorded
Fixed Equipment	
Instance on 1st Floor - Staff (400 SF)	Does not Exist
Instance on 1st Floor - Students	Does not Exist
Floor Finish	
Instance on 1st Floor - Students	Inspected
Condition	2 - Between Good and Fair
Deficiency	VINYL TILES: BROKEN/DETERIORATED/MISSING TILES
Deficiency Location/Instance	Near Entrance
Deficiency Quantity	10
Quantity Uom	S.F.
Potential Action	REPLACE
Urgency of Action	PRIORITY 3
Purpose of Action	LEVEL 2
Deficiency Photo1

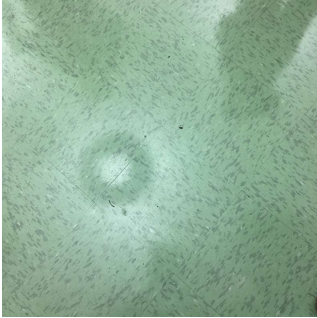
Violations	Near Entrance No violations recorded.
Instance on 1st Floor - Staff (400 SF)	Inspected
Condition	2 - Between Good and Fair
Deficiency	VINYL TILES: BROKEN/DETERIORATED/MISSING TILES
Deficiency Location/Instance	Near Entrance
Deficiency Quantity	10
Quantity Uom	S.F.
Potential Action	REPLACE
Urgency of Action	PRIORITY 3
Purpose of Action	LEVEL 2
Deficiency Photo1

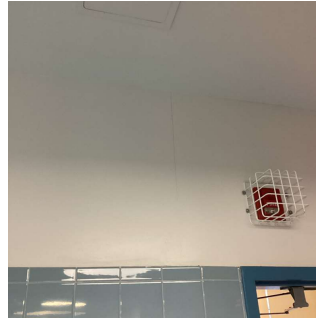
Near Entrance

Deficiency	GYPSUM BOARD: DETERIORATED
------------	----------------------------

Deficiency Location/Instance	Near Entrance, Near Serving Area
------------------------------	----------------------------------

Potential Action	REPLACE
------------------	---------

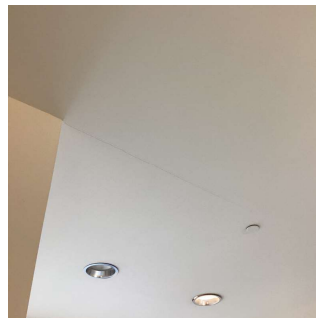
Deficiency	GYPSUM BOARD: DAMAGED/DETERIORATED
------------	------------------------------------

Deficiency Location/Instance	Corridor near Rooms 425, 302, 204, 131
------------------------------	--

Potential Action	REPLACE
------------------	---------

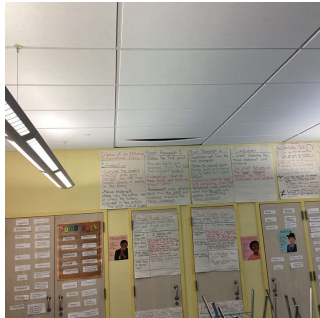
Question	Response
INTERIOR	
CLASSROOMS/CORRIDORS/ADMIN SPACES	
Ceiling	
Violations	Corridor near Room 425 No violations recorded.
Deficiency	ACOUSTIC TILES: DAMAGED/MISSING
Deficiency Location/Instance	Room 512
Deficiency Quantity	10
Quantity Uom	S.F.
Potential Action	REPLACE
Urgency of Action	PRIORITY 3
Purpose of Action	LEVEL 2
Deficiency Photo1

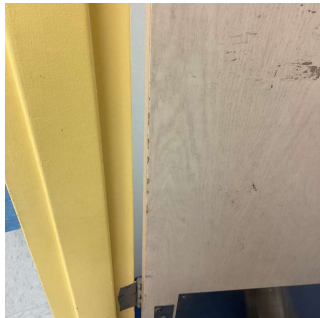
Violations	Room 512 No violations recorded.
Door(s)	Inspected
Condition	3 - Fair
Deficiency	WOOD: DETERIORATED DOOR
Deficiency Location/Instance	Rooms 409, 406
Deficiency Quantity	2
Quantity Uom	EACH
Potential Action	MAINTENANCE
Urgency of Action	PRIORITY 3
Purpose of Action	LEVEL 2
Deficiency Photo1

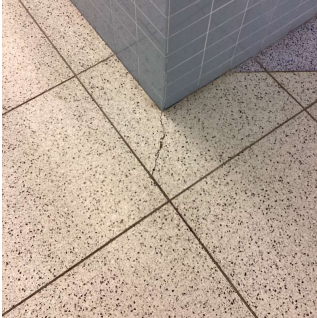
Violations	Room 406 No violations recorded.
Floor Finish	Inspected
Condition	2 - Between Good and Fair
Deficiency	CERAMIC TILE: BROKEN/MISSING TILES
Deficiency Location/Instance	Corridor near Auditorium, Corridor near Kitchen
Deficiency Quantity	20
Quantity Uom	S.F.
Potential Action	REPLACE

Question	Response
INTERIOR	
CLASSROOMS/CORRIDORS/ADMIN SPACES	
Floor Finish	
Urgency of Action	PRIORITY 3
Purpose of Action	LEVEL 2
Deficiency Photo1

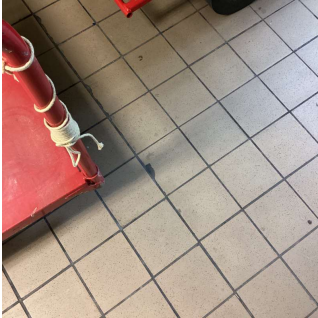
Deficiency	No deficiencies recorded
Door(s)	
Instance on 1st Floor	Inspected
Condition	2 - Between Good and Fair
Deficiency	No deficiencies recorded
Floor Finish	
Instance on 1st Floor	Inspected
Condition	2 - Between Good and Fair
Deficiency	QUARRY TILE: BROKEN/MISSING TILES

Question	Response
INTERIOR	
KITCHEN	
Floor Finish	
Deficiency Location/Instance	Near Room 124, near Exit
Deficiency Quantity	10
Quantity Uom	S.F.
Potential Action	REPLACE
Urgency of Action	PRIORITY 3
Purpose of Action	LEVEL 2
Deficiency Photo1

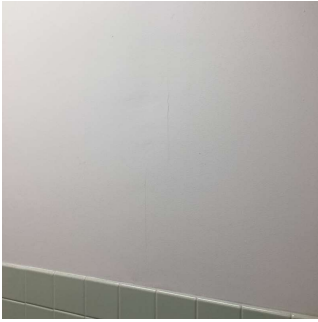
Question	Response
INTERIOR	
LOCKER ROOM	
Locker Room Lockers	
Deficiency	No deficiencies recorded
Walls	
Instance on 5th Floor - Boys (190 Lockers)	Inspected
Condition	2 - Between Good and Fair
Deficiency	GYP SUM BOARD: DETERIORATED
Deficiency Location/Instance	Near Entrance
Deficiency Quantity	10
Quantity Uom	S.F.
Potential Action	REPLACE
Urgency of Action	PRIORITY 3
Purpose of Action	LEVEL 2
Deficiency Photo1

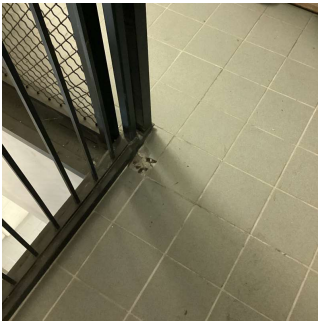
Question	Response
INTERIOR	
STAIRS/RAMPS: INTERIOR	
Partition	Does not Exist
Railings	Inspected
Condition	2 - Between Good and Fair
Deficiency	No deficiencies recorded
Stairs and Landings	Inspected
Condition	2 - Between Good and Fair
Deficiency	CERAMIC TILE: BROKEN/MISSING
Deficiency Location/Instance	Stair B/Bulkhead
Deficiency Quantity	10
Quantity Uom	S.F.
Potential Action	REPLACE
Urgency of Action	PRIORITY 3
Purpose of Action	LEVEL 2
Deficiency Photo1

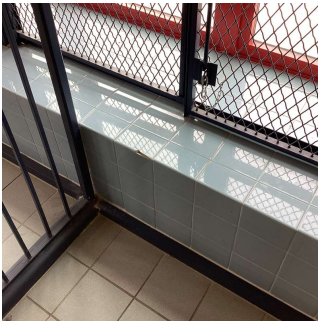
Violations	Stair B/Bulkhead No violations recorded.
Walls	Inspected
Condition	2 - Between Good and Fair
Deficiency	CERAMIC TILE: BROKEN/ MISSING
Deficiency Location/Instance	Stair A/3
Deficiency Quantity	10
Quantity Uom	S.F.
Potential Action	REPLACE
Urgency of Action	PRIORITY 3
Purpose of Action	LEVEL 2
Deficiency Photo1

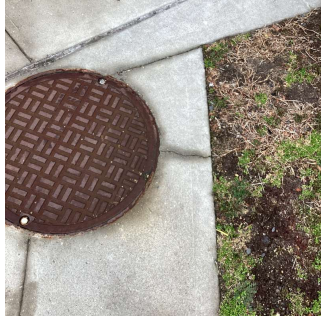
Concrete	Inspected
Condition	2 - Between Good and Fair
Deficiency	CRACKS - MAJOR
Deficiency Location/Instance	Near Main Entrance
Deficiency Quantity	25
Quantity Uom	S.F.
Potential Action	REPLACE
Urgency of Action	PRIORITY 3
Purpose of Action	LEVEL 2

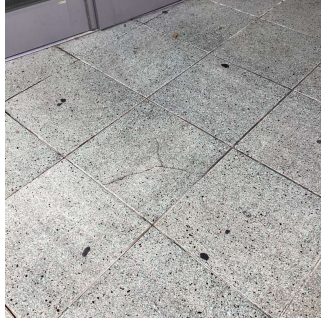
Near Main Entrance
Violations	No violations recorded.
Pavers	Does not Exist
Site Sidewalks & Walkways	Inspected
Asphalt	Does not Exist
Concrete	Inspected
Condition	2 - Between Good and Fair
Deficiency	CRACKS - MAJOR
Deficiency Location/Instance	Near Main Entrance
Deficiency Quantity	25
Quantity Uom	S.F.
Potential Action	REPLACE
Urgency of Action	PRIORITY 3
Purpose of Action	LEVEL 2
Deficiency Photo1

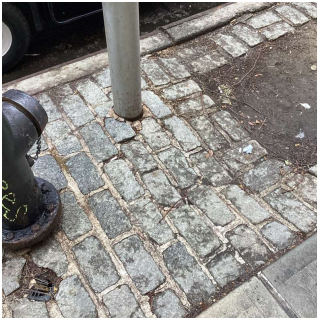
Near Main Entrance
Violations	No violations recorded.
Pavers	Does not Exist
DOT Sidewalk	Inspected
Asphalt	Does not Exist
Concrete	Inspected
Condition	2 - Between Good and Fair
Deficiency	No deficiencies recorded
Pavers	Inspected
Condition	3 - Fair
Deficiency	HEAVING
Deficiency Location/Instance	46th Avenue
Deficiency Quantity	50

Question	Response
SITE	
PAVING	
DOT Sidewalk	
Pavers	
Quantity Uom	S.F.
Potential Action	REPLACE
Urgency of Action	PRIORITY 3
Purpose of Action	LEVEL 2
Deficiency Photo1

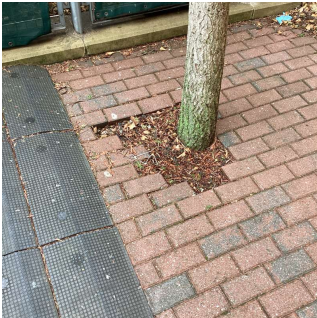
Rear
Violations	No violations recorded.

46th Avenue
Violations	No violations recorded.
PLAYGROUNDS	Inspected
Instance on Near Main Entrance	Inspected
Benches	
Instance on Near Main Entrance	Inspected
Condition	2 - Between Good and Fair
Deficiency	No deficiencies recorded
Fence	
Instance on Near Main Entrance	Inspected
Condition	2 - Between Good and Fair
Deficiency	No deficiencies recorded
Pavement	
Instance on Near Main Entrance	Inspected
Condition	2 - Between Good and Fair
Deficiency	PAVERS: DAMAGED/MISSING
Deficiency Location/Instance	Rear
Deficiency Quantity	10
Quantity Uom	S.F.
Potential Action	REPLACE
Urgency of Action	PRIORITY 3
Purpose of Action	LEVEL 2
Deficiency Photo1

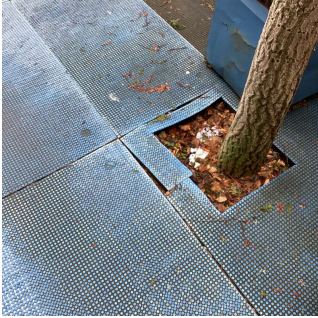
Question	Response
SITE	
PLAYGROUNDS	
Play Equipment	
Instance on Near Main Entrance	Inspected
Condition	2 - Between Good and Fair
Deficiency	No deficiencies recorded
Safety Surfacing	
Instance on Near Main Entrance	Inspected
Condition	2 - Between Good and Fair
Deficiency	DETERIORATED/MISSING
Deficiency Location/Instance	Left Side near Fences
Deficiency Quantity	10
Quantity Uom	S.F.
Potential Action	REPLACE
Urgency of Action	PRIORITY 3
Purpose of Action	LEVEL 2
Deficiency Photo1
