NYC Department of Education
Building Condition Assessment Survey 2023 - 2024

Architectural Inspection

Asset: THE WALTER MCCAFFREY CAMPUS - QUEENS, 45-45 42ND STREET, New York, 11104

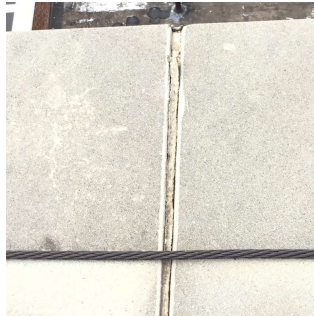
BH2

CAST STONE: DETERIORATED TRANSVERSE JOINTS

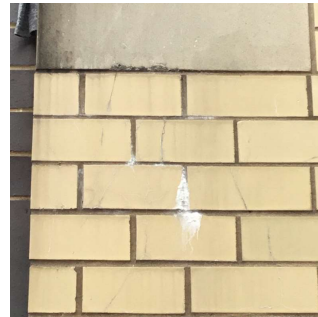
Violations	Facade C No violations recorded.
Deficiency	BRICK: EFFLORESCENCE

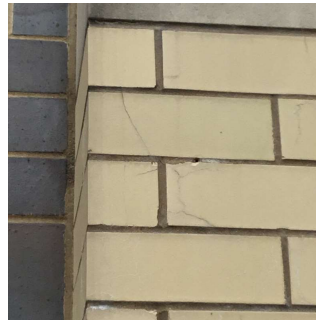
Facade C

BRICK: MINOR CRACKS AND SPALLING

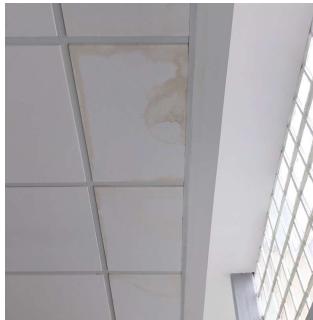
Facade G - 5th Floor Corridor near Elevator (Facade G - 4th, 3rd, and 2nd Floor Corridors near Elevator

GLASS BLOCK: WATER INFILTRATION IN INSTRUCTIONAL SPACE

REPAIR

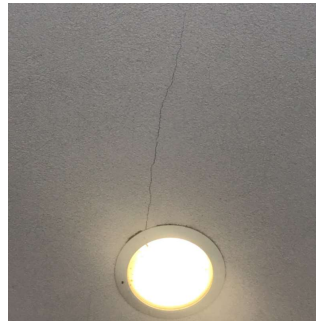
Facade A

STUCCO/PLASTER: MINOR CRACKS/SPALLING

Quantity Uom	S.F.
Potential Action	REPAIR
Urgency of Action	PRIORITY 3
Purpose of Action	LEVEL 2
Deficiency Photo1

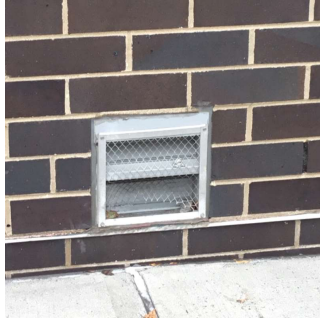
Deficiency	BROKEN/ DENTED BLADES
------------	-----------------------

Deficiency Quantity	10
Quantity Uom	S.F.
Potential Action	REPLACE
Urgency of Action	PRIORITY 4
Purpose of Action	LEVEL 2

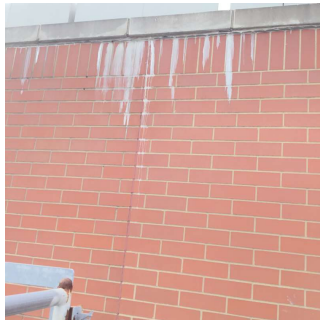
Deficiency Quantity	80
Quantity Uom	S.F.
Potential Action	MAINTENANCE
Urgency of Action	PRIORITY 1
Purpose of Action	LEVEL 1
Deficiency Photo1

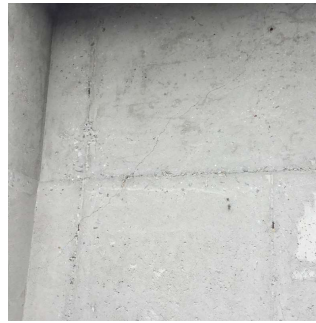
Violations	PH No violations recorded.
Deficiency	CONCRETE: MINOR CRACKS, SPALLING

50
S.F.
REPAIR
PRIORITY 3
LEVEL 2

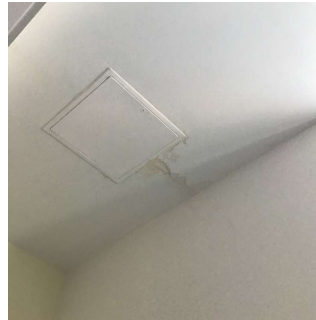
Roof 4 - Room 406

PAVERS: MAJOR ACTIVE PLAZA DECK LEAKS IN INSTRUCTIONAL SPACE

100
S.F.
REPLACE
PRIORITY 5
LEVEL 2

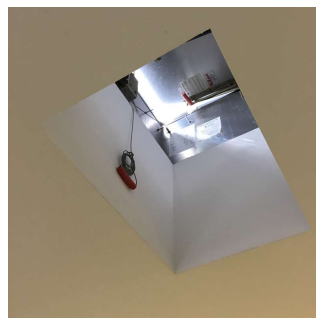
INOPERABLE

1
EACH
REPLACE
PRIORITY 4
LEVEL 2

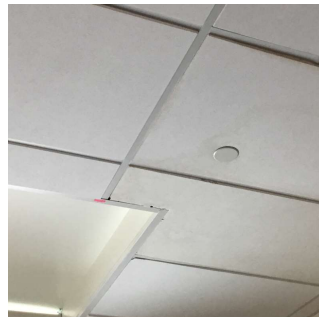
Roof 1
Instance Quantity	5,900
Instance Quantity Uom	S.F.
Does the roof have major mechanical equipment sitting on Dunnage Steel less than 18" above the Roofing?	No
Does this roof instance have a Sustainable Roof System?	No
Do solar panels exist on these roofs?	No
Is/Are the roof(s) suitable for Solar Panel installation?	No
Installation Year	2014
Source of Installation	Custodial Staff
Deficiency	IRMA: ROOFING: MAJOR ACTIVE ROOF LEAKS IN INSTRUCTIONAL SPACE

<p>Roof 1 - Room 503 (Roof 1 - Corridor near Room 502, Room 502 similar)</p>
<p>Violations</p>	<p>No violations recorded.</p>
<p>Deficiency</p>	<p>IRMA: ROOFING: MAJOR ACTIVE ROOF LEAKS IN NON-INSTRUCTIONAL SPACE</p>
<p>Roof Plan reference</p>

Deficiency Quantity	400
Quantity Uom	S.F.
Potential Action	REPLACE ROOFING WITHOUT MAJOR EQUIPMENT REMOVAL
Urgency of Action	PRIORITY 5
Purpose of Action	LEVEL 2

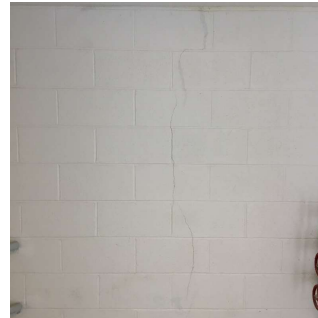
BH1 (BH2, PH)

BULKHEAD/PENTHOUSE WALLS/INTERIOR: CMU
CRACKS/SPALLING

REPLACE

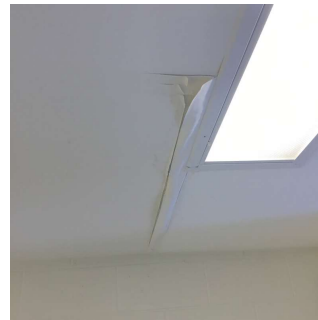
Stair B at 6th Floor

BULKHEAD/PENTHOUSE ROOF: MAJOR LEAKAGE

REPLACE

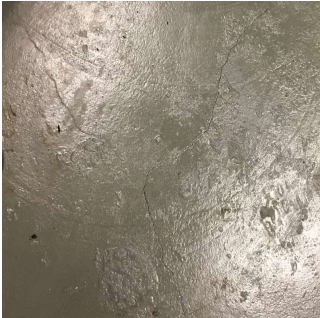
Room C020 (Water Main Room similar)

PH	PH
Violations	No violations recorded.
FLOOR STRUCTURE	Inspected
Condition	3 - Fair
Deficiency	CONCRETE SLAB ON GRADE: THRU CRACKS
Deficiency Location/Instance	Basement
Deficiency Quantity	60
Quantity Uom	S.F.
Potential Action	REPAIR
Urgency of Action	PRIORITY 3
Purpose of Action	LEVEL 5
Deficiency Photo1

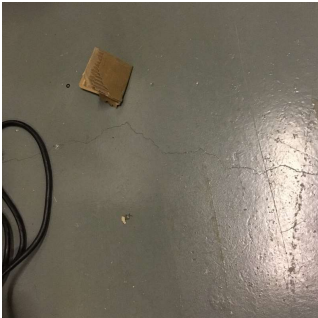
Question	Response
INTERIOR	
STRUCTURAL	
FLOOR STRUCTURE	
Violations	No violations recorded.
Deficiency	CONCRETE: CRACKS/SPALLED/REINFORCEMENT EXPOSED
Deficiency Location/Instance	4th Floor
Deficiency Quantity	40
Quantity Uom	S.F.
Potential Action	REPAIR
Urgency of Action	PRIORITY 3
Purpose of Action	LEVEL 5
Deficiency Photo1

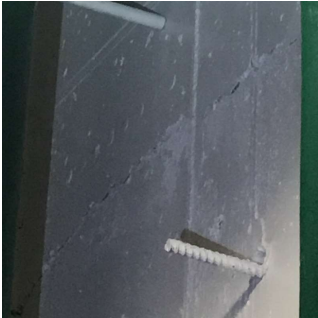
Violations	Room 413 No violations recorded.
FOUNDATION WALLS	
Material Type(s)	Inspected Concrete
Condition	4 - Between Fair and Poor
Deficiency	CONCRETE: CRACKED/SPALLED/REINFORCEMENT EXPOSED
Deficiency Location/Instance	Basement
Deficiency Quantity	20
Quantity Uom	S.F.
Potential Action	REPAIR
Urgency of Action	PRIORITY 4
Purpose of Action	LEVEL 5
Deficiency Photo1

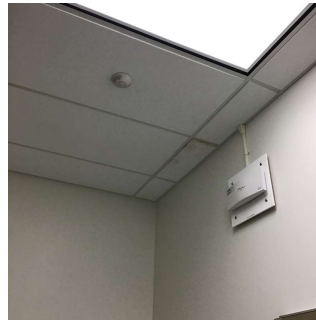
Room 115A

ACOUSTIC TILES: DAMAGED/MISSING

REPLACE

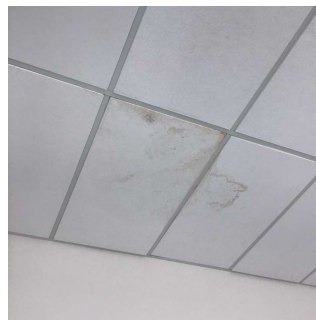
Corridor near Elevator A/5

ACOUSTIC TILES: DAMAGED/MISSING - ACTIVE LEAK

REPLACE

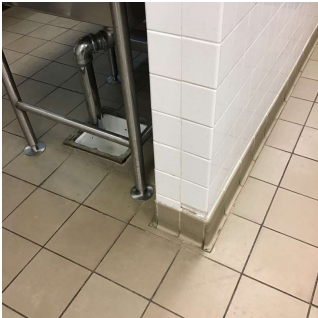
Deficiency	No deficiencies recorded
Floor Finish	
Instance on 1st Floor	Inspected
Condition	2 - Between Good and Fair
Deficiency	No deficiencies recorded
Walls	
Instance on 1st Floor	Inspected
Condition	2 - Between Good and Fair
Deficiency	CERAMIC TILE: BROKEN/ MISSING
Deficiency Location/Instance	Near Sink

Question	Response
INTERIOR	
KITCHEN	
Walls	
Deficiency Quantity	10
Quantity Uom	S.F.
Potential Action	REPLACE
Urgency of Action	PRIORITY 3
Purpose of Action	LEVEL 2
Deficiency Photo1

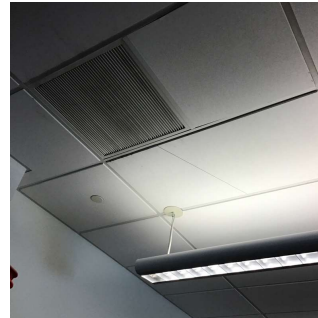
Violations	Near Windows Right Side No violations recorded.
Deficiency	ACOUSTIC TILES: DAMAGED/MISSING
Deficiency Location/Instance	Near Center
Deficiency Quantity	10
Quantity Uom	S.F.
Potential Action	REPLACE
Urgency of Action	PRIORITY 3

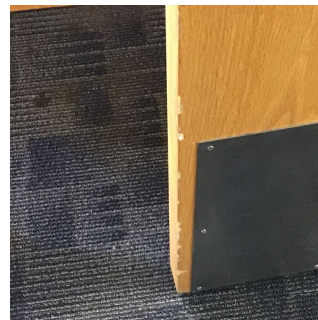
Entrance Right Side

WOOD: DETERIORATED DOOR

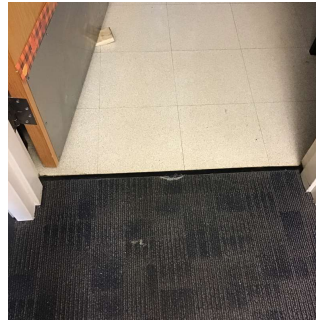
Near Room 503A

CARPET: WORN/DETERIORATED

REPLACE

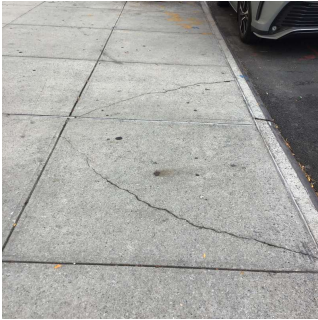
Violations	43rd Street No violations recorded.

Deficiency	DAMAGED CURBS
Deficiency Location/Instance	43rd Street
Deficiency Quantity	10
Quantity Uom	L.F.
Potential Action	REPLACE
Urgency of Action	PRIORITY 3
Purpose of Action	LEVEL 2

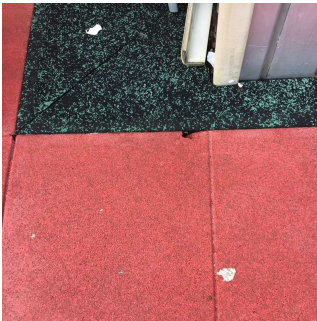
Violations	Near Entrance Left Side No violations recorded.
Unpaved Area	
Instance on 2nd Floor - Plaza Deck	Does not Exist
Instance on 5th Floor - Plaza Deck	Does not Exist
PLAYING SURFACE	Does not Exist
RETAINING WALLS	Does not Exist
SEATING	Does not Exist
SITE WALLS (NOT RETAINING WALLS)	Inspected
Condition	2 - Between Good and Fair
Deficiency	No deficiencies recorded
STAIRS/RAMPS: EXTERIOR	Does not Exist
ARTWORK	Inspected
Instance	Interior - 2nd/3rd Floor Double Height Alcove - 60077
Instance Photo

Deficiency Quantity	10
Quantity Uom	S.F.
Potential Action	REPLACE
Urgency of Action	PRIORITY 3
Purpose of Action	LEVEL 2
