**NYC Department of Education**  
**Building Condition Assessment Survey 2023 - 2024**

Architectural Inspection

Q314

**Asset:** P.S./ I.S. 314 - QUEENS, 88-08 164 STREET, New York, 11432

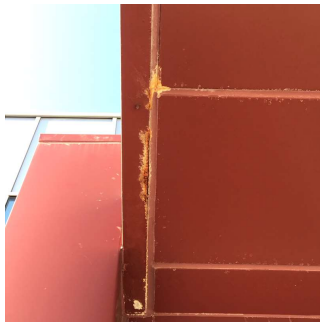
Question	Response
<b>Architectural</b>	
<b>EXTERIOR</b>	Inspected
<b>AREAWAY</b>	Does not Exist
<b>AWNINGS AND CANOPIES</b>	Inspected
Condition	3 - Fair
Deficiency	METAL: WATER PENETRATION
Roof Plan reference	
Deficiency Quantity	20
Quantity Uom	S.F.
Potential Action	REPAIR
Urgency of Action	PRIORITY 5

Question	Response
<b>EXTERIOR</b>	
<b>AWNINGS AND CANOPIES</b>	
Purpose of Action	LEVEL 2
Deficiency Photo1

Violations	Facade A No violations recorded.
<b>CHIMNEY</b>	
Material Type(s)	Inspected Metal
Condition	2 - Between Good and Fair
Deficiency	No deficiencies recorded
<b>COPING</b>	
Condition	Inspected 3 - Fair
Deficiency	CAST STONE: DETERIORATED TRANSVERSE JOINTS
Roof Plan reference

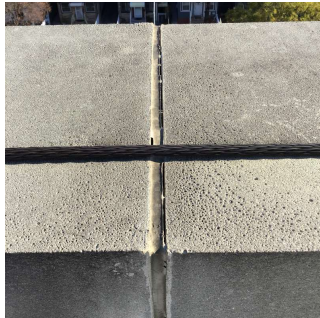
Deficiency Quantity	60
Quantity Uom	L.F.
Potential Action	MAINTENANCE
Urgency of Action	PRIORITY 3
Purpose of Action	LEVEL 2
Deficiency Photo1

Violations	Roof 1 - Facade A No violations recorded.
Deficiency	CAST STONE: CRACKED/BROKEN PIECES

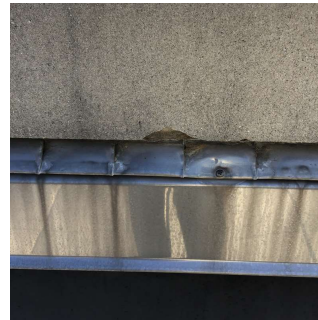
Roof 1  
No violations recorded.

10  
L.F.  
REPLACE-IN-KIND  
PRIORITY 4  
LEVEL 2

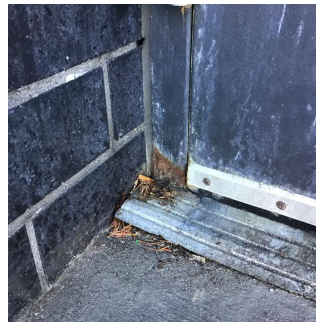
Facade D

METAL: DETERIORATED DOOR AND FRAME - MINOR DETERIORATION

2  
EACH  
MAINTENANCE  
PRIORITY 3  
LEVEL 2

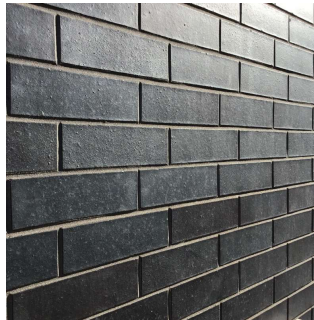
Facade C

BRICK: DETERIORATED JOINTS

50

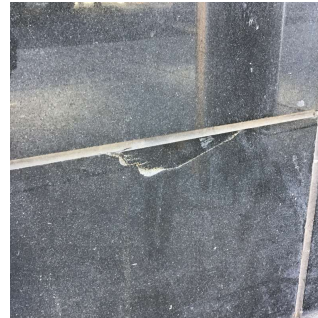
Facade E

STONE: CHIPPED/SPALLED/BROKEN PIECES - MINOR

10

PRIORITY 3  
LEVEL 2

REPAIR

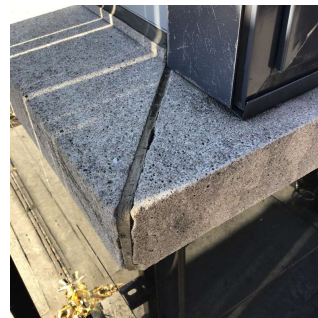
Facade F

STONE: DETERIORATED MASONRY SILLS - MINOR

10

REPAIR

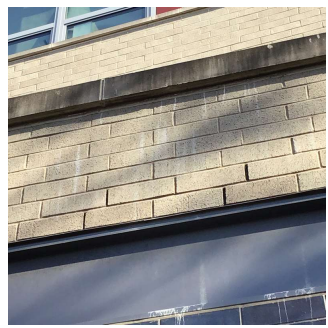
Question	Response
<b>EXTERIOR</b>	
<b>PARAPETS</b>	
Instance on All Roofs	Inspected
Instance Condition	2 - Between Good and Fair
Instance Quantity	5,000
Instance Quantity Uom	C.F.
Deficiency	BRICK: EFFLORESCENCE
Roof Plan reference

Deficiency Quantity	20
Quantity Uom	S.F.
Potential Action	MAINTENANCE
Urgency of Action	PRIORITY 1
Purpose of Action	LEVEL 1
Deficiency Photo1

Roof 4	Roof 4
Violations	No violations recorded.
<b>PLAZA DECK</b>	Does not Exist
<b>ROOF</b>	Inspected
<b>Roofing</b>	Inspected
Replacement Quantity	29,000
Replacement Uom	S.F.
<b>ROOF HATCH/SMOKE HATCH</b>	Inspected
Condition	2 - Between Good and Fair
Deficiency	No deficiencies recorded
<b>LEADERS, GUTTERS, DOWNSPOUTS, SCUPPERS</b>	Inspected
Condition	2 - Between Good and Fair
Deficiency	No deficiencies recorded
<b>ROOF BARRIER/FENCE</b>	Inspected
Condition	2 - Between Good and Fair
Deficiency	No deficiencies recorded
<b>ROOF CAGE</b>	Does not Exist

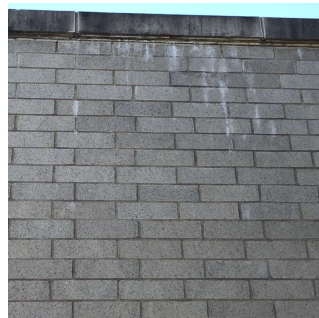
Question	Response
<b>EXTERIOR</b>	
<b>ROOF</b>	
<b>Roofing</b>	Inspected
<b>ROOFING DRAINS</b>	Inspected
Deficiency	No deficiencies recorded
<b>Specialties</b>	Inspected
<b>BULKHEAD/PENTHOUSE</b>	Inspected
Condition	2 - Between Good and Fair
Deficiency	BULKHEAD/PENTHOUSE WALLS/EXTERIOR: EFFLORESCENCE
Roof Plan reference

Deficiency Quantity	20
Quantity Uom	S.F.
Potential Action	MAINTENANCE
Urgency of Action	PRIORITY 1
Purpose of Action	LEVEL 1
Deficiency Photo1

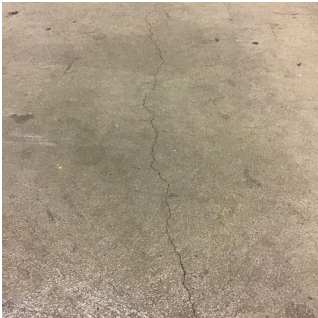
Question	Response
<b>EXTERIOR</b>	
<b>WINDOWS</b>	
<b>LINTELS</b>	Inspected
Condition	2 - Between Good and Fair
Deficiency	No deficiencies recorded
<b>WINDOWS</b>	
Material Type(s)	Inspected Vinyl, Aluminum
Instance on Aluminum - Other: All Facades	Inspected
Instance Condition	2 - Between Good and Fair
Instance Quantity	14,000
Instance Quantity Uom	S.F.
Are these windows insulated	Yes
Installation Year	2015
Source of Installation	Custodial Staff
Deficiency	No deficiencies recorded
<b>INTERIOR</b>	
<b>POOLS</b>	Does not Exist
<b>STRUCTURAL</b>	
<b>COLUMNS/BEAMS/BEARING WALLS</b>	Inspected
Condition	Inspected 2 - Between Good and Fair
Deficiency	No deficiencies recorded
<b>FLOOR STRUCTURE</b>	
Condition	Inspected 3 - Fair
Deficiency	CONCRETE: CRACKS/SPALLED/REINFORCEMENT EXPOSED
Deficiency Location/Instance	PH
Deficiency Quantity	60
Quantity Uom	S.F.
Potential Action	REPAIR
Urgency of Action	PRIORITY 3
Purpose of Action	LEVEL 5

Violations	PH No violations recorded.
Deficiency	CONCRETE SLAB ON GRADE: THRU CRACKS
Deficiency Location/Instance	Basement - Rooms C016, C017, C029
Deficiency Quantity	30
Quantity Uom	S.F.
Potential Action	REPAIR
Urgency of Action	PRIORITY 3
Purpose of Action	LEVEL 5

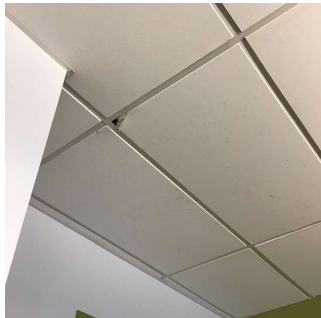
Question	Response
<b>INTERIOR</b>	
<b>CAFETERIA</b>	Inspected
<b>Walls</b>	
Violations	No violations recorded.
<b>Window Curtains/Shades/Blinds</b>	
Instance on 1st Floor	Does not Exist
<b>CLASSROOMS/CORRIDORS/ADMIN SPACES</b>	Inspected
<b>Ceiling</b>	Inspected
Condition	2 - Between Good and Fair
Deficiency	ACOUSTIC TILES: DAMAGED/MISSING
Deficiency Location/Instance	Room 418, Corridor near Room C003
Deficiency Quantity	20
Quantity Uom	S.F.
Potential Action	REPLACE
Urgency of Action	PRIORITY 3
Purpose of Action	LEVEL 2
Deficiency Photo1

Room 418	
Violations	No violations recorded.
<b>Door(s)</b>	Inspected
Condition	3 - Fair
Deficiency	WOOD: DETERIORATED DOOR
Deficiency Location/Instance	Rooms 425, 416D
Deficiency Quantity	2
Quantity Uom	EACH
Potential Action	MAINTENANCE
Urgency of Action	PRIORITY 3
Purpose of Action	LEVEL 2
Deficiency Photo1

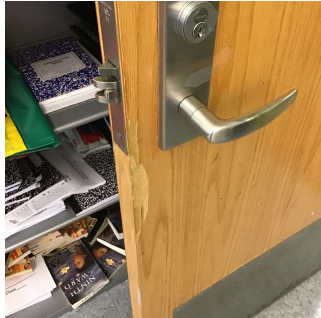
Room 425	
Violations	No violations recorded.
<b>Floor Finish</b>	Inspected

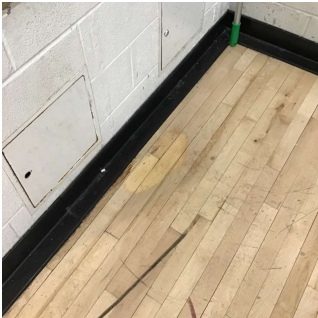
Question	Response
<b>INTERIOR</b>	
<b>GYMNASIUM</b>	
Instance on Basement	Inspected
Condition	2 - Between Good and Fair
Deficiency	No deficiencies recorded
<b>Fixed Equipment</b>	
Instance on Basement	Inspected
Condition	2 - Between Good and Fair
Deficiency	No deficiencies recorded
<b>Floor Finish</b>	
Instance on Basement	Inspected
Condition	2 - Between Good and Fair
Deficiency	WOOD: DAMAGED/DETERIORATED
Deficiency Location/Instance	Near Drinking Fountain
Deficiency Quantity	10
Quantity Uom	S.F.
Potential Action	REPLACE
Urgency of Action	PRIORITY 3
Purpose of Action	LEVEL 2
Deficiency Photo1

Violations	Near Drinking Fountain No violations recorded.
<b>Seating</b>	
Instance on Basement	Inspected
Condition	2 - Between Good and Fair
Deficiency	No deficiencies recorded
<b>Sliding-folding Partition</b>	
Instance on Basement	Inspected
Condition	2 - Between Good and Fair
Deficiency	No deficiencies recorded
<b>Stage</b>

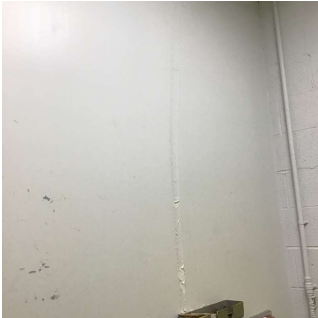
Instance on 1st Floor	Inspected
Condition	2 - Between Good and Fair
Deficiency	GYPSUM BOARD: DETERIORATED
Deficiency Location/Instance	Exit Vestibule near Room 119
Deficiency Quantity	10
Quantity Uom	S.F.
Potential Action	REPLACE
Urgency of Action	PRIORITY 3
Purpose of Action	LEVEL 2
Deficiency Photo1

Violations	Exit Vestibule No violations recorded.

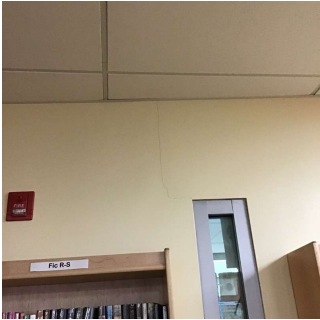
Question	Response
<b>INTERIOR</b>	
<b>LIBRARY</b>	
<b>Ceiling</b>	
Condition	2 - Between Good and Fair
Deficiency	No deficiencies recorded
<b>Door(s)</b>	
Instance on Room 225	Inspected
Condition	2 - Between Good and Fair
Deficiency	No deficiencies recorded
<b>Floor Finish</b>	
Instance on Room 225	Inspected
Condition	2 - Between Good and Fair
Deficiency	No deficiencies recorded
<b>Walls</b>	
Instance on Room 225	Inspected
Condition	2 - Between Good and Fair
Deficiency	GYPSON BOARD: DETERIORATED
Deficiency Location/Instance	Right Side
Deficiency Quantity	10
Quantity Uom	S.F.
Potential Action	REPLACE
Urgency of Action	PRIORITY 3
Purpose of Action	LEVEL 2
Deficiency Photo1

Right Side
Violations	No violations recorded.
<b>LOCKER ROOM</b>	
Instance on Basement - Boys (282 Lockers)	Inaccessible
Instance on Basement - Girls (366 Lockers)	Inaccessible
<b>MULTI-PURPOSE ROOM</b>	
Instance on 2nd Floor	Inspected
<b>Ceiling</b>

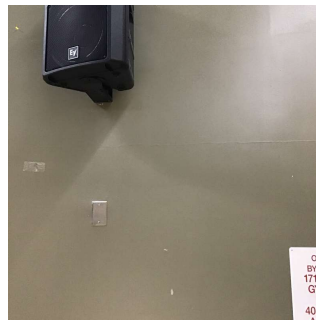
Left Side near Stage

GYPSUM BOARD: DETERIORATED

REPLACE

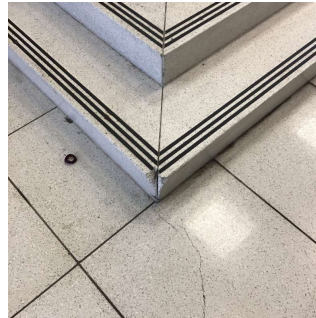
Corridor near Cafeteria

TERRAZZO: CRACKS

REPLACE

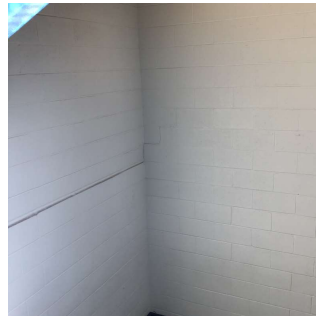
MASONRY: CRACKS/SPALLING

REPLACE

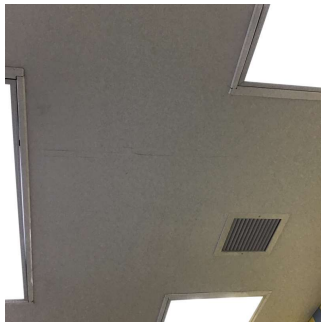
Question	Response
<b>INTERIOR</b>	
<b>STAIRS/RAMPS: INTERIOR</b>	Inspected
<b>Walls</b>	Inspected
Violations	Stair A/3 No violations recorded.
<b>TOILET ROOMS - STAFF</b>	Inspected
<b>Ceiling</b>	Inspected
Condition	2 - Between Good and Fair
Deficiency	No deficiencies recorded
<b>Door(s)</b>	Inspected
Condition	2 - Between Good and Fair
Deficiency	No deficiencies recorded
<b>Floor Finish</b>	Inspected
Condition	2 - Between Good and Fair
Deficiency	No deficiencies recorded
<b>Stalls</b>	Inspected
Condition	2 - Between Good and Fair
Deficiency	No deficiencies recorded
<b>Walls</b>	Inspected
Condition	2 - Between Good and Fair
Deficiency	No deficiencies recorded
<b>TOILET ROOMS - STUDENTS</b>	Inspected
<b>Ceiling</b>	Inspected
Condition	2 - Between Good and Fair
Deficiency	GYPSON BOARD: DAMAGED/DETERIORATED
Deficiency Location/Instance	Rooms 116A, 116B
Deficiency Quantity	20
Quantity Uom	S.F.
Potential Action	REPLACE
Urgency of Action	PRIORITY 3

Violations	Room 116A No violations recorded.
<b>Door(s)</b>	Inspected
Condition	3 - Fair
Deficiency	WOOD: DETERIORATED DOOR
Deficiency Location/Instance	Room 116B
Deficiency Quantity	1
Quantity Uom	EACH
Potential Action	MAINTENANCE
Urgency of Action	PRIORITY 3

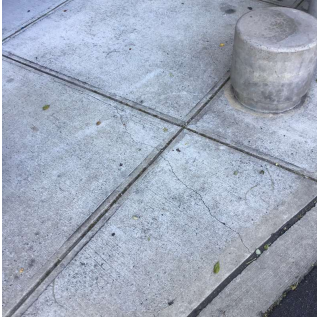
Question	Response
<b>SITE</b>	
<b>FENCES</b>	
Purpose of Action	LEVEL 2
Deficiency Photo1	 
Violations	164th Street No violations recorded.
<b>IRRIGATION SYSTEM</b>	Does not Exist
<b>PAVING</b>	Inspected
<b>Student Non-Use</b>	Inspected
Gravel Exists?	No
<b>Asphalt</b>	Does not Exist
<b>Concrete</b>	Inspected
Condition	2 - Between Good and Fair
Deficiency	No deficiencies recorded
<b>Pavers</b>	Does not Exist
<b>Student Use</b>	Inspected
Gravel Exists?	No
<b>Asphalt</b>	Inspected
Condition	3 - Fair
Deficiency	CRACKS - MAJOR
Deficiency Location/Instance	Schoolyard
Deficiency Quantity	50
Quantity Uom	S.F.
Potential Action	REPLACE
Urgency of Action	PRIORITY 3
Purpose of Action	LEVEL 2
Deficiency Photo1	 
Violations	Schoolyard No violations recorded.
<b>Concrete</b>	Inspected
Condition	3 - Fair
Deficiency	CRACKS - MAJOR
Deficiency Location/Instance	Schoolyard

Question	Response
<b>SITE</b>	
<b>PAVING</b>	
<b>Student Use</b>	
<b>Concrete</b>	
Deficiency Quantity	50
Quantity Uom	S.F.
Potential Action	REPLACE
Urgency of Action	PRIORITY 3
Purpose of Action	LEVEL 2
Deficiency Photo1

Violations	Schoolyard No violations recorded.
<b>Pavers</b>	Does not Exist
<b>Site Sidewalks &amp; Walkways</b>	Inspected
<b>Asphalt</b>	Inspected
Condition	2 - Between Good and Fair
Deficiency	CRACKS - MAJOR
Deficiency Location/Instance	Rear of Building near Playground, Near Gas meter Room
Deficiency Quantity	40
Quantity Uom	S.F.
Potential Action	REPLACE
Urgency of Action	PRIORITY 3
Purpose of Action	LEVEL 2
Deficiency Photo1

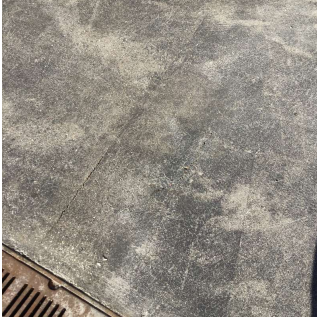
Violations	Rear of Building near Playground No violations recorded.
<b>Concrete</b>	Inspected
Condition	2 - Between Good and Fair
Deficiency	DAMAGED/DETERIORATED/MISSING SECTIONS
Deficiency Location/Instance	164th Street
Deficiency Quantity	25
Quantity Uom	S.F.
Potential Action	REPLACE

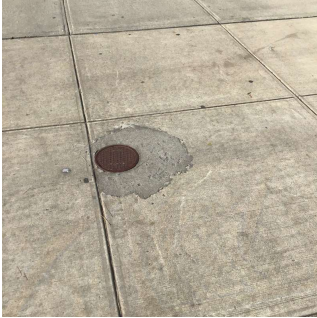
164th Street
Violations	No violations recorded.
<b>Pavers</b>	Does not Exist
<b>DOT Sidewalk</b>	Inspected
<b>Asphalt</b>	Does not Exist
<b>Concrete</b>	Inspected
Condition	3 - Fair
Deficiency	HEAVING
Deficiency Location/Instance	164th Street
Deficiency Quantity	50
Quantity Uom	S.F.
Potential Action	REPLACE
Urgency of Action	PRIORITY 3
Purpose of Action	LEVEL 2
Deficiency Photo1	 
	164th Street
Violations	No violations recorded.
Deficiency	DAMAGED/DETERIORATED/MISSING SECTIONS
Deficiency Location/Instance	Hillside Avenue, 164th Street
Deficiency Quantity	200
Quantity Uom	S.F.
Potential Action	REPLACE
Urgency of Action	PRIORITY 3
Purpose of Action	LEVEL 2

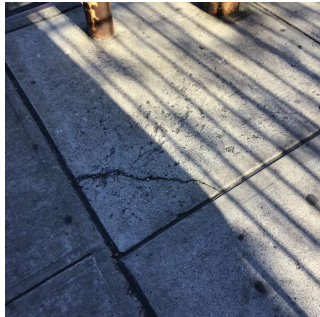
Violations	Hillside Avenue No violations recorded.
<b>Pavers</b>	Inspected
Condition	2 - Between Good and Fair
Deficiency	DAMAGED/MISSING
Deficiency Location/Instance	Hillside Avenue
Deficiency Quantity	20
Quantity Uom	S.F.
Potential Action	REPLACE
Urgency of Action	PRIORITY 3
Purpose of Action	LEVEL 2
Deficiency Photo1

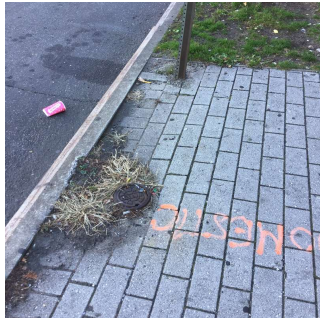
Violations	Hillside Avenue No violations recorded.
<b>PLAYGROUNDS</b>	Inspected
Instance on West of Building	Inspected
<b>Benches</b>	
Instance on West of Building	Does not Exist
<b>Fence</b>	
Instance on West of Building	Inspected
Condition	2 - Between Good and Fair
Deficiency	No deficiencies recorded
<b>Pavement</b>	
Instance on West of Building	Does not Exist
<b>Play Equipment</b>	
Instance on West of Building	Inspected
Condition	2 - Between Good and Fair
Deficiency	No deficiencies recorded

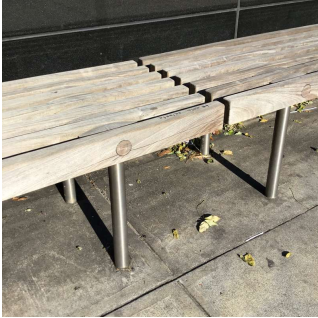
Question	Response
<b>SITE</b>	
<b>PLAYING SURFACE</b>	Inspected
<b>Running Track</b>	Does not Exist
<b>RETAINING WALLS</b>	Inspected
Are there any Retaining Walls 6' OR higher facing public street/sidewalk?	No
Condition	2 - Between Good and Fair
Deficiency	No deficiencies recorded
<b>SEATING</b>	Inspected
<b>Benches</b>	Inspected
<b>Concrete</b>	Inspected
Condition	2 - Between Good and Fair
Deficiency	No deficiencies recorded
<b>Metal/Wood/Plastic</b>	Inspected
Condition	3 - Fair
Deficiency	DAMAGED/DETERIORATED
Deficiency Location/Instance	Near Main Entrance
Deficiency Quantity	1
Quantity Uom	EACH
Potential Action	REPLACE
Urgency of Action	PRIORITY 3
Purpose of Action	LEVEL 2
Deficiency Photo1

Violations	Near Main Entrance No violations recorded.
<b>Bleachers</b>	Does not Exist
<b>SITE WALLS (NOT RETAINING WALLS)</b>	Does not Exist
<b>STAIRS/RAMPS: EXTERIOR</b>	Does not Exist
<b>ARTWORK</b>	Inspected
Instance	Interior - Lobby and Atrium - 100011
