**NYC Department of Education**  
**Building Condition Assessment Survey 2023 - 2024**

Architectural Inspection

Q315

**Asset: THE TIFFANY SCHOOL, 43-18 97TH PLACE, New York, 11368**

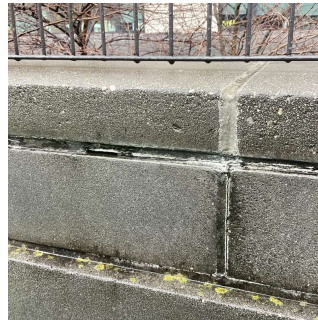
Roof 6 - Facade L

**COPING**

50  
L.F.  
REPOINT  
PRIORITY 3  
LEVEL 2

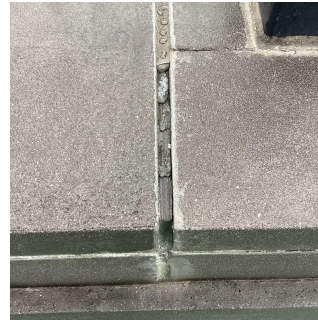
Roof 6

**CAST STONE: DETERIORATED TRANSVERSE JOINTS**

10  
L.F.  
MAINTENANCE  
PRIORITY 3  
LEVEL 2

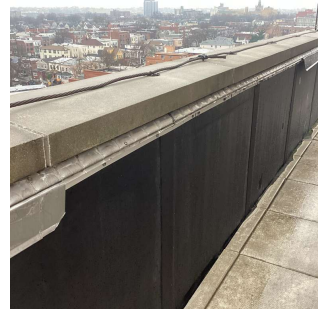
Roof 1 - Facade A

**CAST STONE: DETERIORATED FLASHING**

10

REPLACE

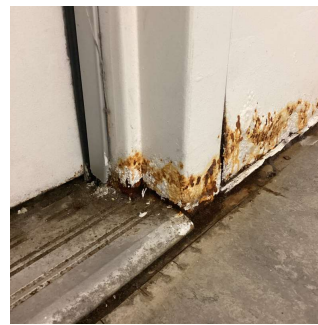
Exit 3  
No violations recorded.

**METAL: DETERIORATED DOOR AND FRAME - MINOR DETERIORATION**

2  
EACH  
MAINTENANCE  
PRIORITY 3  
LEVEL 2

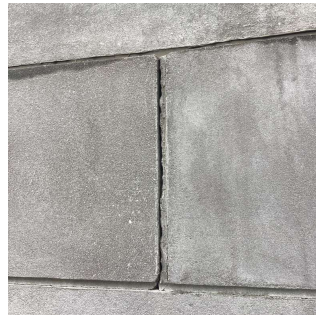
Facade E

**CAST IN PLACE / PRE-CAST CONCRETE: DETERIORATED JOINTS**

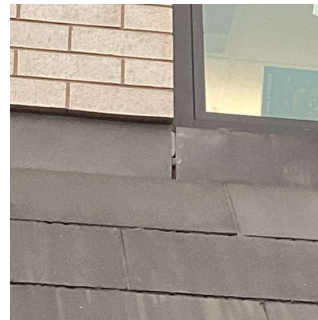
Facade C

**BRICK: MASONRY SILLS - DETERIORATED JOINTS**

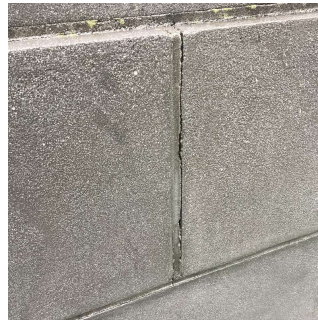
Roof 6

**PARAPETS**

40  
S.F.  
REPOINT  
PRIORITY 3  
LEVEL 2

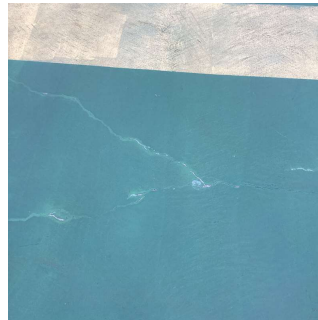
Roof 6

**PLAZA DECK**

2,000  
S.F.  
REPAIR  
PRIORITY 3  
LEVEL 2

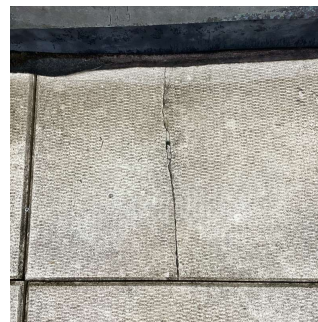
Roof 1  
No violations recorded.

Is/Are the roof(s) suitable for Solar Panel installation?	No
Installation Year	2015
Source of Installation	Custodial Staff
Deficiency	IRMA: ROOFING: DETERIORATED PAVERS WITH INTEGRAL INSULATION

20  
S.F.  
REPLACE  
PRIORITY 4  
LEVEL 2

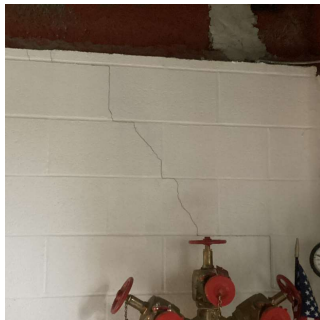
Question	Response
<b>EXTERIOR</b>	
<b>ROOF</b>	
<b>Specialties</b>	
<b>BULKHEAD/PENTHOUSE</b>	
Urgency of Action	PRIORITY 3
Purpose of Action	LEVEL 2
Deficiency Photo1	 
Violations	PH No violations recorded.
Deficiency	BULKHEAD/PENTHOUSE WALLS/INTERIOR: CMU CRACKS/SPALLING
Roof Plan reference	Q315

Deficiency Quantity	40
Quantity Uom	S.F.
Potential Action	REPLACE
Urgency of Action	PRIORITY 3
Purpose of Action	LEVEL 2
Deficiency Photo1

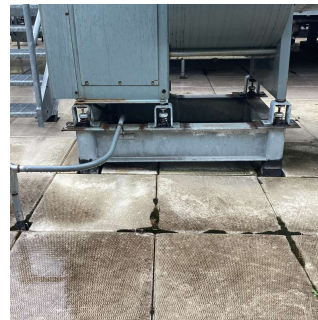
Roof 3  
No violations recorded.

Violations	BH1 No violations recorded.
<b>CUPOLA/ SPIRES/ TOWERS</b>	Does not Exist
<b>DORMER</b>	Does not Exist
<b>DUNNAGE STEEL</b>	Inspected
Condition	2 - Between Good and Fair
Deficiency	HEIGHT LESS THAN 18"

20  
L.F.  
REPLACE  
PRIORITY 3  
LEVEL 2

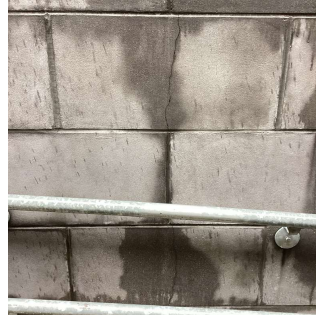
Facade B

MASONRY UNIT: CRACKS/SPALLING - MINOR

20  
S.F.  
REPAIR  
PRIORITY 3

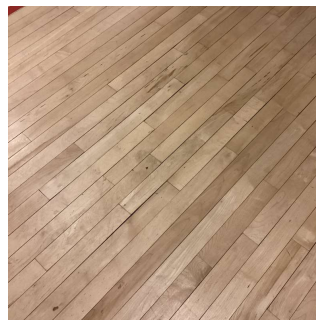
WOOD: DAMAGED/DETERIORATED

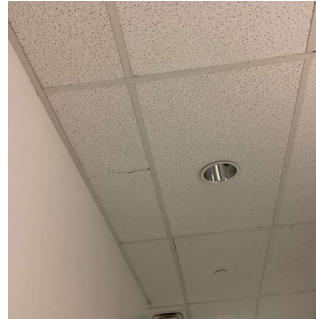
Deficiency	No deficiencies recorded
<b>INTERIOR GUARDS</b>	Inspected
Condition	2 - Between Good and Fair
Deficiency	No deficiencies recorded
<b>KITCHEN</b>	Inspected
Instance on Ground Floor	Inspected
<b>Ceiling</b>	
Instance on Ground Floor	Inspected
Condition	2 - Between Good and Fair
Deficiency	ACOUSTIC TILES: DAMAGED/MISSING

Deficiency Location/Instance	Near Exit 7
Deficiency Quantity	10
Quantity Uom	S.F.
Potential Action	REPLACE
Urgency of Action	PRIORITY 3
Purpose of Action	LEVEL 2
Deficiency Photo1

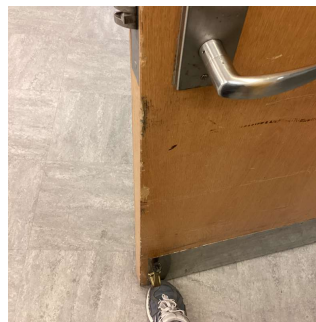
Instance on Ground Floor	Inspected
Condition	3 - Fair
Deficiency	WOOD: DETERIORATED DOOR
Deficiency Location/Instance	Entrance From Cafeteria near Exit 7
Deficiency Quantity	1
Quantity Uom	EACH
Potential Action	MAINTENANCE
Urgency of Action	PRIORITY 3
Purpose of Action	LEVEL 2
Deficiency Photo1

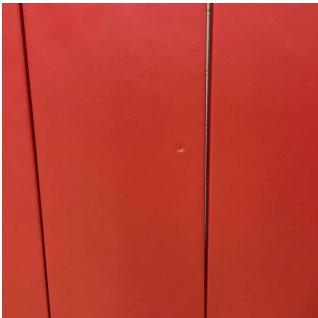
Question	Response
<b>INTERIOR</b>	
<b>MULTI-PURPOSE ROOM</b>	
<b>Fixed Equipment</b>	
Instance on Basement	Does not Exist
<b>Floor Finish</b>	
Instance on Basement	Inspected
Condition	2 - Between Good and Fair
Deficiency	No deficiencies recorded
<b>Sliding-folding Partition</b>	
Instance on Basement	Does not Exist
<b>Stage</b>	
Instance on Basement	Inspected
<b>Stage</b>	
Instance on Basement	Inspected
Condition	2 - Between Good and Fair
Deficiency	No deficiencies recorded
<b>Stage Curtain Rigging</b>	
Instance on Basement	Inspected
Condition	2 - Between Good and Fair
Deficiency	No deficiencies recorded
<b>Stage Curtains</b>	
Instance on Basement	Inspected
Condition	2 - Between Good and Fair
Deficiency	No deficiencies recorded
<b>Walls</b>	
Instance on Basement	Inspected
Condition	2 - Between Good and Fair
Deficiency	WALL PADDING: DETERIORATED
Deficiency Location/Instance	Left Side
Deficiency Quantity	20
Quantity Uom	S.F.

Potential Action	REPLACE
Urgency of Action	PRIORITY 3
Purpose of Action	LEVEL 2
Deficiency Photo1

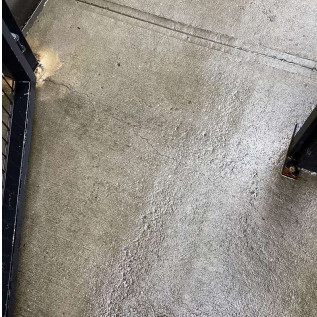
Courtyard	Courtyard
Violations	No violations recorded.
<b>Site Sidewalks &amp; Walkways</b>	Inspected
<b>Asphalt</b>	Does not Exist
<b>Concrete</b>	Inspected
Condition	2 - Between Good and Fair
Deficiency	CRACKS - MAJOR

Deficiency Location/Instance	Near Exit 3
Deficiency Quantity	25
Quantity Uom	S.F.
Potential Action	REPLACE
Urgency of Action	PRIORITY 3
Purpose of Action	LEVEL 2

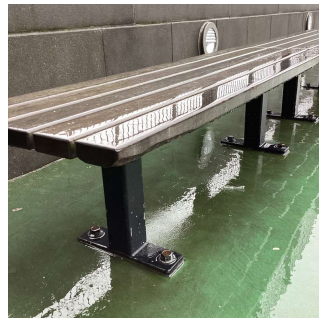
<b>Benches</b>	Inspected
<b>Concrete</b>	Does not Exist
<b>Metal/Wood/Plastic</b>	Inspected
Condition	3 - Fair
Deficiency	DAMAGED/DETERIORATED
Deficiency Location/Instance	Near Exit 5
Deficiency Quantity	1
Quantity Uom	EACH
Potential Action	REPLACE
Urgency of Action	PRIORITY 3
Purpose of Action	LEVEL 2
