NYC Department of Education
Building Condition Assessment Survey 2023 - 2024

Architectural Inspection

Asset: THE RIDGEWOOD SCHOOL, 360 SENECA AVENUE, New York, 11385

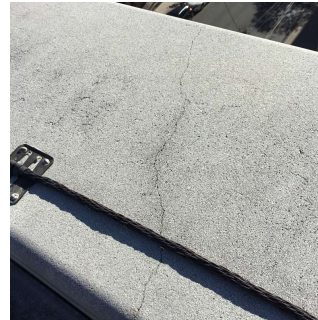
Roof 1

CAST STONE: CRACKED/BROKEN PIECES

20
L.F.
REPLACE-IN-KIND
PRIORITY 4
LEVEL 2

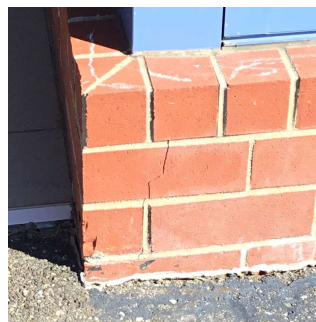
Facade C

Question	Response
EXTERIOR	
DOORS	Inspected
LINTELS	Inspected
Deficiency	No deficiencies recorded
TRANSOM/SIDE LIGHT	Inspected
Condition	2 - Between Good and Fair
Deficiency	No deficiencies recorded
EXTERIOR WALLS	Inspected
Material Type(s)	Steel, Masonry
Replacement Quantity	29,000
Replacement Uom	S.F.
Instance on All Facades (Masonry)	Inspected
Instance Condition	2 - Between Good and Fair
Instance Quantity	25,000
Instance Quantity Uom	S.F.
Deficiency	BRICK: MINOR CRACKS AND SPALLING
Roof Plan reference	Q320

10
S.F.
RESTITCH
PRIORITY 3
LEVEL 2

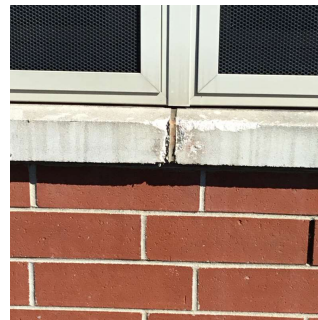
Facade C

BRICK: DETERIORATED MASONRY SILLS - MINOR

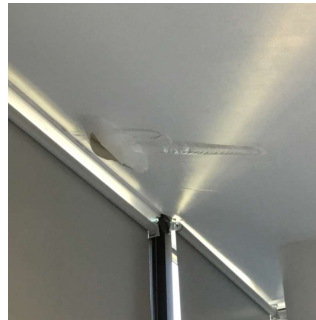
Facade D - Room 301 (shown), Facade A - Rooms 201, 301, 401,
Facade D - Rooms 201, 401

METAL/GLASS CURT WALL: WATER INFILTRATION IN INSTRUCTIONAL SPACE

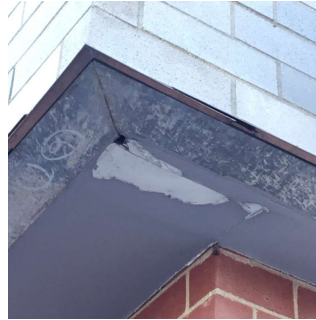
Facade D

STUCCO/PLASTER: MAJOR CRACKS/SPALLING

Deficiency Quantity	30
Quantity Uom	S.F.
Potential Action	REPLACE
Urgency of Action	PRIORITY 4
Purpose of Action	LEVEL 2
Deficiency Photo1

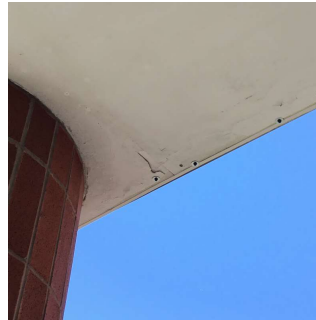
Facade C

Deficiency STUCCO/PLASTER: MINOR CRACKS/SPALLING

Deficiency Quantity	20
Quantity Uom	S.F.
Potential Action	REPAIR
Urgency of Action	PRIORITY 3
Purpose of Action	LEVEL 2

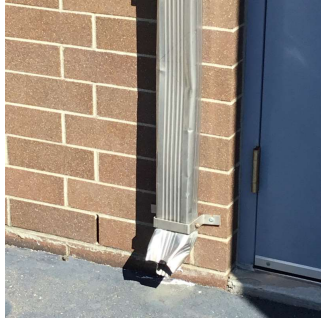
Question	Response
EXTERIOR	
PARAPETS	Inspected
	Facade C
Violations	No violations recorded.
PLAZA DECK	Does not Exist
ROOF	Inspected
Roofing	Inspected
Replacement Quantity	16,000
Replacement Uom	S.F.
ROOF HATCH/SMOKE HATCH	Inspected
Condition	2 - Between Good and Fair
Deficiency	No deficiencies recorded
LEADERS, GUTTERS, DOWNSPOUTS, SCUPPERS	Inspected
Condition	3 - Fair
Deficiency	DAMAGED/MISSING
Roof Plan reference	Q320

Deficiency Quantity	10
Quantity Uom	L.F.
Potential Action	REPLACE
Urgency of Action	PRIORITY 4
Purpose of Action	LEVEL 2
Deficiency Photo1

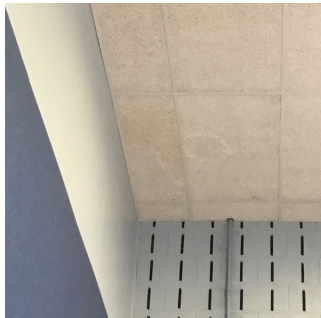
Roof 1
Instance Quantity	16,000
Instance Quantity Uom	S.F.
Does the roof have major mechanical equipment sitting on Dunnage Steel less than 18" above the Roofing?	No
Does this roof instance have a Sustainable Roof System?	No
Do solar panels exist on these roofs?	No
Is/Are the roof(s) suitable for Solar Panel installation?	No
Installation Year	2015
Source of Installation	Custodial Staff
Deficiency	IRMA: ROOFING: MAJOR ACTIVE ROOF LEAKS IN INSTRUCTIONAL SPACE
Roof Plan reference	Q320

Deficiency Quantity	400
Quantity Uom	S.F.
Potential Action	REPLACE ROOFING WITHOUT MAJOR EQUIPMENT REMOVAL
Urgency of Action	PRIORITY 5
Purpose of Action	LEVEL 2
Deficiency Photo1

Roof 1 - Gymnasium (Roof 1 - Vestibule Room 414E, Roof 4 - Stairwell A/1 similar)
Violations	No violations recorded.
Deficiency	IRMA: ROOFING: DETERIORATED PAVERS WITH INTEGRAL INSULATION

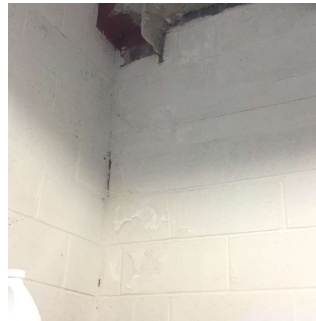
PH
 No violations recorded.

BULKHEAD/PENTHOUSE WALLS/EXTERIOR: WATER INFILTRATION

50
 S.F.
 REPAIR

PRIORITY 5
 LEVEL 2

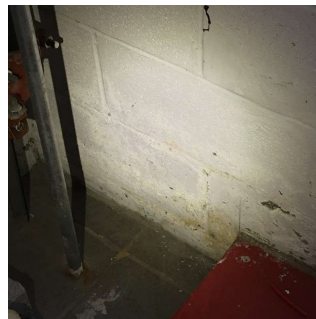
BH
 No violations recorded.

BULKHEAD/PENTHOUSE WALLS/INTERIOR: CMU
 CRACKS/SPALLING

30
 S.F.
 REPLACE
 PRIORITY 3
 LEVEL 2

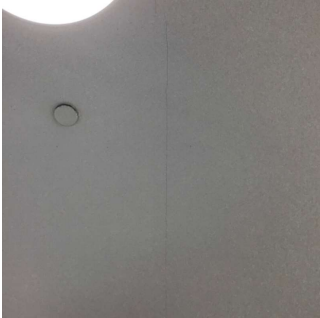
Question	Response
INTERIOR	
CAFETERIA	Inspected
Fixed Equipment	
Instance on Basement	Does not Exist
Floor Finish	
Instance on Basement	Inspected
Condition	2 - Between Good and Fair
Deficiency	No deficiencies recorded
Sliding-folding Partition	
Instance on Basement	Does not Exist
Stage	
Instance on Basement	Does not Exist
Walls	
Instance on Basement	Inspected
Condition	2 - Between Good and Fair
Deficiency	No deficiencies recorded
Window Curtains/Shades/Blinds	
Instance on Basement	Does not Exist
CLASSROOMS/CORRIDORS/ADMIN SPACES	Inspected
Ceiling	Inspected
Condition	2 - Between Good and Fair
Deficiency	GYPSON BOARD: DAMAGED/DETERIORATED
Deficiency Location/Instance	Near Entrance.
Deficiency Quantity	20
Quantity Uom	S.F.
Potential Action	REPLACE
Urgency of Action	PRIORITY 3
Purpose of Action	LEVEL 2
Deficiency Photo1

Near Entrance
Violations	No violations recorded.
Deficiency	ACOUSTIC TILES: DAMAGED/MISSING
Deficiency Location/Instance	Near Entrance , Corridor near Room 206

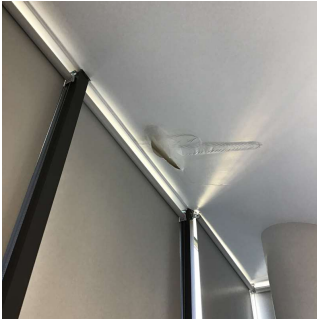
Corridor near Room 206
Violations	No violations recorded.
Deficiency	GYPSUM BOARD: DAMAGED/DETERIORATED - ACTIVE LEAK
Deficiency Location/Instance	Room 301
Deficiency Quantity	20
Quantity Uom	S.F.
Potential Action	REPLACE
Urgency of Action	PRIORITY 5
Purpose of Action	LEVEL 2
Deficiency Photo1

Room 301
Violations	No violations recorded.
Door(s)	Inspected
Condition	5 - Poor
Deficiency	WOOD: DETERIORATED DOOR
Deficiency Location/Instance	Rooms 101, 109, 209, 312, 315.
Deficiency Quantity	5
Quantity Uom	EACH
Potential Action	MAINTENANCE
Urgency of Action	PRIORITY 3
Purpose of Action	LEVEL 2

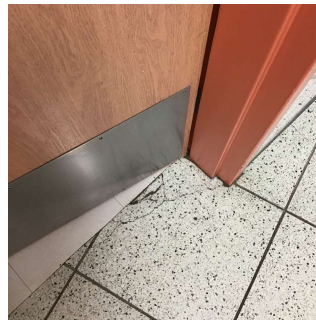
Corridor near Room 103A

CERAMIC TILE: BROKEN/MISSING TILES

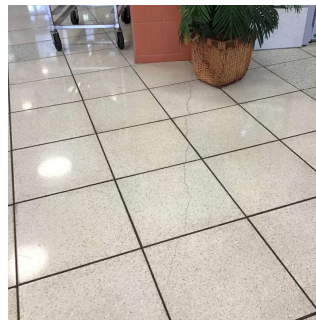
CERAMIC TILE: DETERIORATED SUBSTRATE

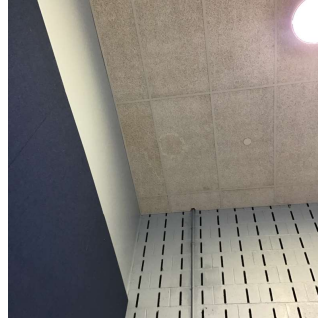
Near left Side Windows.

Deficiency	TECTUM: DAMAGED/MISSING - ACTIVE LEAK
Deficiency Location/Instance	Near Left Side Windows and center.
Deficiency Quantity	40
Quantity Uom	S.F.
Potential Action	REPLACE
Urgency of Action	PRIORITY 5
Purpose of Action	LEVEL 2
Deficiency Photo1

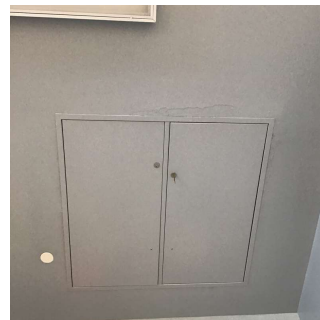
Deficiency	GYPSUM BOARD: DAMAGED/DETERIORATED
Deficiency Location/Instance	Near Entrance
Deficiency Quantity	10
Quantity Uom	S.F.
Potential Action	REPLACE
Urgency of Action	PRIORITY 3
Purpose of Action	LEVEL 2
Deficiency Photo1

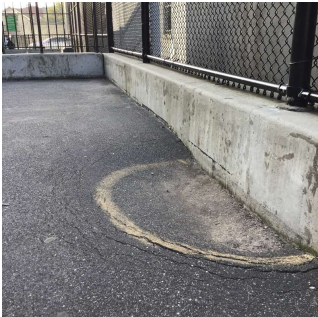
Question	Response
SITE	
PAVING	
Student Non-Use	
Concrete	Inspected
Condition	2 - Between Good and Fair
Deficiency	No deficiencies recorded
Pavers	Does not Exist
Student Use	Inspected
Gravel Exists?	No
Asphalt	Inspected
Condition	3 - Fair
Deficiency	LOCALIZED SINK AREA
Deficiency Location/Instance	Near Neighbors Retaining Wall
Deficiency Quantity	30
Quantity Uom	S.F.
Potential Action	REPAIR
Urgency of Action	PRIORITY 5
Purpose of Action	LEVEL 6
Deficiency Photo1

Violations	Near Neighbor Retaining Wall No violations recorded.
Deficiency	CRACKS - MAJOR
Deficiency Location/Instance	Near Center
Deficiency Quantity	30
Quantity Uom	S.F.
Potential Action	REPLACE
Urgency of Action	PRIORITY 3
Purpose of Action	LEVEL 2
Deficiency Photo1

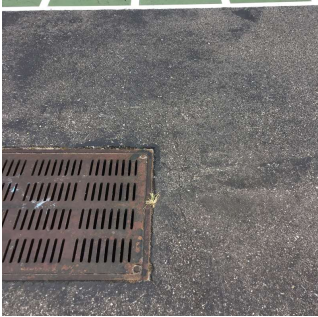
Violations	Near Center No violations recorded.
Concrete	Does not Exist
Pavers	Inspected
Condition	2 - Between Good and Fair

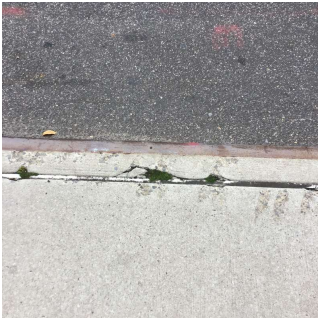
Question	Response
SITE	
PAVING	
DOT Sidewalk	
Concrete	
Violations	No violations recorded.
Deficiency	DAMAGED CURBS
Deficiency Location/Instance	Stockholm Avenue, Seneca Avenue, Dekalb Avenue.
Deficiency Quantity	15
Quantity Uom	L.F.
Potential Action	REPLACE
Urgency of Action	PRIORITY 3
Purpose of Action	LEVEL 2
Deficiency Photo1

Violations	Dekalb Avenue No violations recorded.
Pavers	Does not Exist
PLAYGROUNDS	Inspected
Instance on Schoolyard	Inspected
Benches	
Instance on Schoolyard	Inspected
Condition	2 - Between Good and Fair
Deficiency	No deficiencies recorded
Fence	
Instance on Schoolyard	Inspected
Condition	2 - Between Good and Fair
Deficiency	No deficiencies recorded
Pavement	
Instance on Schoolyard	Does not Exist
Play Equipment	
Instance on Schoolyard	Inspected
Condition	2 - Between Good and Fair
Deficiency	No deficiencies recorded
Safety Surfacing	
Instance on Schoolyard	Inspected
Condition	2 - Between Good and Fair

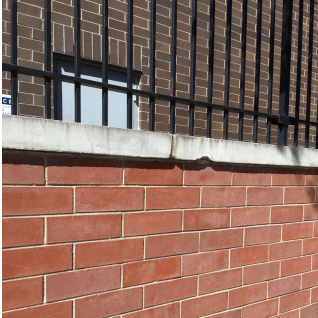
Question	Response
SITE	
RETAINING WALLS	
Condition	3 - Fair
Deficiency	BRICK: DETERIORATED COPING STONE
Deficiency Location/Instance	Stockholm Avenue
Deficiency Quantity	10
Quantity Uom	S.F.
Potential Action	REPLACE
Urgency of Action	PRIORITY 3
Purpose of Action	LEVEL 2
Deficiency Photo1

Violations	Stockholm Avenue No violations recorded.
Deficiency	BRICK: DETERIORATED JOINT AT COPING STONE
Deficiency Location/Instance	Stockholm Avenue
Deficiency Quantity	10
Quantity Uom	L.F.
Potential Action	MAINTENANCE
Urgency of Action	PRIORITY 3
Purpose of Action	LEVEL 2
Deficiency Photo1

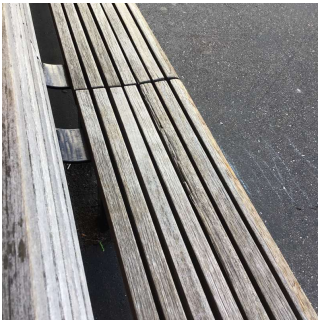
No	Protruding Elements	Severely damaged wood Bench with splintered pieces is a potential safety hazard.	SITE SEATING Benches Metal/Wood/Plastic	Schoolyard	Benjamin Santiago	Fireman

Violations	Playground Area No violations recorded.
SEATING	Inspected
Benches	Inspected
Concrete	Does not Exist
Metal/Wood/Plastic	Inspected
Condition	3 - Fair
Deficiency	DAMAGED/DETERIORATED
Deficiency Location/Instance	Schoolyard
Deficiency Quantity	1
Quantity Uom	EACH
Potential Action	REPLACE
Urgency of Action	PRIORITY 5
Purpose of Action	LEVEL 6
Deficiency Photo1

Violations	Schoolyard No violations recorded.
Bleachers	Does not Exist
SITE WALLS (NOT RETAINING WALLS)	Does not Exist
STAIRS/RAMPS: EXTERIOR	Inspected
Railings	Inspected
Condition	2 - Between Good and Fair
Deficiency	No deficiencies recorded
Site Cheek/flank Walls	Inspected
Condition	2 - Between Good and Fair
Deficiency	No deficiencies recorded
Stairs/ramps	Inspected
Condition	2 - Between Good and Fair
Deficiency	No deficiencies recorded
ARTWORK	Inspected
