NYC Department of Education
Building Condition Assessment Survey 2023 - 2024

Architectural Inspection

Asset: **PRE-K CENTER @ 70-24 47TH AVENUE - QUEENS, 70-24 47TH AVENUE, New York, 11377**

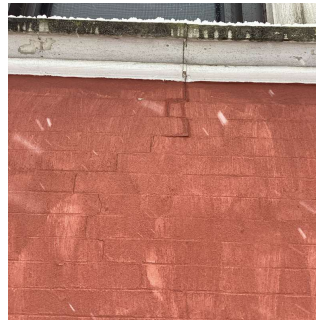
Facade A

Instance Quantity	3,000
Instance Quantity Uom	S.F.
Deficiency	BRICK: MINOR CRACKS AND SPALLING

RESTITCH

PRIORITY 3

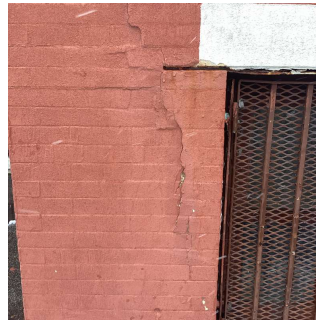
Facade B

BRICK: MAJOR / THRU CRACKS

REMOVE AND REBUILD

PRIORITY 4

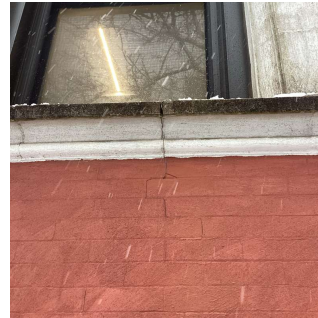
Facade A

BRICK: DETERIORATED MASONRY SILLS - MAJOR

REMOVE AND REPLACE

PRIORITY 4
LEVEL 2

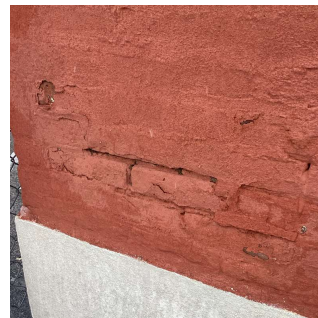
Facade A

BRICK: DETERIORATED JOINTS

REPOINT

PRIORITY 4

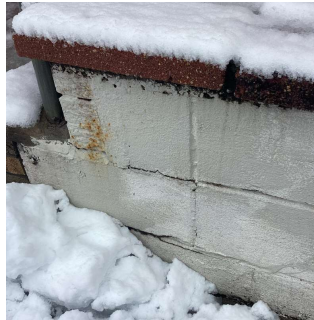
Facade C

MASONRY UNIT: DETERIORATED JOINTS

REPOINT

PRIORITY 3

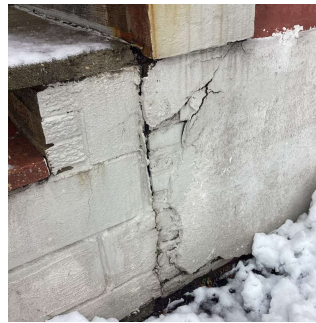
Facade C

STUCCO CEMENT SURFACE: CRACKS/SPALLING - MAJOR

REPLACE

PRIORITY 4

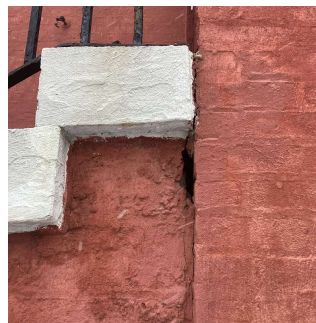
Facade C

BRICK: CRACKS/SPALLING - MAJOR

REPLACE

PRIORITY 4

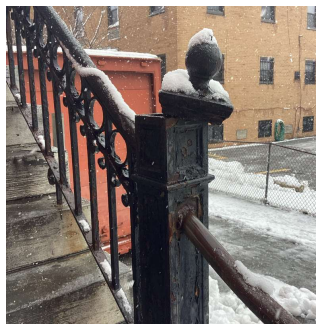
Facade C

DAMAGED

10
 L.F.
 REPLACE
 PRIORITY 4
 LEVEL 2

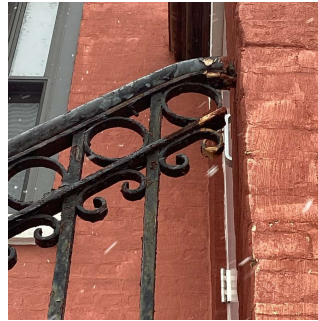
Facade C

RUST - MAJOR

10
 L.F.
 REPLACE
 PRIORITY 4
 LEVEL 2

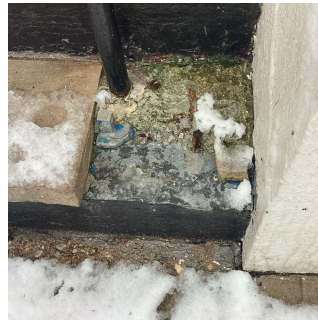
Facade A

STONE: CRACKS/SPALLING - MAJOR

REPLACE

PRIORITY 4

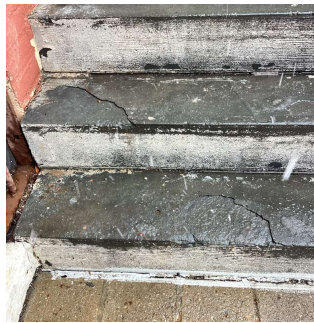
Facade C
No violations recorded.

STONE: WORN-OUT TREAD/RISER/NOSING

20
S.F.
REPLACE
PRIORITY 4
LEVEL 2

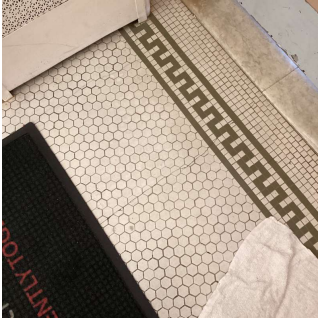
Question	Response
INTERIOR	
STRUCTURAL	Inspected
COLUMNS/BEAMS/BEARING WALLS	Inspected
Condition	2 - Between Good and Fair
Deficiency	No deficiencies recorded
FLOOR STRUCTURE	Inspected
Condition	2 - Between Good and Fair
Deficiency	No deficiencies recorded
FOUNDATION WALLS	Inaccessible
ROOF STRUCTURE	Inspected
Condition	2 - Between Good and Fair
Deficiency	No deficiencies recorded
VAULTS-BUNKERS	Does not Exist
AUDITORIUM	Does not Exist
CAFETERIA	Does not Exist
CLASSROOMS/CORRIDORS/ADMIN SPACES	Inspected
Ceiling	Inspected
Condition	2 - Between Good and Fair
Deficiency	No deficiencies recorded
Door(s)	Inspected
Condition	2 - Between Good and Fair
Deficiency	No deficiencies recorded
Floor Finish	Inspected
Condition	2 - Between Good and Fair
Deficiency	CERAMIC TILE: BROKEN/MISSING TILES
Deficiency Location/Instance	Main Entrance Vestibule
Deficiency Quantity	20
Quantity Uom	S.F.
Potential Action	REPLACE
Urgency of Action	PRIORITY 3

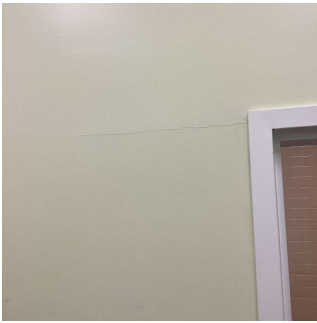
Violations	Room 109A No violations recorded.
LIBRARY	Does not Exist
LOCKER ROOM	Does not Exist
MULTI-PURPOSE ROOM	Does not Exist
SCIENCE DEMO ROOM	Does not Exist
SCIENCE LAB	Does not Exist
SCIENCE PREP ROOM	Does not Exist
SHOWER ROOM	Does not Exist
STAIRS/RAMPS: INTERIOR	Does not Exist
TOILET ROOMS - STAFF	Inspected
Ceiling	Inspected
Condition	2 - Between Good and Fair
Deficiency	No deficiencies recorded
Door(s)	Inspected
Condition	5 - Poor
Deficiency	METAL CLAD WOOD: DETERIORATED DOOR AND FRAME
Deficiency Location/Instance	Room 106
Deficiency Quantity	1
Quantity Uom	EACH
Potential Action	MAINTENANCE
Urgency of Action	PRIORITY 3
Purpose of Action	LEVEL 2
Deficiency Photo1	 
Violations	Room 106 No violations recorded.
Floor Finish	Inspected
Condition	2 - Between Good and Fair
Deficiency	No deficiencies recorded

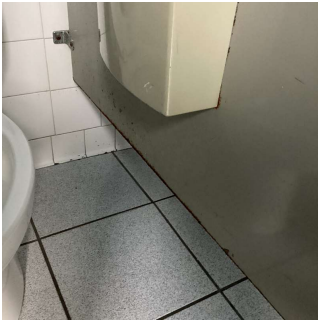
Question	Response
INTERIOR	
TOILET ROOMS - STAFF	Inspected
Stalls	Does not Exist
Walls	Inspected
Condition	2 - Between Good and Fair
Deficiency	No deficiencies recorded
TOILET ROOMS - STUDENTS	Inspected
Ceiling	Inspected
Condition	2 - Between Good and Fair
Deficiency	No deficiencies recorded
Door(s)	Inspected
Condition	2 - Between Good and Fair
Deficiency	No deficiencies recorded
Floor Finish	Inspected
Condition	2 - Between Good and Fair
Deficiency	No deficiencies recorded
Stalls	Inspected
Condition	5 - Poor
Deficiency	RUST - MAJOR
Deficiency Location/Instance	Room 114
Deficiency Quantity	2
Quantity Uom	EACH
Potential Action	REPLACE
Urgency of Action	PRIORITY 3
Purpose of Action	LEVEL 2
Deficiency Photo1
