NYC Department of Education
Building Condition Assessment Survey 2023 - 2024

Architectural Inspection

Q322

Asset: P.S. 14 ANNEX - QUEENS, 89-11 43RD AVENUE, New York, 11373

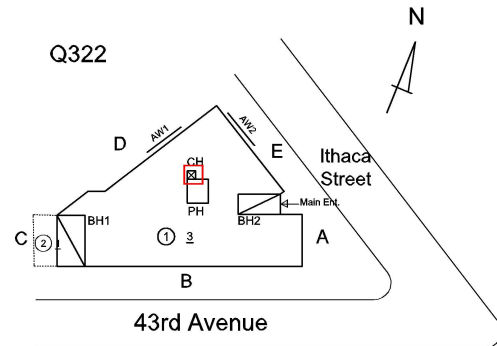
BRICK: DETERIORATED JOINTS

80
 S.F.
 REPOINT
 PRIORITY 3
 LEVEL 2

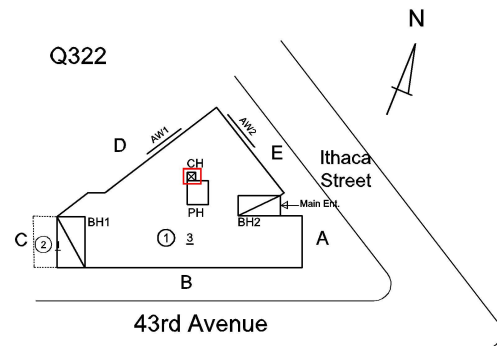
BRICK: DETERIORATED JOINTS

10
 S.F.
 REPOINT
 PRIORITY 4
 LEVEL 2

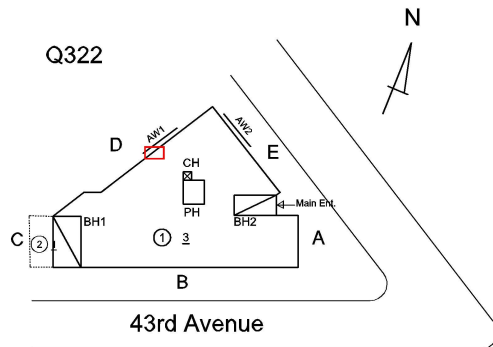
METAL: DETERIORATED DOOR AND FRAME - MAJOR DETERIORATION

1
EACH
REPLACE
PRIORITY 4
LEVEL 2

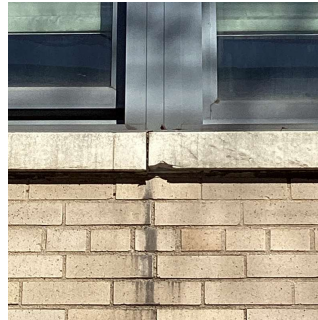
Facade B

BRICK: DETERIORATED MASONRY SILLS - MINOR

REPAIR

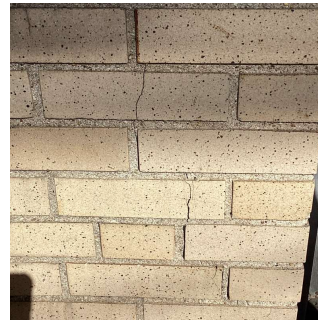
Facade B

BRICK: MINOR CRACKS AND SPALLING

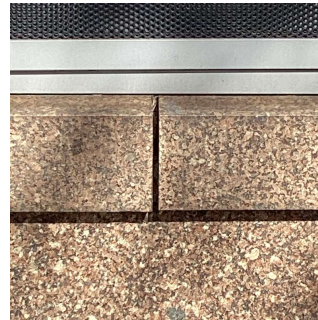
Facade B

BRICK: MASONRY SILLS - DETERIORATED JOINTS

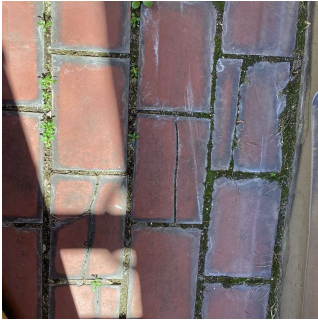
PAVERS: PAVERS IN POOR CONDITION

30
S.F.
REPLACE
PRIORITY 4
LEVEL 2

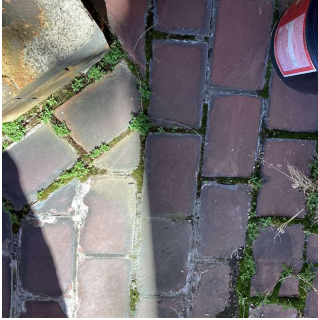
Violations	Roof 2 No violations recorded.
Deficiency	PAVERS: DETERIORATED JOINTS
Roof Plan reference

Deficiency Quantity	40
Quantity Uom	L.F.
Potential Action	REPOINT
Urgency of Action	PRIORITY 4
Purpose of Action	LEVEL 2
Deficiency Photo1

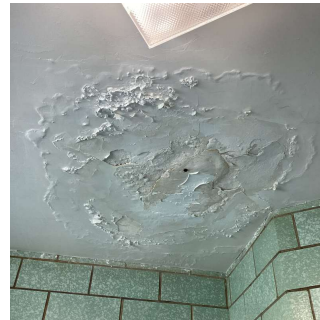
Roof 1 - Stair A/3 shown, Stair B/3 similar

BUILT-UP: ROOFING: MAJOR ACTIVE ROOF LEAKS IN INSTRUCTIONAL SPACE

REPLACE ROOFING WITHOUT MAJOR EQUIPMENT REMOVAL

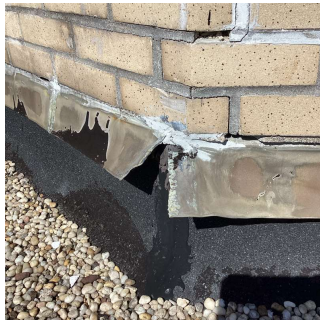
Violations	Roof 1 No violations recorded.
Deficiency	BUILT-UP: FLASHING: CAP FLASHING DAMAGED
Roof Plan reference

Deficiency Quantity	30
Quantity Uom	L.F.
Potential Action	REPLACE
Urgency of Action	PRIORITY 4
Purpose of Action	LEVEL 2
Deficiency Photo1

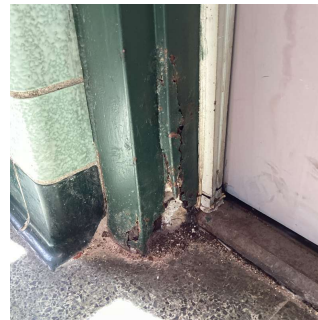
BH2
No violations recorded.

Violations	Roof 1 No violations recorded.
ROOFING DRAINS	Does not Exist
Specialties	Inspected
BULKHEAD/PENTHOUSE	Inspected
Condition	4 - Between Fair and Poor
Deficiency	BULKHEAD/PENTHOUSE DOORS: DETERIORATED DOOR AND FRAME

1
EACH
REPLACE DOOR AND FRAME
PRIORITY 4
LEVEL 2

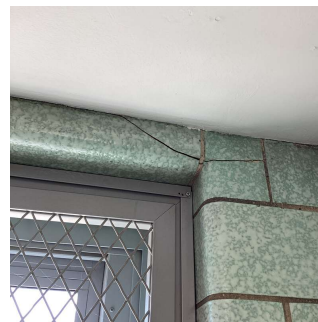
BH2

BULKHEAD/PENTHOUSE WALLS/INTERIOR: GLAZED BLOCK CRACKS/SPALLING

10
S.F.
REPLACE
PRIORITY 3
LEVEL 2

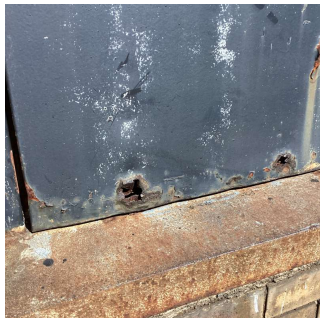
Violations	BH1 No violations recorded.
Deficiency	BULKHEAD/PENTHOUSE DOORS: DETERIORATED DOOR
Roof Plan reference

Deficiency Quantity	1
Quantity Uom	EACH
Potential Action	REPLACE DOOR
Urgency of Action	PRIORITY 4
Purpose of Action	LEVEL 2
Deficiency Photo1

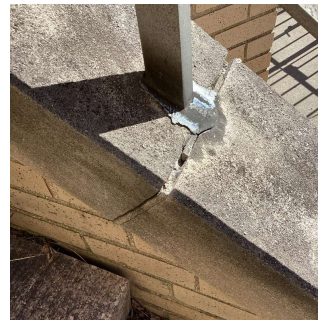
Facade C

BRICK: DETERIORATED JOINTS AT COPING STONES

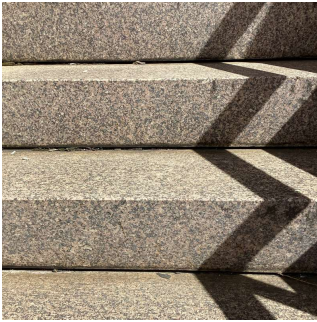
Violations	Facade C No violations recorded.
RAILINGS	Inspected
Condition	2 - Between Good and Fair
Deficiency	No deficiencies recorded
STAIRS/RAMPS	Inspected
Condition	3 - Fair
Deficiency	STONE: DETERIORATED JOINTS
Roof Plan reference

Deficiency Quantity	30
Quantity Uom	L.F.
Potential Action	REPOINT
Urgency of Action	PRIORITY 3
Purpose of Action	LEVEL 2
Deficiency Photo1

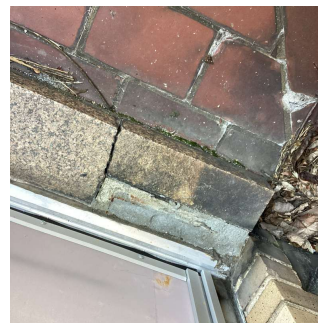
Violations	Facade C No violations recorded.
Deficiency	STONE: CRACKS/SPALLING - MAJOR

10
S.F.
REPLACE
PRIORITY 4
LEVEL 2
