NYC Department of Education
Building Condition Assessment Survey 2023 - 2024

Architectural Inspection

Asset: EAST ELMHURST COMMUNITY SCHOOL - QUEENS, 26-25 97TH STREET, New York, 11369

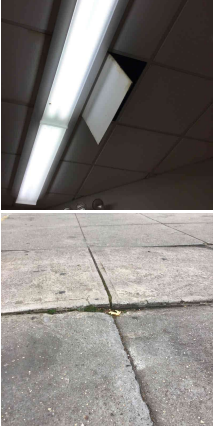
No	Potential Falling Debris	Loose ceiling tile is a potential safety hazard.	INTERIOR STAIRS/RAMP S: INTERIOR Ceiling	Stair A/Basement	Jessy Correra	Cleaner

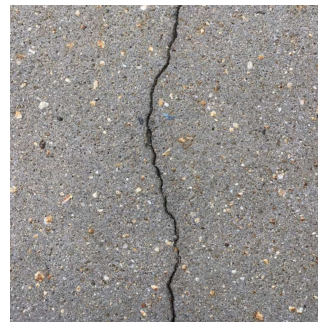
Question	Response
Architectural	
EXTERIOR	Inspected
AREAWAY	Inspected
Instance on AW1 - AW5	Inspected
Instance Condition	3 - Fair
Instance Quantity	5
Instance Quantity Uom	EACH
Deficiency	AREAWAY STAIRS: DETERIORATED TREADS/RISERS/NOSINGS

10
 S.F.
 REPLACE
 PRIORITY 4
 LEVEL 2

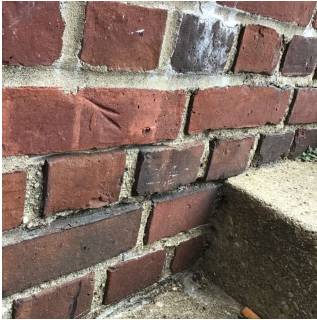
AREAWAY WALLS: DETERIORATED JOINTS

10
 S.F.
 REPAIR
 PRIORITY 4
 LEVEL 2

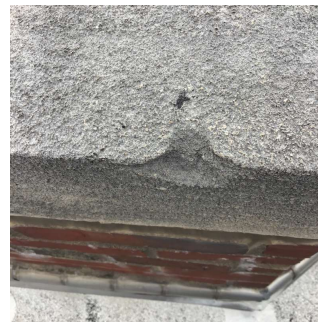
Roof 1
 No violations recorded.

Violations	CH No violations recorded.
COPING	Inspected
Condition	3 - Fair
Deficiency	CAST STONE: CRACKED/BROKEN PIECES

40
 L.F.
 REPLACE-IN-KIND
 PRIORITY 4
 LEVEL 2

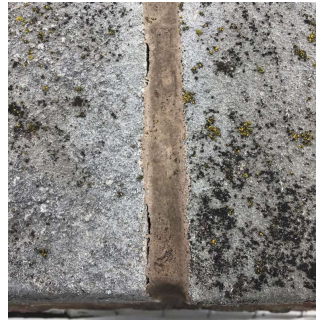
Roof 1

CAST STONE: DETERIORATED TRANSVERSE JOINTS

15
 L.F.
 MAINTENANCE
 PRIORITY 3
 LEVEL 2

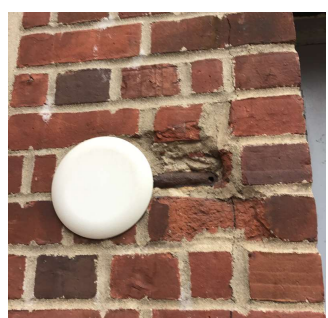
Question	Response
EXTERIOR	
DOORS	Inspected
TRANSOM/SIDE LIGHT	
Violations	Facade A No violations recorded.
EXTERIOR WALLS	Inspected
Material Type(s)	Masonry
Replacement Quantity	28,000
Replacement Uom	S.F.
Instance on All Facades	Inspected
Instance Condition	3 - Fair
Instance Quantity	28,000
Instance Quantity Uom	S.F.
Deficiency	BRICK: MAJOR / THRU CRACKS
Roof Plan reference	<p>Q329</p>

<p align="center">97TH STREET</p>
Deficiency Quantity	10
Quantity Uom	S.F.
Potential Action	REMOVE AND REBUILD
Urgency of Action	PRIORITY 4
Purpose of Action	LEVEL 2
Deficiency Photo1

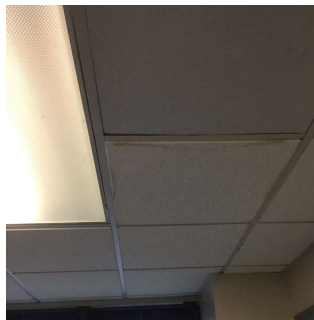
Roof 1 - Rooms 302, 304, 305, 317 (Shown)

Installation Year	2013
Source of Installation	Custodial Staff
Deficiency	MODIFIED BITUMEN: ROOFING: MAJOR ACTIVE ROOF LEAKS IN INSTRUCTIONAL SPACE

REPLACE ROOFING WITHOUT MAJOR EQUIPMENT REMOVAL

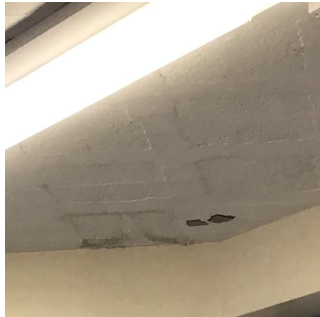
Roof 1 - Rooms 301, 306, 307, 310 (Shown), 313, Stair A/3, Corridor near Room 317
Violations	No violations recorded.
Deficiency	MODIFIED BITUMEN: ROOFING: DELAMINATION
Roof Plan reference

REPLACE ROOFING WITHOUT MAJOR EQUIPMENT REMOVAL

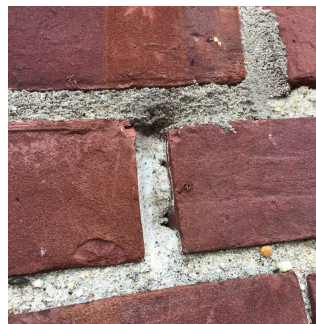
BH
 No violations recorded.

<p>BH</p> <p>No violations recorded.</p>
<p>Deficiency</p>	<p>BULKHEAD/PENTHOUSE WALLS/EXTERIOR: DETERIORATED JOINTS</p>

20
 S.F.
 REPOINT
 PRIORITY 3
 LEVEL 2

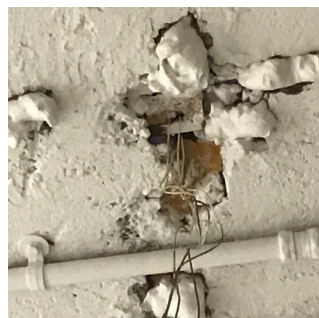
Question	Response
INTERIOR	
STRUCTURAL	
FLOOR STRUCTURE	
Deficiency Deficiency Location/Instance Deficiency Quantity Quantity Uom Potential Action Urgency of Action Purpose of Action Deficiency Photo1	CONCRETE: CRACKS/SPALLED/REINFORCEMENT EXPOSED Basement - Custodian Office 20 S.F. REPAIR PRIORITY 4 LEVEL 5

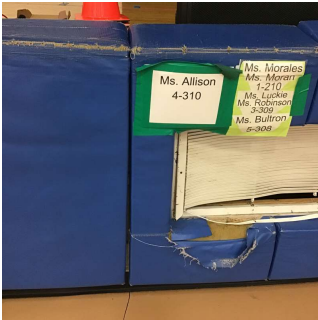
Question	Response
INTERIOR	
CAFETERIA	
Walls	
Instance on Basement	Inspected
Condition	4 - Between Fair and Poor
Deficiency	WALL PADDING: DETERIORATED
Deficiency Location/Instance	Near Stage
Deficiency Quantity	300
Quantity Uom	S.F.
Potential Action	REPLACE
Urgency of Action	PRIORITY 3
Purpose of Action	LEVEL 2
Deficiency Photo1

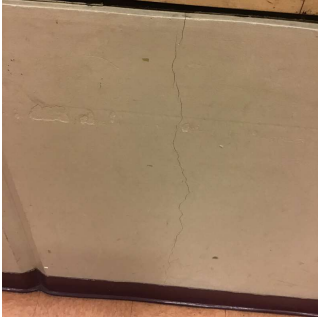
Violations	Near Stage No violations recorded.
Deficiency	PLASTER: CRACKS/SPALLING
Deficiency Location/Instance	Near Serving Area, Stage
Deficiency Quantity	30
Quantity Uom	S.F.
Potential Action	REPLACE
Urgency of Action	PRIORITY 3
Purpose of Action	LEVEL 2
Deficiency Photo1

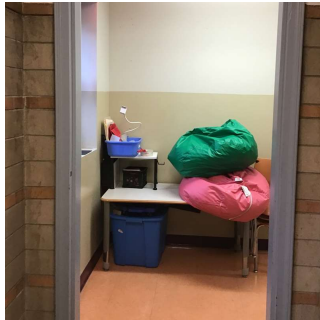
Question	Response
INTERIOR	
CLASSROOMS/CORRIDORS/ADMIN SPACES	
Door(s)	Inspected
Condition	3 - Fair
Deficiency	METAL: MISSING DOOR
Deficiency Location/Instance	Vestibule Exit 8
Deficiency Quantity	1
Quantity Uom	EACH
Potential Action	MAINTENANCE
Urgency of Action	PRIORITY 3
Purpose of Action	LEVEL 2
Deficiency Photo1

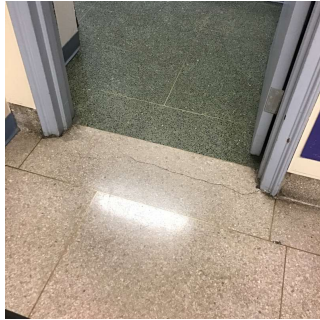
Violations	Vestibule Exit 8 No violations recorded.
Floor Finish	Inspected
Condition	2 - Between Good and Fair
Deficiency	TERRAZZO: CRACKS
Deficiency Location/Instance	Main Entrance
Deficiency Quantity	10
Quantity Uom	S.F.
Potential Action	REPLACE
Urgency of Action	PRIORITY 3
Purpose of Action	LEVEL 2
Deficiency Photo1

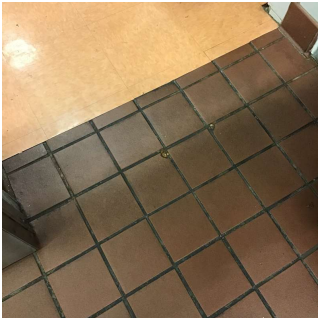
Near Serving Area
Violations	No violations recorded.

Question	Response
INTERIOR	
KITCHEN	
Instance on Basement	Inspected
Ceiling	
Instance on Basement	Inspected
Condition	2 - Between Good and Fair
Deficiency	No deficiencies recorded
Door(s)	
Instance on Basement	Inspected
Condition	2 - Between Good and Fair
Deficiency	No deficiencies recorded
Floor Finish	
Instance on Basement	Inspected
Condition	2 - Between Good and Fair
Deficiency	QUARRY TILE: BROKEN/MISSING TILES
Deficiency Location/Instance	Near Serving Area
Deficiency Quantity	10
Quantity Uom	S.F.
Potential Action	REPLACE
Urgency of Action	PRIORITY 3
Purpose of Action	LEVEL 2
Deficiency Photo1

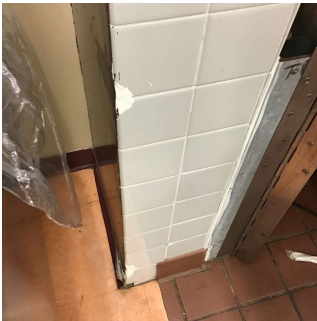
Walls	
Instance on Basement	Inspected
Condition	2 - Between Good and Fair
Deficiency	CERAMIC TILE: BROKEN/ MISSING
Deficiency Location/Instance	Near Serving Area
Deficiency Quantity	10
Quantity Uom	S.F.
Potential Action	REPLACE
Urgency of Action	PRIORITY 3
Purpose of Action	LEVEL 2

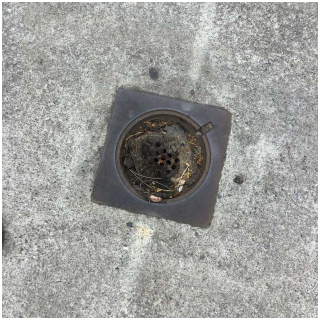
No	Tripping Hazard	Severely heaving concrete is a potential tripping hazard.	SITE PAVING Student Use Concrete	Near Exit 8	Jessy Correra	Cleaner

Violations	Playground No violations recorded.
Culverts - Asphalt Covering	Does not Exist
Drainage System for Concrete	Inspected
Catch Basins/Manhole - Surrounded by concrete	Inspected
Condition	3 - Fair
Deficiency	DAMAGED COVER
Deficiency Location/Instance	Near Exit 8
Deficiency Quantity	1
Quantity Uom	EACH
Potential Action	REPLACE
Urgency of Action	PRIORITY 5
Purpose of Action	LEVEL 6
Deficiency Photo1

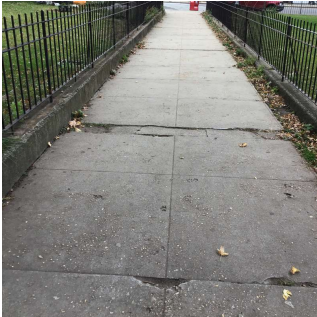
Violations	Near Exit 6 No violations recorded.
Concrete	Inspected
Condition	4 - Between Fair and Poor
Deficiency	DAMAGED/DETERIORATED/MISSING SECTIONS
Deficiency Location/Instance	Between Gardens area, Near Exit 6.
Deficiency Quantity	775
Quantity Uom	S.F.
Potential Action	REPLACE
Urgency of Action	PRIORITY 3
Purpose of Action	LEVEL 2
Deficiency Photo1
