NYC Department of Education
Building Condition Assessment Survey 2023 - 2024

Architectural Inspection

Asset: BAYSIDE HILLS SCHOOL OF EXCELLENCE - QUEENS, 210-21 48TH AVENUE, 11364

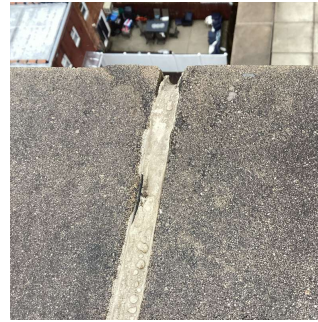
Roof 7

Deficiency CAST STONE: DETERIORATED TRANSVERSE JOINTS
 Roof Plan reference

Deficiency Quantity
 Quantity Uom
 Potential Action
 Urgency of Action
 Purpose of Action

20
 L.F.
 MAINTENANCE
 PRIORITY 3
 LEVEL 2

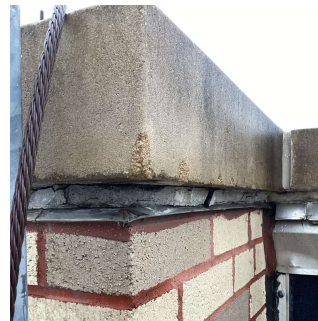
Roof 1

CAST STONE: DETERIORATED BED JOINT

70

PRIORITY 3

REPOINT

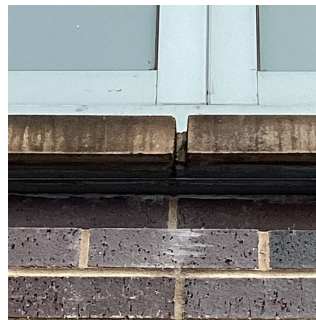
Facade E

BRICK: MASONRY SILLS - DETERIORATED JOINTS

10
L.F.
REPOINT
PRIORITY 3
LEVEL 2

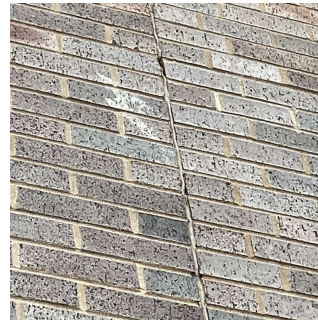
Facade B

BRICK: DETERIORATED CONTROL/EXPANSION JOINTS

PRIORITY 3

MAINTENANCE

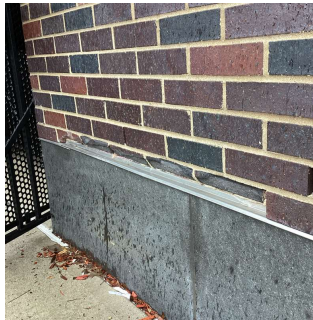
Facade A

BRICK: MAJOR / THRU CRACKS

PRIORITY 4

REMOVE AND REBUILD

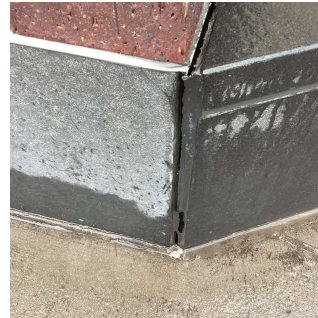
Facade A

STONE: DETERIORATED CONTROL/EXPANSION JOINTS

PRIORITY 3
LEVEL 2

MAINTENANCE

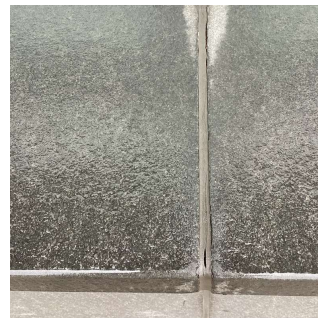
Facade A

STONE: MASONRY SILLS - DETERIORATED JOINTS

PRIORITY 3

REPOINT

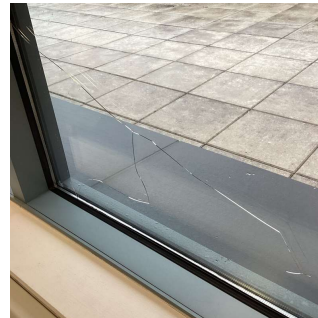
METAL/GLASS CURT WALL: BROKEN GLASS

PRIORITY 3

Facade A - 4th floor corridor near Rooms 401A, 401, 403

REPLACE

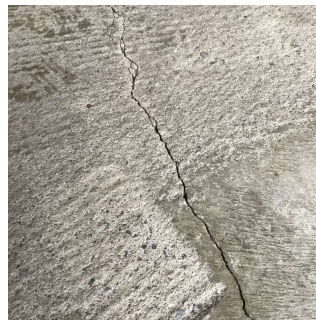
Facade C

Question	Response
EXTERIOR	
ROOF	
Roofing	Inspected
ROOFING DRAINS	Inspected
Condition	2 - Between Good and Fair
Deficiency	No deficiencies recorded
Specialties	Inspected
BULKHEAD/PENTHOUSE	Inspected
Condition	2 - Between Good and Fair
Deficiency	No deficiencies recorded
CUPOLA/ SPIRES/ TOWERS	Does not Exist
DORMER	Does not Exist
DUNNAGE STEEL	Inspected
Condition	2 - Between Good and Fair
Deficiency	No deficiencies recorded
SKYLIGHT/ROOF VENT	Does not Exist
ROOF/GRAVITY TANK	Does not Exist
STAIRS/RAMPS: EXTERIOR	Inspected
BUILDING CHEEK/FLANK WALLS	Does not Exist
RAILINGS	Inspected
Condition	2 - Between Good and Fair
Deficiency	No deficiencies recorded
STAIRS/RAMPS	Inspected
Condition	5 - Poor
Deficiency	CONCRETE: CRACKS/SPALLING - MAJOR
Roof Plan reference

25
S.F.
REPLACE
PRIORITY 4
LEVEL 2

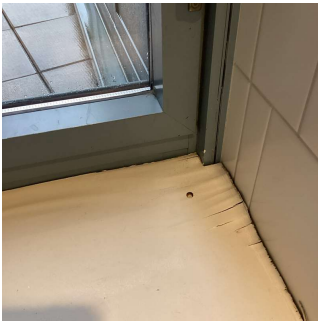
Question	Response
EXTERIOR	
STAIRS/RAMPS: EXTERIOR	Inspected
STAIRS/RAMPS	
Violations	No violations recorded.
WINDOWS	Inspected
Replacement Quantity	8,000
Replacement Uom	S.F.
EXTERIOR GUARDS	Does not Exist
LINTELS	Inspected
Condition	2 - Between Good and Fair
Deficiency	No deficiencies recorded
WINDOWS	Inspected
Material Type(s)	Aluminum
Instance on Aluminum - Other: All Facades	Inspected
Instance Condition	2 - Between Good and Fair
Instance Quantity	8,000
Instance Quantity Uom	S.F.
Are these windows insulated	Yes
Installation Year	2016
Source of Installation	Custodial Staff
Deficiency	ALUMINUM - OTHER: AIR/WATER INFILTRATION, DETERIORATED JOINTS WITH DAMAGED CAULKING
Roof Plan reference	<p>Q332</p>
Elevation	
Deficiency Quantity	20
Quantity Uom	L.F.
Potential Action	MAINTENANCE
Urgency of Action	PRIORITY 3
Purpose of Action	LEVEL 2

Violations	Facade F - Corridor near Room 202 No violations recorded.
INTERIOR	Inspected
POOLS	Does not Exist
STRUCTURAL	Inspected
COLUMNS/BEAMS/BEARING WALLS	Inspected
Condition	2 - Between Good and Fair
Deficiency	No deficiencies recorded
FLOOR STRUCTURE	Inspected
Condition	2 - Between Good and Fair
Deficiency	CONCRETE SLAB ON GRADE: THRU CRACKS
Deficiency Location/Instance	Basement - Gas Meter Room, Corridor near Gas Meter Room, Room C10
Deficiency Quantity	20
Quantity Uom	S.F.
Potential Action	REPAIR
Urgency of Action	PRIORITY 3
Purpose of Action	LEVEL 5
Deficiency Photo1

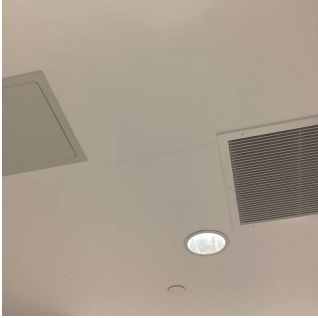
Question	Response
INTERIOR	
AUDITORIUM	Does not Exist
CAFETERIA	Inspected
Instance on 1st Floor	Inspected
Ceiling	
Instance on 1st Floor	Inspected
Condition	2 - Between Good and Fair
Deficiency	GYPSUM BOARD: DAMAGED/DETERIORATED
Deficiency Location/Instance	Near Room 119
Deficiency Quantity	10
Quantity Uom	S.F.
Potential Action	REPLACE
Urgency of Action	PRIORITY 3
Purpose of Action	LEVEL 2
Deficiency Photo1

Near Room 119	
Violations	No violations recorded.
Door(s)	
Instance on 1st Floor	Inspected
Condition	2 - Between Good and Fair
Deficiency	No deficiencies recorded
Fixed Equipment	
Instance on 1st Floor	Does not Exist
Floor Finish	
Instance on 1st Floor	Inspected
Condition	2 - Between Good and Fair
Deficiency	No deficiencies recorded
Sliding-folding Partition	
Instance on 1st Floor	Does not Exist
Stage	
Instance on 1st Floor	Does not Exist
Walls	
Instance on 1st Floor	Inspected
Condition	2 - Between Good and Fair
Deficiency	GYPSUM BOARD: DETERIORATED

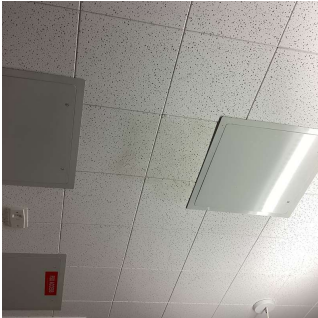
Question	Response
INTERIOR	
LIBRARY	
Built-in Furnishing	
Instance on Room 403	Does not Exist
Ceiling	
Instance on Room 403	Inspected
Condition	2 - Between Good and Fair
Deficiency	ACOUSTIC TILES: DAMAGED/MISSING
Deficiency Location/Instance	Near Entrance
Deficiency Quantity	10
Quantity Uom	S.F.
Potential Action	REPLACE
Urgency of Action	PRIORITY 3
Purpose of Action	LEVEL 2
Deficiency Photo1

Violations	Near Entrance No violations recorded.
Deficiency	ACOUSTIC TILES: DAMAGED/MISSING - ACTIVE LEAK
Deficiency Location/Instance	Right Side
Deficiency Quantity	10
Quantity Uom	S.F.
Potential Action	REPLACE
Urgency of Action	PRIORITY 5
Purpose of Action	LEVEL 2
Deficiency Photo1

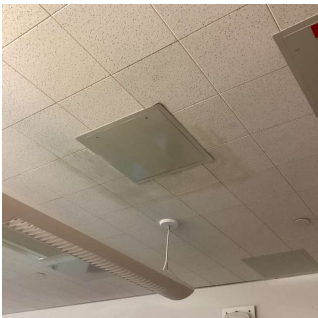
Violations	Right Side No violations recorded.
Door(s)	
Instance on Room 403	Inspected
Condition	2 - Between Good and Fair
Deficiency	No deficiencies recorded
Floor Finish	
Instance on Room 403	Inspected
Condition	2 - Between Good and Fair

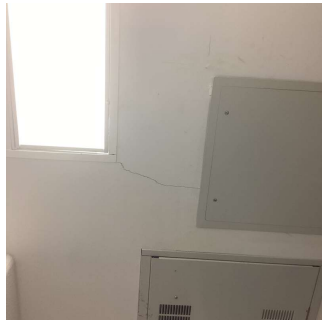
Question	Response
INTERIOR	
LIBRARY	
Floor Finish	
Deficiency	No deficiencies recorded
Walls	
Instance on Room 403	Inspected
Condition	2 - Between Good and Fair
Deficiency	No deficiencies recorded
LOCKER ROOM	Does not Exist
MULTI-PURPOSE ROOM	Does not Exist
SCIENCE DEMO ROOM	Does not Exist
SCIENCE LAB	Inspected
Instance on Room 402	Inspected
Alternative use	Yes
Fixed Equipment	
Instance on Room 402	Inspected
Condition	2 - Between Good and Fair
Deficiency	No deficiencies recorded
SCIENCE PREP ROOM	Inspected
Instance on Room 402A	Inspected
Alternative use	Yes
Fixed Equipment	
Instance on Room 402A	Inspected
Condition	2 - Between Good and Fair
Deficiency	No deficiencies recorded
SHOWER ROOM	Does not Exist
STAIRS/RAMPS: INTERIOR	Inspected
Do Letter Stair Signs Exist?	Yes
Ceiling	
Condition	2 - Between Good and Fair
Deficiency	GYPSUM BOARD: DAMAGED/DETERIORATED
Deficiency Location/Instance	Stair A/Basement, B/4
Deficiency Quantity	20

Quantity Uom	S.F.
Potential Action	REPLACE
Urgency of Action	PRIORITY 3
Purpose of Action	LEVEL 2
Deficiency Photo1

Violations	Stair A/Basement No violations recorded.
Door(s)	
Condition	Inspected 2 - Between Good and Fair

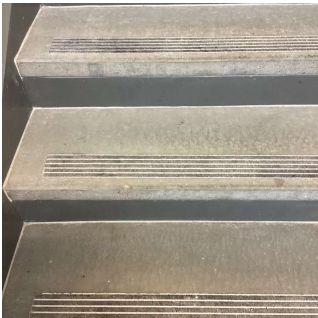
Question	Response
INTERIOR	
STAIRS/RAMPS: INTERIOR	
Door(s)	Inspected
Deficiency	No deficiencies recorded
Partition	Does not Exist
Railings	Inspected
Condition	2 - Between Good and Fair
Deficiency	No deficiencies recorded
Stairs and Landings	Inspected
Condition	2 - Between Good and Fair
Deficiency	STONE: BROKEN/MISSING
Deficiency Location/Instance	Stair C/Bulkhead
Deficiency Quantity	10
Quantity Uom	S.F.
Potential Action	REPLACE
Urgency of Action	PRIORITY 3
Purpose of Action	LEVEL 2
Deficiency Photo1

Violations	Stair C/Bulkhead No violations recorded.
Walls	Inspected
Condition	2 - Between Good and Fair
Deficiency	MASONRY: CRACKS/SPALLING
Deficiency Location/Instance	Stairs A/Basement, C/Basement
Deficiency Quantity	20
Quantity Uom	S.F.
Potential Action	REPLACE
Urgency of Action	PRIORITY 3
Purpose of Action	LEVEL 2
Deficiency Photo1

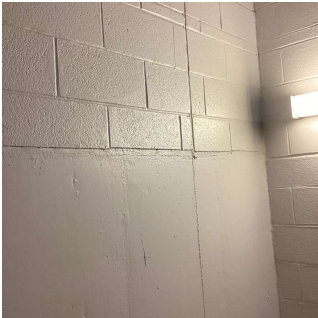
Violations	Stair A/Basement No violations recorded.
Deficiency	GYPSUM BOARD: DETERIORATED

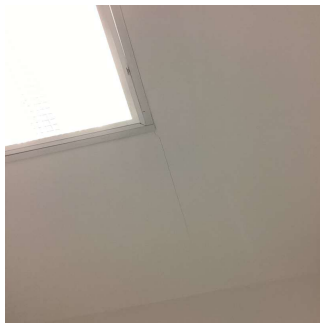
Question	Response
INTERIOR	
STAIRS/RAMPS: INTERIOR	
Walls	
Deficiency Quantity	10
Quantity Uom	S.F.
Potential Action	REPLACE
Urgency of Action	PRIORITY 3
Purpose of Action	LEVEL 2
Deficiency Photo1	 
	Stair B/Basement
Violations	No violations recorded.
TOILET ROOMS - STAFF	Inspected
Ceiling	Inspected
Condition	2 - Between Good and Fair
Deficiency	No deficiencies recorded
Door(s)	Inspected
Condition	2 - Between Good and Fair
Deficiency	No deficiencies recorded
Floor Finish	Inspected
Condition	2 - Between Good and Fair
Deficiency	No deficiencies recorded
Stalls	Inspected
Condition	2 - Between Good and Fair
Deficiency	No deficiencies recorded
Walls	Inspected
Condition	2 - Between Good and Fair
Deficiency	No deficiencies recorded
TOILET ROOMS - STUDENTS	Inspected
Ceiling	Inspected
Condition	2 - Between Good and Fair
Deficiency	GYPSUM BOARD: DAMAGED/DETERIORATED
Deficiency Location/Instance	Room C04
Deficiency Quantity	10
Quantity Uom	S.F.

Potential Action	REPLACE
Urgency of Action	PRIORITY 3
Purpose of Action	LEVEL 2

Violations	Room C04 No violations recorded.
Door(s)	Inspected
Condition	2 - Between Good and Fair
Deficiency	No deficiencies recorded
Floor Finish	Inspected
Condition	2 - Between Good and Fair
Deficiency	No deficiencies recorded
Stalls	Inspected
Condition	2 - Between Good and Fair
Deficiency	No deficiencies recorded
Walls	Inspected
Condition	2 - Between Good and Fair
Deficiency	No deficiencies recorded
LIFE SAFETY	Inspected
F.D. HOLDING AREA	Does not Exist
STEEL STAIRS	Does not Exist
SITE	Inspected
CONTAINERIZATION	Does not Exist
Drainage System for Asphalt	Inspected
Catch Basins/Manhole - Surrounded by asphalt	Inspected
Condition	2 - Between Good and Fair
Deficiency	No deficiencies recorded
Culverts - Asphalt Covering	Does not Exist
Drainage System for Concrete	Inspected
Catch Basins/Manhole - Surrounded by concrete	Inspected
Condition	2 - Between Good and Fair

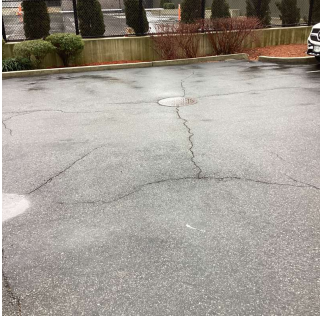
Question	Response
SITE	
PAVING	
Student Non-Use	
Gravel Exists?	No
Asphalt	Inspected
Condition	3 - Fair
Deficiency	CRACKS - MAJOR
Deficiency Location/Instance	47th Avenue
Deficiency Quantity	200
Quantity Uom	S.F.
Potential Action	REPLACE
Urgency of Action	PRIORITY 3
Purpose of Action	LEVEL 2
Deficiency Photo1

47th Avenue
Violations	No violations recorded.
Concrete	Inspected
Condition	2 - Between Good and Fair
Deficiency	No deficiencies recorded
Pavers	Does not Exist
Student Use	Inspected
Gravel Exists?	No
Asphalt	Inspected
Condition	3 - Fair
Deficiency	CRACKS - MAJOR
Deficiency Location/Instance	Schoolyard
Deficiency Quantity	200
Quantity Uom	S.F.
Potential Action	REPLACE
Urgency of Action	PRIORITY 3
Purpose of Action	LEVEL 2
Deficiency Photo1

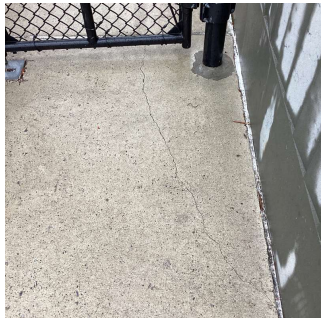
Question	Response
SITE	
PAVING	
Student Use	
Concrete	Inspected
Condition	2 - Between Good and Fair
Deficiency	No deficiencies recorded
Pavers	Does not Exist
Site Sidewalks & Walkways	Inspected
Asphalt	Does not Exist
Concrete	Inspected
Condition	3 - Fair
Deficiency	CRACKS - MAJOR
Deficiency Location/Instance	Near Schoolyard, Exit 1
Deficiency Quantity	100
Quantity Uom	S.F.
Potential Action	REPLACE
Urgency of Action	PRIORITY 3
Purpose of Action	LEVEL 2
Deficiency Photo1

Violations	Near Schoolyard No violations recorded.
Pavers	Does not Exist
DOT Sidewalk	Inspected
Asphalt	Does not Exist
Concrete	Inspected
Condition	2 - Between Good and Fair
Deficiency	No deficiencies recorded
Pavers	Inspected
Condition	2 - Between Good and Fair
Deficiency	DAMAGED/MISSING
Deficiency Location/Instance	48th Avenue
Deficiency Quantity	20
Quantity Uom	S.F.
Potential Action	REPLACE
Urgency of Action	PRIORITY 3
Purpose of Action	LEVEL 2
