NYC Department of Education
Building Condition Assessment Survey 2023 - 2024

Architectural Inspection

Asset: **CENTREVILLE EDUCATIONAL BUILDING - QUEENS, 150-15 RALEIGH STREET, 11417**

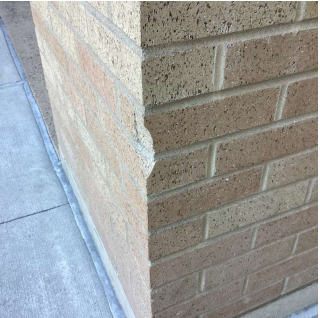
Violations	Facade A No violations recorded.
EXTERIOR SOFFITS	
Condition	Inspected
Deficiency	STUCCO/PLASTER: MINOR CRACKS/SPALLING

Question	Response
EXTERIOR	
EXTERIOR WALLS	
Instance Condition	2 - Between Good and Fair
Instance Quantity	46,000
Instance Quantity Uom	S.F.
Deficiency	BRICK: MINOR CRACKS AND SPALLING
Roof Plan reference	 
Elevation

Deficiency Quantity	10
Quantity Uom	S.F.
Potential Action	RESTITCH
Urgency of Action	PRIORITY 3
Purpose of Action	LEVEL 2
Deficiency Photo1

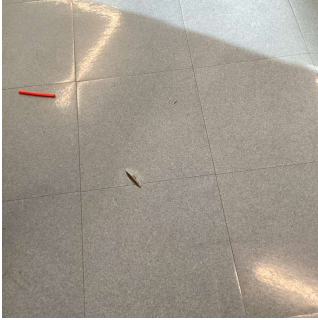
Question	Response
INTERIOR	
CAFETERIA	
Ceiling	
Instance on 1st Floor	Inspected
Condition	2 - Between Good and Fair
Deficiency	No deficiencies recorded
Door(s)	
Instance on 1st Floor	Inspected
Condition	2 - Between Good and Fair
Deficiency	No deficiencies recorded
Fixed Equipment	
Instance on 1st Floor	Does not Exist
Floor Finish	
Instance on 1st Floor	Inspected
Condition	2 - Between Good and Fair
Deficiency	VINYL TILES: BROKEN/DETERIORATED/MISSING TILES
Deficiency Location/Instance	Near center
Deficiency Quantity	10
Quantity Uom	S.F.
Potential Action	REPLACE
Urgency of Action	PRIORITY 3
Purpose of Action	LEVEL 2
Deficiency Photo1

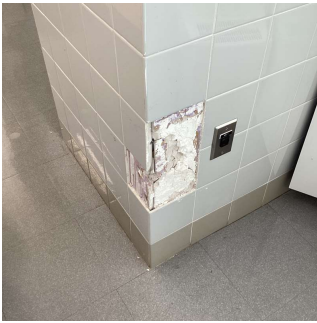
Violations	No violations recorded.
Sliding-folding Partition	
Instance on 1st Floor	Does not Exist
Stage	
Instance on 1st Floor	Does not Exist
Walls	
Instance on 1st Floor	Inspected
Condition	2 - Between Good and Fair
Deficiency	CERAMIC TILE: BROKEN/ MISSING
Deficiency Location/Instance	Near Windows

Deficiency Quantity	10
Quantity Uom	S.F.
Potential Action	REPLACE
Urgency of Action	PRIORITY 3
Purpose of Action	LEVEL 2

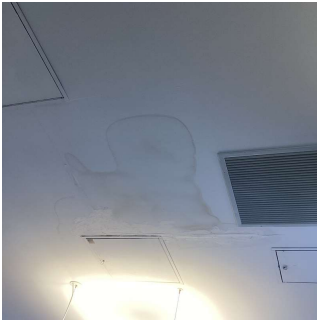
Violations	Near Windows No violations recorded.
Window Curtains/Shades/Blinds	
Instance on 1st Floor	Does not Exist
CLASSROOMS/CORRIDORS/ADMIN SPACES	
Ceiling	
Condition	2 - Between Good and Fair
Deficiency	GYPSUM BOARD: DAMAGED/DETERIORATED
Deficiency Location/Instance	Corridor near Rooms 120, 225
Deficiency Quantity	30
Quantity Uom	S.F.
Potential Action	REPLACE
Urgency of Action	PRIORITY 3
Purpose of Action	LEVEL 2
Deficiency Photo1

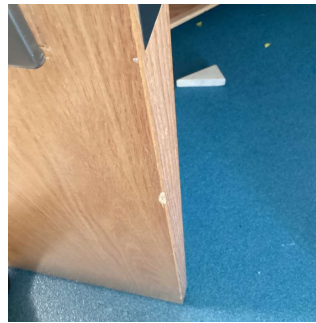
Violations	Corridor near Room 225 No violations recorded.
Door(s)	
Condition	2 - Between Good and Fair
Deficiency	WOOD: DETERIORATED DOOR
Deficiency Location/Instance	Room 424
Deficiency Quantity	1
Quantity Uom	EACH
Potential Action	MAINTENANCE
Urgency of Action	PRIORITY 3
Purpose of Action	LEVEL 2

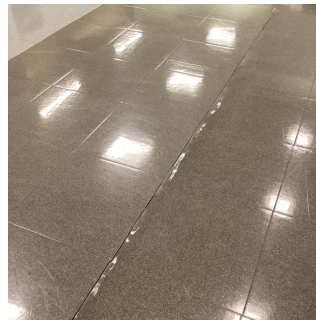
Corridor near Room 320

VINYL TILES: DETERIORATED SUBSTRATE

Potential Action

REPLACE

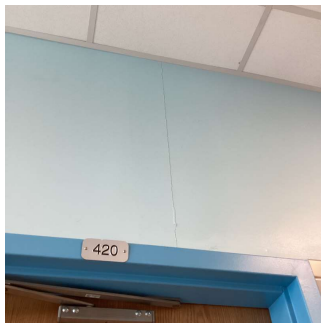
GYPSUM BOARD: DETERIORATED

Room 225, Corridor near Rooms 127B, 210, 324, 420, and others.

Potential Action

REPLACE

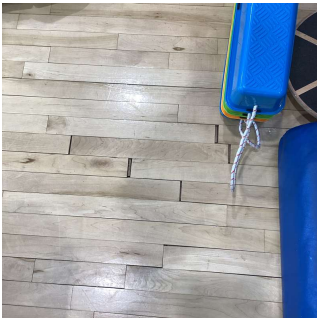
Question	Response
INTERIOR	
GYMNASIUM	
Floor Finish	
Deficiency	CERAMIC TILE: BROKEN/MISSING TILES
Deficiency Location/Instance	Near Drinking Fountain
Deficiency Quantity	10
Quantity Uom	S.F.
Potential Action	REPLACE
Urgency of Action	PRIORITY 3
Purpose of Action	LEVEL 2
Deficiency Photo1	 
Violations	Near Drinking Fountain No violations recorded.
Deficiency	WOOD: DAMAGED/DETERIORATED
Deficiency Location/Instance	Near Drinking Fountain
Deficiency Quantity	30
Quantity Uom	S.F.
Potential Action	REPLACE
Urgency of Action	PRIORITY 3
Purpose of Action	LEVEL 2
Deficiency Photo1

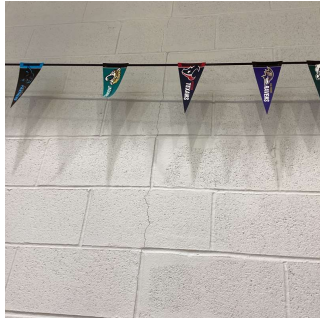
Question	Response
INTERIOR	
GYMNASIUM	
Stage	
Stage	Inspected
Deficiency	No deficiencies recorded
Stage Curtain Rigging	
Stage Curtain Rigging	Inspected
Instance on 1st Floor	Inspected
Condition	2 - Between Good and Fair
Deficiency	No deficiencies recorded
Stage Curtains	
Stage Curtains	Inspected
Instance on 1st Floor	Inspected
Condition	2 - Between Good and Fair
Deficiency	No deficiencies recorded
Walls	
Instance on 1st Floor	Inspected
Condition	2 - Between Good and Fair
Deficiency	MASONRY: CRACKS/SPALLING
Deficiency Location/Instance	Near Windows
Deficiency Quantity	10
Quantity Uom	S.F.
Potential Action	REPLACE
Urgency of Action	PRIORITY 3
Purpose of Action	LEVEL 2
Deficiency Photo1

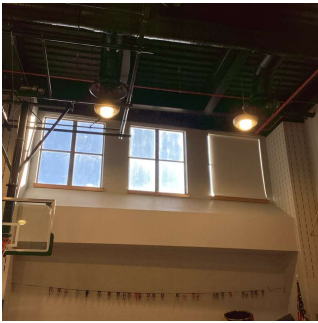
Near Windows
Violations	No violations recorded.
Window Curtains/Shades/Blinds	
Instance on 1st Floor	Inspected
Condition	5 - Poor
Deficiency	INOPERABLE SHADES
Deficiency Location/Instance	Near Stage
Deficiency Quantity	2
Quantity Uom	EACH

Potential Action	MAINTENANCE
Urgency of Action	PRIORITY 3
Purpose of Action	LEVEL 2

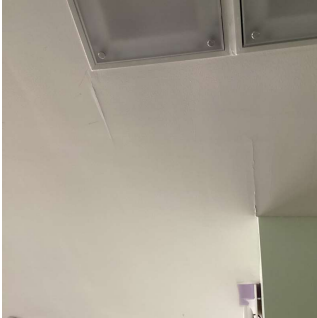
Ceiling	
Instance on Room 322	Inspected
Condition	2 - Between Good and Fair
Deficiency	GYPSUM BOARD: DAMAGED/DETERIORATED
Deficiency Location/Instance	Near Entrance
Deficiency Quantity	10
Quantity Uom	S.F.
Potential Action	REPLACE

Question	Response
INTERIOR	
LIBRARY	
Ceiling	
Urgency of Action	PRIORITY 3
Purpose of Action	LEVEL 2
Deficiency Photo1

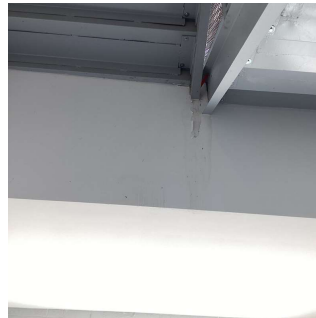
Ceiling	Inspected
Deficiency	No deficiencies recorded
Door(s)	Inspected
Condition	2 - Between Good and Fair
Deficiency	No deficiencies recorded
Partition	Does not Exist
Railings	Inspected
Condition	2 - Between Good and Fair
Deficiency	No deficiencies recorded
Stairs and Landings	Inspected
Condition	2 - Between Good and Fair
Deficiency	No deficiencies recorded
Walls	Inspected
Condition	2 - Between Good and Fair
Deficiency	GYPSUM BOARD: DETERIORATED
Deficiency Location/Instance	Stair B/2
Deficiency Quantity	10
Quantity Uom	S.F.
Potential Action	REPLACE
Urgency of Action	PRIORITY 3
Purpose of Action	LEVEL 2
Deficiency Photo1

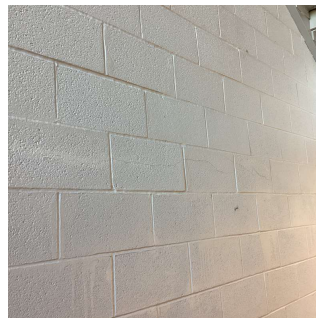
Deficiency	MASONRY: CRACKS/SPALLING
Deficiency Location/Instance	Stair A/1, 3, B/2
Deficiency Quantity	20
Quantity Uom	S.F.
Potential Action	REPLACE
Urgency of Action	PRIORITY 3
Purpose of Action	LEVEL 2
Deficiency Photo1

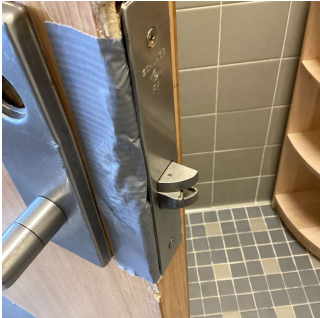
Question	Response
INTERIOR	
STAIRS/RAMPS: INTERIOR	Inspected
Walls	Inspected
Violations	Stair A/1 No violations recorded.
TOILET ROOMS - STAFF	Inspected
Ceiling	Inspected
Condition	2 - Between Good and Fair
Deficiency	No deficiencies recorded
Door(s)	Inspected
Condition	5 - Poor
Deficiency	WOOD: DETERIORATED DOOR
Deficiency Location/Instance	Room 235
Deficiency Quantity	1
Quantity Uom	EACH
Potential Action	MAINTENANCE
Urgency of Action	PRIORITY 3
Purpose of Action	LEVEL 2
Deficiency Photo1

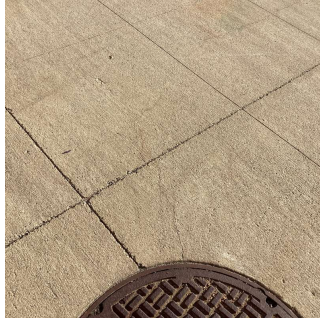
Near Building Entrance
Violations	No violations recorded.
Pavers	Does not Exist
Site Sidewalks & Walkways	Inspected
Asphalt	Does not Exist
Concrete	Inspected
Condition	3 - Fair
Deficiency	DAMAGED/DETERIORATED/MISSING SECTIONS

Question	Response
SITE	
PAVING	
Student Use	Inspected
Gravel Exists?	No
Asphalt	Inspected
Condition	3 - Fair
Deficiency	CRACKS - MAJOR
Deficiency Location/Instance	Near Building Entrance, Center, playgrounds
Deficiency Quantity	200
Quantity Uom	S.F.
Potential Action	REPLACE
Urgency of Action	PRIORITY 3
Purpose of Action	LEVEL 2
Deficiency Photo1	 
	Near Building Entrance
Violations	No violations recorded.
Concrete	Inspected
Condition	3 - Fair
Deficiency	DAMAGED/DETERIORATED/MISSING SECTIONS
Deficiency Location/Instance	Near Building Entrance
Deficiency Quantity	50
Quantity Uom	S.F.
Potential Action	REPLACE
Urgency of Action	PRIORITY 3
Purpose of Action	LEVEL 2
Deficiency Photo1

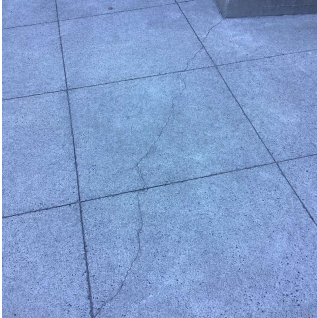
Question	Response
SITE	
PAVING	
Site Sidewalks & Walkways	
Concrete	
Deficiency Location/Instance	Main Entrance, Entrance Schoolyard
Deficiency Quantity	50
Quantity Uom	S.F.
Potential Action	REPLACE
Urgency of Action	PRIORITY 3
Purpose of Action	LEVEL 2
Deficiency Photo1

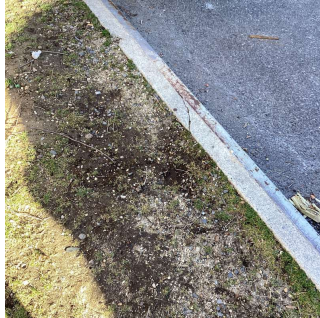
Violations	Main Entrance No violations recorded.
Pavers	Does not Exist
DOT Sidewalk	Inspected
Asphalt	Does not Exist
Concrete	Inspected
Condition	3 - Fair
Deficiency	DAMAGED/DETERIORATED/MISSING SECTIONS
Deficiency Location/Instance	Albert Road, Raleigh Street
Deficiency Quantity	150
Quantity Uom	S.F.
Potential Action	REPLACE
Urgency of Action	PRIORITY 3
Purpose of Action	LEVEL 2
Deficiency Photo1	 
Violations	Albert Road No violations recorded.
Deficiency	DAMAGED CURBS
Deficiency Location/Instance	Albert Road, are Leigh street
Deficiency Quantity	50
Quantity Uom	L.F.
Potential Action	REPLACE
Urgency of Action	PRIORITY 3

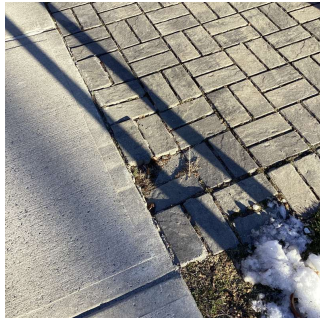
Violations	Albert Road No violations recorded.
Pavers	Inspected
Condition	2 - Between Good and Fair
Deficiency	DAMAGED/MISSING
Deficiency Location/Instance	Albert Road
Deficiency Quantity	20
Quantity Uom	S.F.
Potential Action	REPLACE
Urgency of Action	PRIORITY 3
Purpose of Action	LEVEL 2
Deficiency Photo1

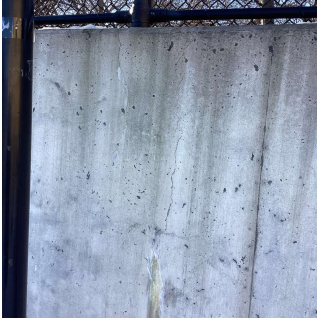
Condition	3 - Fair
Deficiency	CAST IN PLACE CONCRETE: CRACKS/SPALLING - MAJOR
Deficiency Location/Instance	Near Playground East, Stairs
Deficiency Quantity	60
Quantity Uom	S.F.
Potential Action	REPLACE
Urgency of Action	PRIORITY 3
Purpose of Action	LEVEL 2
Deficiency Photo1

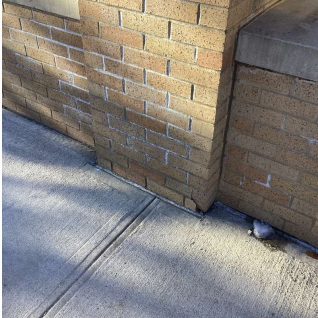
Question	Response
SITE	
RETAINING WALLS	
Deficiency Location/Instance	Albert Road, Raleigh street
Deficiency Quantity	100
Quantity Uom	S.F.
Potential Action	REPLACE
Urgency of Action	PRIORITY 3
Purpose of Action	LEVEL 2
Deficiency Photo1	 
Violations	Raleigh street No violations recorded.
Deficiency	BRICK: CRACKS/SPALLING - MAJOR
Deficiency Location/Instance	Albert Road
Deficiency Quantity	10
Quantity Uom	S.F.
Potential Action	REPLACE
Urgency of Action	PRIORITY 3
Purpose of Action	LEVEL 2
Deficiency Photo1	 
Violations	Albert Road No violations recorded.
SEATING	Inspected
Benches	Inspected
Concrete	Does not Exist
Metal/Wood/Plastic	Inspected
Condition	2 - Between Good and Fair
Deficiency	No deficiencies recorded
Bleachers	Does not Exist
SITE WALLS (NOT RETAINING WALLS)	Inspected
Condition	2 - Between Good and Fair
Deficiency	BRICK: CRACKS/SPALLING - MAJOR
Deficiency Location/Instance	Albert Road
Deficiency Quantity	10
Quantity Uom	S.F.

Question	Response
SITE	
SITE WALLS (NOT RETAINING WALLS)	
Potential Action	REPLACE
Urgency of Action	PRIORITY 3
Purpose of Action	LEVEL 2
Deficiency Photo1

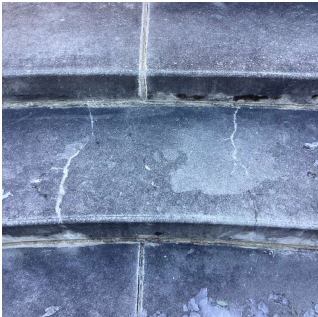
Albert Road
Violations	No violations recorded.
STAIRS/RAMPS: EXTERIOR	
	Inspected
Railings	Inspected
Condition	2 - Between Good and Fair
Deficiency	No deficiencies recorded
Site Cheek/flank Walls	Inspected
Condition	2 - Between Good and Fair
Deficiency	No deficiencies recorded
Stairs/ramps	Inspected
Condition	2 - Between Good and Fair
Deficiency	CAST IN PLACE CONCRETE: CRACKS/SPALLING - MAJOR
Deficiency Location/Instance	Main Entrance
Deficiency Quantity	20
Quantity Uom	S.F.
Potential Action	REPLACE
Urgency of Action	PRIORITY 3
Purpose of Action	LEVEL 2
Deficiency Photo1
