**NYC Department of Education**  
**Building Condition Assessment Survey 2023 - 2024**

Architectural Inspection

**Asset:** P.S. 339 - QUEENS, 39-07 57TH STREET, New York, 11377

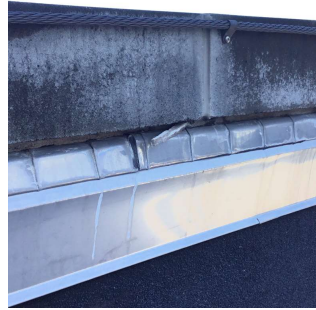
Roof 1

Question	Response
<b>Architectural</b>	
<b>EXTERIOR</b>	Inspected
<b>AREAWAY</b>	Does not Exist
<b>AWNINGS AND CANOPIES</b>	Does not Exist
<b>CHIMNEY</b>	Inspected
Material Type(s)	Metal
Condition	2 - Between Good and Fair
Deficiency	No deficiencies recorded
<b>COPING</b>	Inspected
Condition	3 - Fair
Deficiency	CAST STONE: DETERIORATED BED JOINT
Roof Plan reference	Q339

Deficiency Quantity	10
Quantity Uom	L.F.
Potential Action	REPOINT
Urgency of Action	PRIORITY 3
Purpose of Action	LEVEL 2

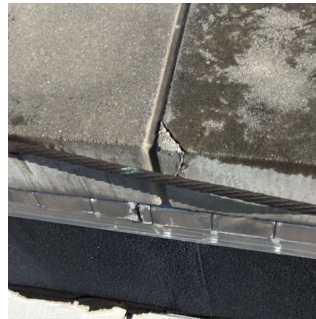
BH

**CAST STONE: CRACKED/BROKEN PIECES**

**REPLACE-IN-KIND**

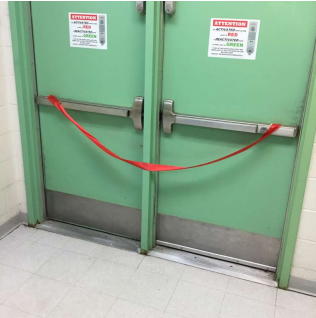
**METAL: DETERIORATED DOOR AND FRAME - MAJOR DETERIORATION**

Violations	Facade B - Exit 2 No violations recorded.
<b>DOOR HARDWARE</b>	Inspected
Condition	2 - Between Good and Fair
Deficiency	No deficiencies recorded
<b>LINTELS</b>	Inspected
Condition	2 - Between Good and Fair
Deficiency	No deficiencies recorded
<b>TRANSOM/SIDE LIGHT</b>	Inspected
Condition	2 - Between Good and Fair
Deficiency	No deficiencies recorded
<b>EXTERIOR WALLS</b>	Inspected
Material Type(s)	Masonry
Replacement Quantity	26,000
Replacement Uom	S.F.
Instance on All Facades	Inspected
Instance Condition	3 - Fair
Instance Quantity	26,000
Instance Quantity Uom	S.F.
Deficiency	BRICK: EFFLORESCENCE

Deficiency Quantity	2
Quantity Uom	EACH
Potential Action	REPLACE
Urgency of Action	PRIORITY 4
Purpose of Action	LEVEL 2
Deficiency Photo1

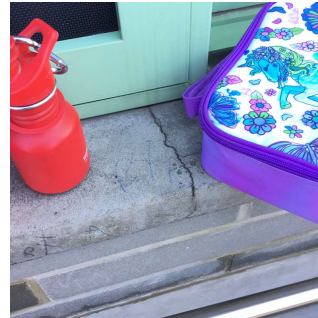
Facade A

BRICK: DETERIORATED MASONRY SILLS - MINOR

REPAIR

PRIORITY 3  
LEVEL 2

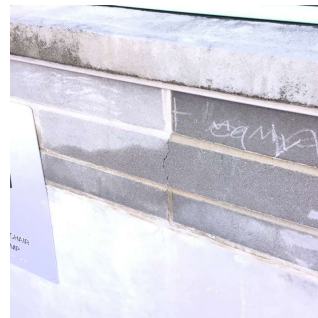
Facade A

BRICK: MINOR CRACKS AND SPALLING

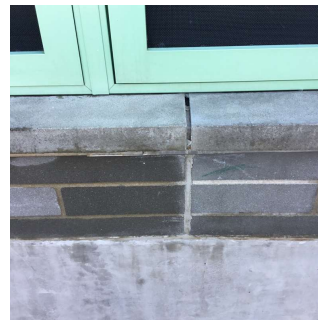
Facade A

BRICK: MASONRY SILLS - DETERIORATED JOINTS

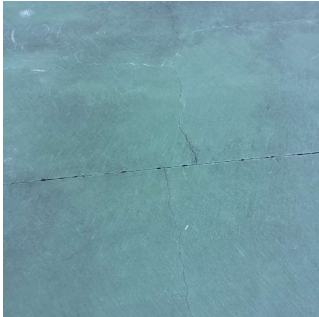
Question	Response
<b>EXTERIOR</b>	
<b>PLAZA DECK</b>	
Source of Installation	Documented
Deficiency	CONCRETE: MINOR CRACKS
Roof Plan reference	Q339

Violations	Roof 3 No violations recorded.
<b>ROOF</b>	Inspected
<b>Roofing</b>	Inspected
Replacement Quantity	11,000
Replacement Uom	S.F.
<b>ROOF HATCH/SMOKE HATCH</b>	Inspected
Condition	2 - Between Good and Fair
Deficiency	No deficiencies recorded
<b>LEADERS, GUTTERS, DOWNSPOUTS, SCUPPERS</b>	Inspected
Condition	2 - Between Good and Fair
Deficiency	No deficiencies recorded
<b>ROOF BARRIER/FENCE</b>	Inspected
Condition	2 - Between Good and Fair
Deficiency	No deficiencies recorded
<b>ROOF CAGE</b>	Does not Exist
<b>ROOFING</b>	Inspected
Instance on IRMA: Roofs 1, 2	Inspected
Instance Condition	4 - Between Fair and Poor

Deficiency Quantity	70
Quantity Uom	S.F.
Potential Action	REPAIR
Urgency of Action	PRIORITY 3
Purpose of Action	LEVEL 2
Deficiency Photo1

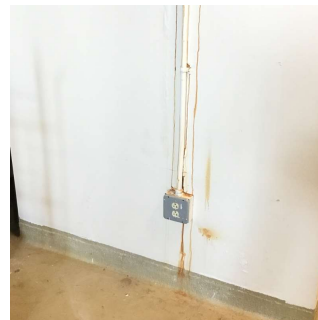
Roof 1 - Room 509

Deficiency IRMA: ROOFING: MAJOR ACTIVE ROOF LEAKS IN NON-INSTRUCTIONAL SPACE

Deficiency Quantity	100
Quantity Uom	S.F.
Potential Action	REPLACE ROOFING WITHOUT MAJOR EQUIPMENT REMOVAL
Urgency of Action	PRIORITY 5
Purpose of Action	LEVEL 2
Deficiency Photo1

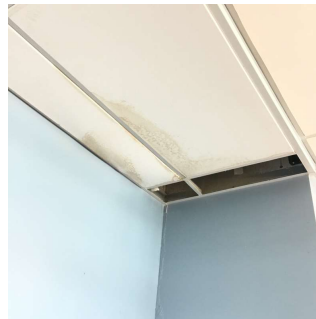
Roof 1 - Room 502  
 No violations recorded.

Violations	No violations recorded.
Deficiency	IRMA: ROOFING: MAJOR ACTIVE ROOF LEAKS IN INSTRUCTIONAL SPACE

Q339  
 100  
 S.F.  
 REPLACE ROOFING WITHOUT MAJOR EQUIPMENT  
 REMOVAL  
 PRIORITY 5  
 LEVEL 2

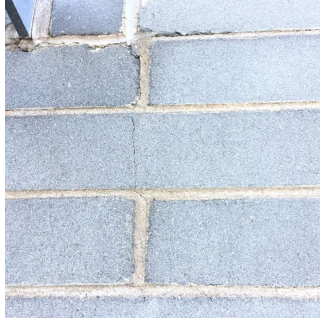
BULKHEAD/PENTHOUSE WALLS/EXTERIOR:  
 CRACKS/SPALLING - MINOR

Violations	BH No violations recorded.
Deficiency	BULKHEAD/PENTHOUSE WALLS/INTERIOR: CMU CRACKS/SPALLING
Roof Plan reference	Q339

Question	Response
<b>EXTERIOR</b>	
<b>ROOF</b>	
<b>Specialties</b>	
<b>BULKHEAD/PENTHOUSE</b>	
Potential Action	REPAIR
Urgency of Action	PRIORITY 3
Purpose of Action	LEVEL 2
Deficiency Photo1

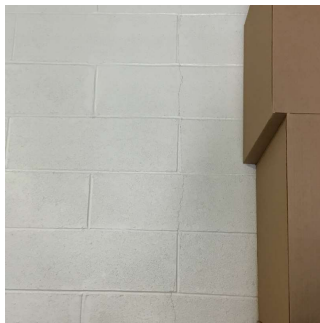
Violations	BH No violations recorded.
<b>CUPOLA/ SPIRES/ TOWERS</b>	Does not Exist
<b>DORMER</b>	Does not Exist
<b>DUNNAGE STEEL</b>	Inspected
Condition	2 - Between Good and Fair

Deficiency Quantity	40
Quantity Uom	S.F.
Potential Action	REPLACE
Urgency of Action	PRIORITY 3
Purpose of Action	LEVEL 2
Deficiency Photo1

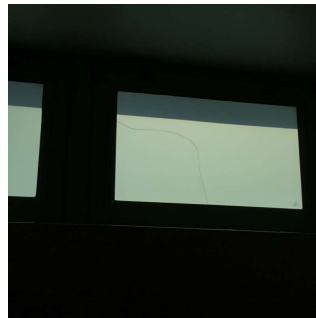
Facade C - Room 505

ALUMINUM - OTHER: BROKEN PANE

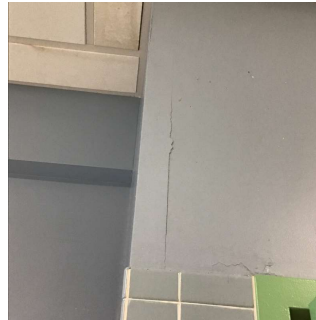
Corridor near Room 509

GYPSON BOARD: DETERIORATED

REPLACE

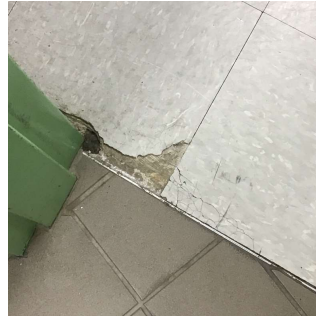
Room 102D

Deficiency	VINYL TILES: BROKEN/DETERIORATED/MISSING TILES
------------	--

Potential Action	REPLACE
------------------	---------

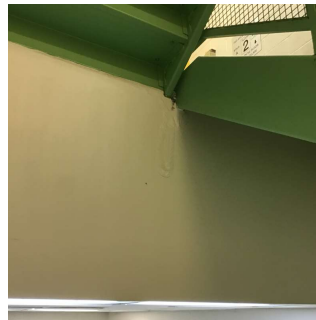
Stair A/1

GYP SUM BOARD: DETERIORATED

REPLACE

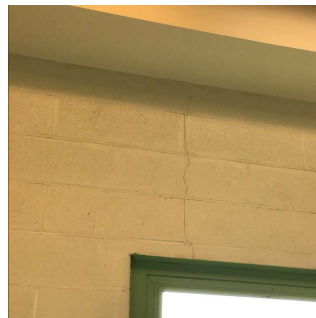
MASONRY: CRACKS/SPALLING

REPLACE

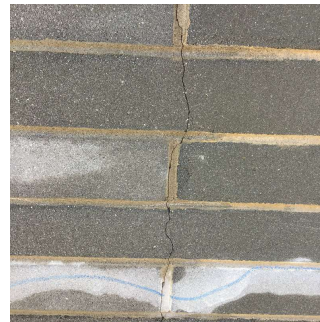
39th Avenue

**BRICK: CRACKS/SPALLING - MAJOR**

REPLACE

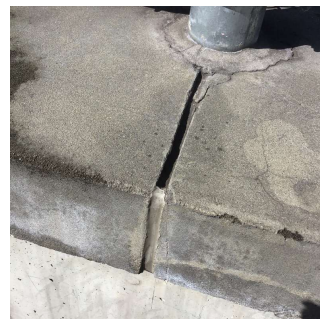
Schoolyard

**CAST IN PLACE CONCRETE: DETERIORATED CONTROL/EXPANSION JOINT**

REPLACE
