NYC Department of Education
Building Condition Assessment Survey 2023 - 2024

Architectural Inspection

Q346

Asset: 3K CENTER @ 11-11 40TH AVENUE - QUEENS, 11-11 40TH AVENUE , 11101

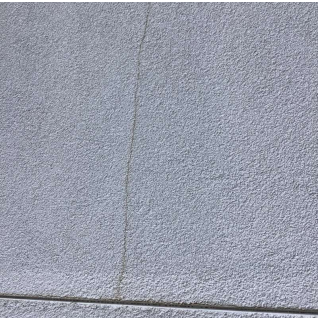
Question	Response
EXTERIOR	
EXTERIOR WALLS	Inspected
Material Type(s)	Masonry
Replacement Quantity	6,300
Replacement Uom	S.F.
Instance on All Facades	Inspected
Instance Condition	5 - Poor
Instance Quantity	6,300
Instance Quantity Uom	S.F.
Deficiency	STUCCO CEMENT SURFACE: CRACKS, SPALLING
Roof Plan reference

Violations	Facade D No violations recorded.
Deficiency	BRICK: DETERIORATED MASONRY SILLS - MINOR

Deficiency Quantity	100
Quantity Uom	S.F.
Potential Action	REPLACE
Urgency of Action	PRIORITY 4
Purpose of Action	LEVEL 2
Deficiency Photo1

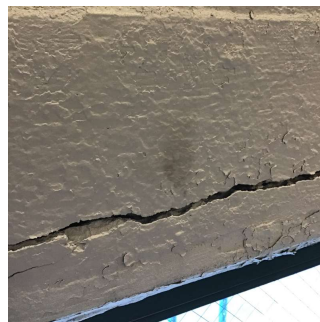
BH
No violations recorded.

BULKHEAD/PENTHOUSE	
Condition	Inspected
Deficiency	4 - Between Fair and Poor
	BULKHEAD/PENTHOUSE WALLS/INTERIOR: PLASTER CRACKS/SPALLING

10
S.F.
REPLACE
PRIORITY 4
LEVEL 2

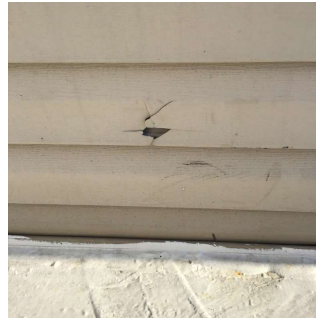
PH, BH

Deficiency	BULKHEAD/PENTHOUSE WALLS/EXTERIOR: CRACKS/SPALLING - MAJOR
------------	---

30
S.F.
REPLACE
PRIORITY 4
LEVEL 2

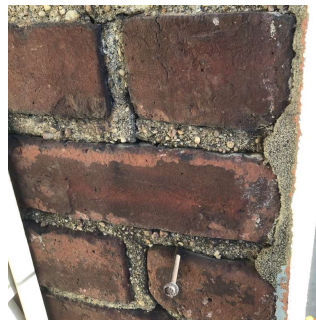
PH

BULKHEAD/PENTHOUSE WALLS/EXTERIOR: DETERIORATED JOINTS

REPOINT

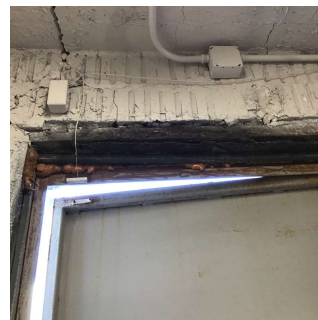
BH
 No violations recorded.

BULKHEAD/PENTHOUSE DOORS: DETERIORATED LINTELS

10
 L.F.
 REPLACE
 PRIORITY 4
 LEVEL 2

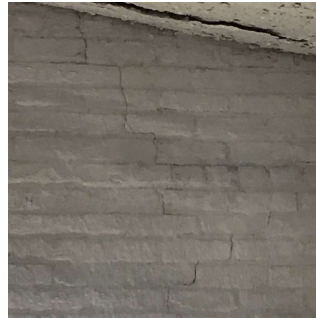
BH

Deficiency **BULKHEAD/PENTHOUSE WALLS/INTERIOR: BRICK CRACKS/SPALLING**

50
 S.F.
 REPLACE
 PRIORITY 4
 LEVEL 2

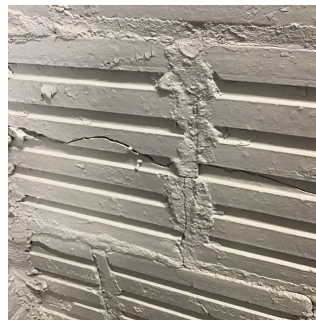
BH

**BULKHEAD/PENTHOUSE WALLS/INTERIOR: CMU
CRACKS/SPALLING**

REPLACE

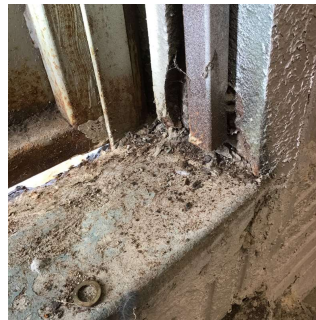
BH
 No violations recorded.

**BULKHEAD/PENTHOUSE DOORS: DETERIORATED DOOR
AND FRAME**

2
 EACH
 REPLACE DOOR AND FRAME
 PRIORITY 4
 LEVEL 2

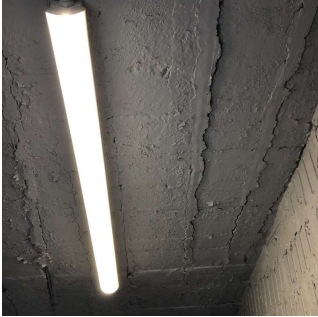
BULKHEAD/PENTHOUSE CEILING: PLASTER DAMAGED/DETERIORATED

BH
Violations	No violations recorded.
CUPOLA/ SPIRES/ TOWERS	Does not Exist
DORMER	Does not Exist
DUNNAGE STEEL	Inspected
Condition	1 - Good
Deficiency	No deficiencies recorded
SKYLIGHT/ROOF VENT	Inspected
Material Type(s)	Plastic
Condition	1 - Good
Deficiency	No deficiencies recorded
ROOF/GRAVITY TANK	Does not Exist
STAIRS/RAMPS: EXTERIOR	Does not Exist
WINDOWS	Inspected
Replacement Quantity	1,100
Replacement Uom	S.F.
EXTERIOR GUARDS	Inspected
Condition	2 - Between Good and Fair
Deficiency	No deficiencies recorded
LINTELS	Inspected
Condition	2 - Between Good and Fair
Deficiency	No deficiencies recorded
WINDOWS	Inspected
Material Type(s)	Aluminum, Steel
Instance on Steel: Facade A	Inspected
Instance Condition	5 - Poor
Instance Quantity	100
Instance Quantity Uom	S.F.
Are these windows insulated	No
Installation Year	1991
Source of Installation	Custodial Staff

30
 S.F.
 REPLACE
 PRIORITY 4
 LEVEL 2

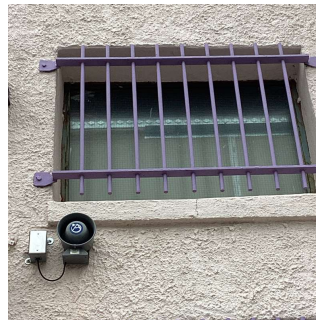
Facade A
No violations recorded.

Deficiency	STEEL: DETERIORATED

100
S.F.
REPLACE WINDOW
PRIORITY 4
LEVEL 2

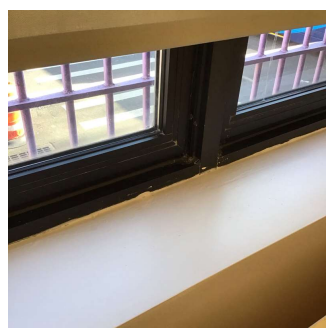
Instance on Aluminum - Other: Facade A, B, C	Inspected
Instance Condition	3 - Fair
Instance Quantity	1,000
Instance Quantity Uom	S.F.
Are these windows insulated	Yes
Installation Year	2005
Source of Installation	Custodial Staff
Deficiency	ALUMINUM - OTHER: AIR/WATER INFILTRATION

Violations	<p>Facade A - Room 208</p> <p>No violations recorded.</p>
INTERIOR	Inspected
POOLS	Does not Exist
STRUCTURAL	Inspected
COLUMNS/BEAMS/BEARING WALLS	Inspected
Condition	3 - Fair
Deficiency	CONCRETE COLUMNS/BEAMS: CRACKED/SPALLED/REINFORCEMENT EXPOSED
Deficiency Location/Instance	Basement - Electrical Panel Room
Deficiency Quantity	30
Quantity Uom	S.F.
Potential Action	REPAIR
Urgency of Action	PRIORITY 3

Elevation	 
Deficiency Quantity	90
Quantity Uom	L.F.
Potential Action	REPLACE TRIM, SILLS OR WEATHERSTRIPPING
Urgency of Action	PRIORITY 5
Purpose of Action	LEVEL 2
Deficiency Photo1

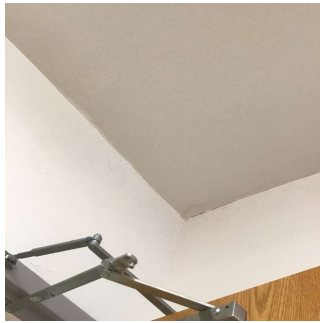
Violations	No violations recorded.
VAULTS-BUNKERS	Does not Exist
AUDITORIUM	Does not Exist
CAFETERIA	Does not Exist
CLASSROOMS/CORRIDORS/ADMIN SPACES	Inspected
Ceiling	Inspected
Condition	2 - Between Good and Fair
Deficiency	GYPSUM BOARD: DAMAGED/DETERIORATED - ACTIVE LEAK

Deficiency Location/Instance	Rooms 208, 209
Deficiency Quantity	20
Quantity Uom	S.F.
Potential Action	REPLACE
Urgency of Action	PRIORITY 5
Purpose of Action	LEVEL 2

Room 209
Violations	No violations recorded.
Deficiency	GYPSUM BOARD: DAMAGED/DETERIORATED
Deficiency Location/Instance	Main Entrance
Deficiency Quantity	20
Quantity Uom	S.F.
Potential Action	REPLACE
Urgency of Action	PRIORITY 3
Purpose of Action	LEVEL 2
Deficiency Photo1

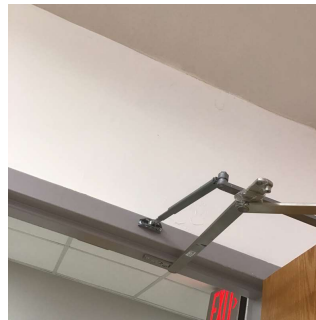
Room 209

GYPSON BOARD: DETERIORATED - ACTIVE LEAK

Rooms 204, 209

REPLACE

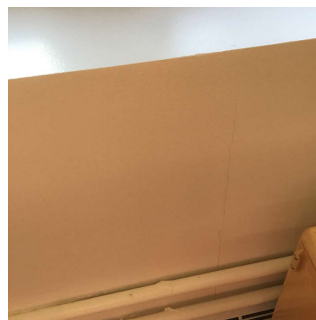
GYPSON BOARD: DETERIORATED

Rooms 208, 209

Question	Response
INTERIOR	
CLASSROOMS/CORRIDORS/ADMIN SPACES	Inspected
Walls	Inspected
Violations	Room 208 No violations recorded.
Specialties	Does not Exist
GYMNASIUM	Does not Exist
INTERIOR DOOR HARDWARE	Inspected
Condition	1 - Good
Deficiency	No deficiencies recorded
INTERIOR GUARDS	Does not Exist
KITCHEN	Inspected
Instance on Basement	Inspected
Ceiling	
Instance on Basement	Inspected
Condition	1 - Good
Deficiency	No deficiencies recorded
Door(s)	
Instance on Basement	Inspected
Condition	1 - Good
Deficiency	No deficiencies recorded
Floor Finish	
Instance on Basement	Inspected
Condition	1 - Good
Deficiency	No deficiencies recorded
Walls	
Instance on Basement	Inspected
Condition	1 - Good
Deficiency	No deficiencies recorded
LIBRARY	Does not Exist
LOCKER ROOM	Does not Exist
MULTI-PURPOSE ROOM	Does not Exist
SCIENCE DEMO ROOM	Does not Exist
SCIENCE LAB	Does not Exist
SCIENCE PREP ROOM	Does not Exist
SHOWER ROOM	Does not Exist

REPLACE
