**NYC Department of Education**  
**Building Condition Assessment Survey 2023 - 2024**

Architectural Inspection

**Asset:**        **PRE-K CENTER @ 56-01 61ST STREET - QUEENS, 56-01 61ST STREET, New York, 11378**

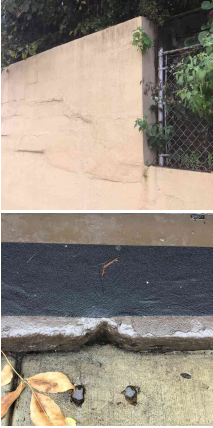
No	Potential Falling Debris	Leaning retaining wall creates a potential hazardous condition.	SITE   RETAINING WALLS	Schoolyard	Chris Paulinho	Fireman

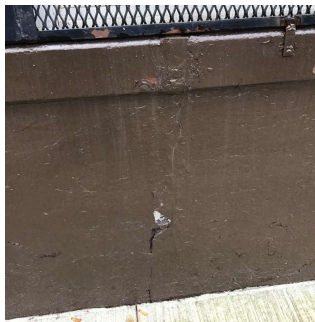
Facades A, B (Shown)

BRICK: DETERIORATED MASONRY SILLS - MAJOR

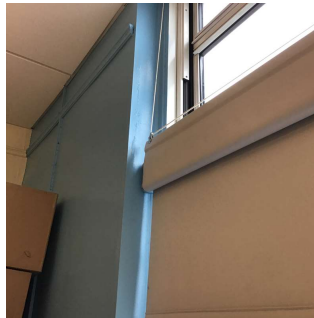
Facade B - Rooms 107, 109, 204, 206

BROKEN/ DENTED BLADES

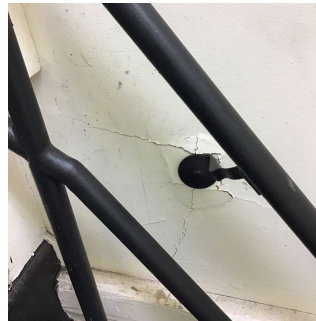
BH1

BULKHEAD/PENTHOUSE WALLS/INTERIOR: PLASTER  
CRACKS/SPALLING

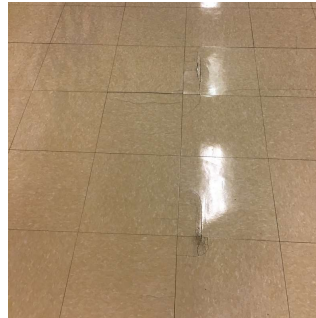
Corridor near Room 104

VINYL TILES: BROKEN/DETERIORATED/MISSING TILES

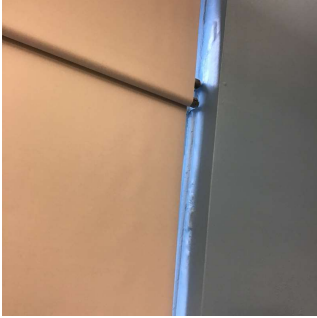
Room 109
Violations	No violations recorded.
Deficiency	PLASTER: CRACKS/SPALLING
Deficiency Location/Instance	Room 109
Deficiency Quantity	20
Quantity Uom	S.F.
Potential Action	REPLACE
Urgency of Action	PRIORITY 3
Purpose of Action	LEVEL 2

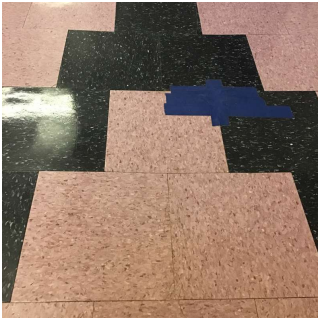
Violations	Near Stage No violations recorded.
Deficiency	VINYL TILES: BROKEN/DETERIORATED/MISSING TILES
Deficiency Location/Instance	Near Stage, steps right side, Center, Windows
Deficiency Quantity	20
Quantity Uom	S.F.

Potential Action	REPLACE
Urgency of Action	PRIORITY 3
Purpose of Action	LEVEL 2

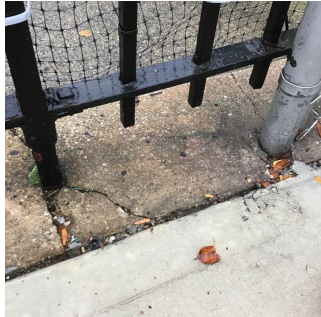
Violations	61st Street No violations recorded.
Deficiency	<b>WROUGHT IRON: DAMAGED/DETERIORATED</b>
Deficiency Location/Instance	61st Street
Deficiency Quantity	40
Quantity Uom	S.F.
Potential Action	REPLACE
Urgency of Action	PRIORITY 3
Purpose of Action	LEVEL 2
Deficiency Photo1

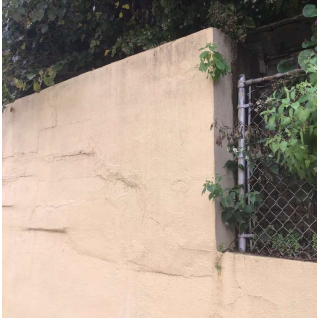
Schoolyard
Violations	No violations recorded.
Deficiency	CAST IN PLACE CONCRETE: CRACKS/SPALLING - MAJOR
