NYC Department of Education
Building Condition Assessment Survey 2023 - 2024

Architectural Inspection

Q363

Asset: 3K CENTER @ 134-35 SPRINGFIELD BOULEVARD - QUEENS, 134-35 SPRINGFIELD BOULEVARD, New York, 11413

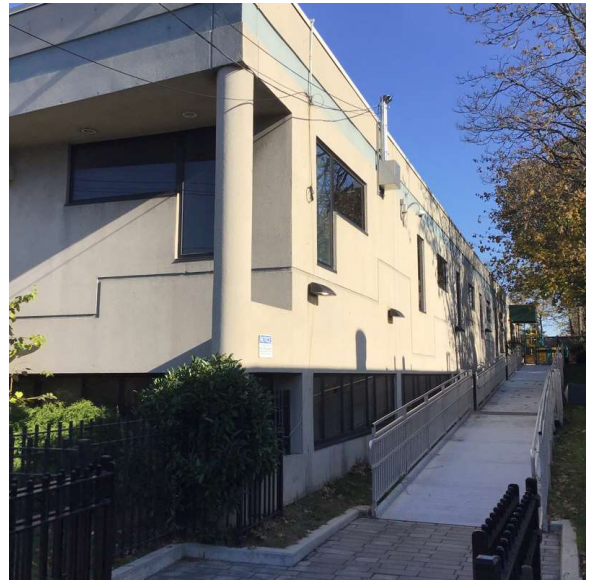
Corner of Facades A and B - Northeast view

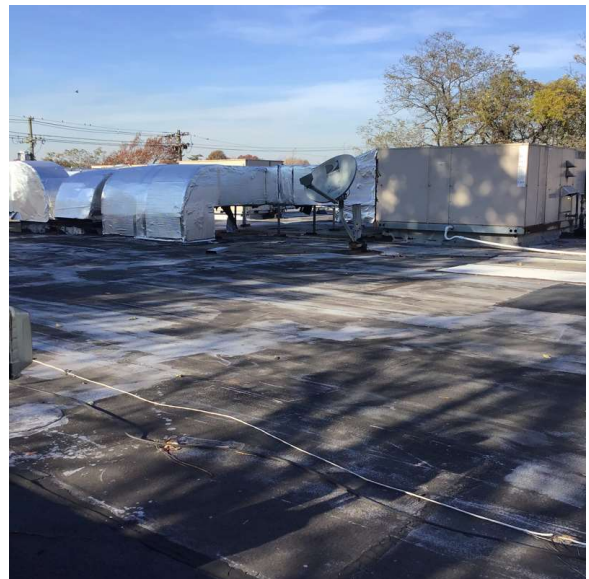
Roof 1 - North view

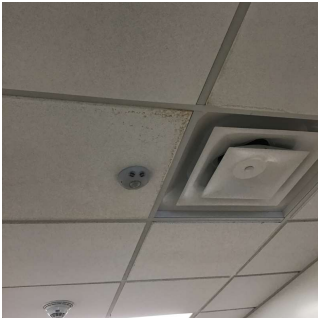
Question	Response
EXTERIOR	Inspected
WINDOWS	
WINDOWS	
Installation Year	2001
Source of Installation	Custodial Staff
Deficiency	No deficiencies recorded
INTERIOR	Inspected
POOLS	Does not Exist
STRUCTURAL	Inspected
COLUMNS/BEAMS/BEARING WALLS	Inspected
Condition	2 - Between Good and Fair
Deficiency	No deficiencies recorded
FLOOR STRUCTURE	Inspected
Condition	2 - Between Good and Fair
Deficiency	No deficiencies recorded
FOUNDATION WALLS	Inspected
Material Type(s)	Concrete
Condition	2 - Between Good and Fair
Deficiency	No deficiencies recorded
ROOF STRUCTURE	Inspected
Condition	2 - Between Good and Fair
Deficiency	No deficiencies recorded
VAULTS-BUNKERS	Not Required
AUDITORIUM	Does not Exist
CAFETERIA	Does not Exist
CLASSROOMS/CORRIDORS/ADMIN SPACES	Inspected
Ceiling	Inspected
Condition	2 - Between Good and Fair
Deficiency	ACOUSTIC TILES: DAMAGED/MISSING
Deficiency Location/Instance	Near room 116
Deficiency Quantity	10
Quantity Uom	S.F.

Potential Action	REPLACE
Urgency of Action	PRIORITY 3
Purpose of Action	LEVEL 2
Deficiency Photo1

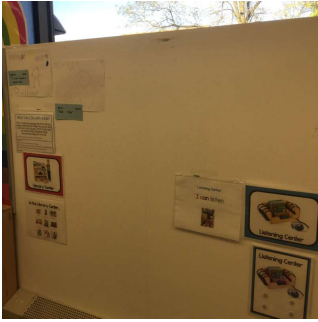
Question	Response
INTERIOR	Inspected
CLASSROOMS/CORRIDORS/ADMIN SPACES	
Floor Finish	Inspected
Condition	1 - Good
Deficiency	No deficiencies recorded
Walls	Inspected
Condition	2 - Between Good and Fair
Deficiency	PLASTER: CRACKS/SPALLING
Deficiency Location/Instance	Room 102
Deficiency Quantity	15
Quantity Uom	S.F.
Potential Action	REPLACE
Urgency of Action	PRIORITY 3
Purpose of Action	LEVEL 2
Deficiency Photo1
