NYC Department of Education
Building Condition Assessment Survey 2023 - 2024

Architectural Inspection

Asset: 3K CENTER @ 75-01 BROADWAY - QUEENS, 75-01 BROADWAY, New York, 11373

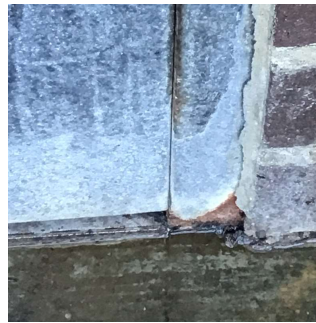
Facade B

Deficiency METAL: DETERIORATED DOOR AND FRAME - MINOR DETERIORATION

MAINTENANCE

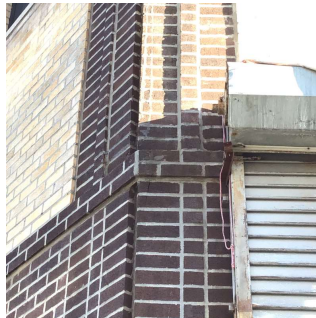
Facade A

BRICK: CRACKS/DISPLACED/SPALLED BRICK AT BUILDING CORNERS

REMOVE AND REBUILD

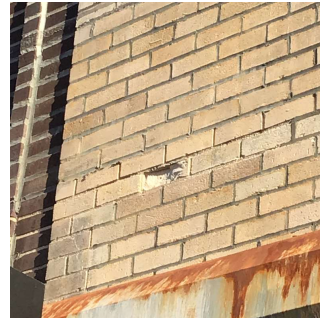
Facade A

BRICK: MAJOR / THRU CRACKS

REMOVE AND REBUILD

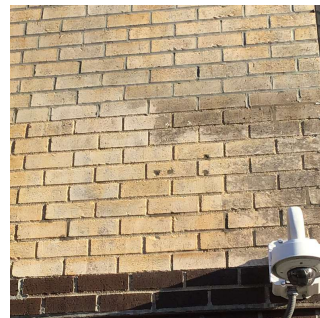
Facade A

BRICK: DETERIORATED JOINTS

REPOINT

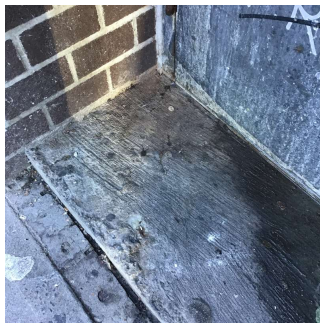
Question	Response
EXTERIOR	
EXTERIOR WALLS	Inspected
Violations	No violations recorded.
EXTERIOR SOFFITS	Inspected
Condition	2 - Between Good and Fair
Deficiency	No deficiencies recorded
LOADING DOCK	Does not Exist
LOUVER	Does not Exist
PARAPETS	Not Required
PLAZA DECK	Does not Exist
ROOF	Inspected
Roofing	Not Required
Specialties	Inspected
BULKHEAD/PENTHOUSE	Does not Exist
CUPOLA/ SPIRES/ TOWERS	Does not Exist
DORMER	Does not Exist
DUNNAGE STEEL	Inspected
Condition	2 - Between Good and Fair
Deficiency	No deficiencies recorded
SKYLIGHT/ROOF VENT	Does not Exist
ROOF/GRAVITY TANK	Does not Exist
STAIRS/RAMPS: EXTERIOR	Inspected
BUILDING CHEEK/FLANK WALLS	Does not Exist
RAILINGS	Does not Exist
STAIRS/RAMPS	Inspected
Condition	3 - Fair
Deficiency	CONCRETE: WORN-OUT TREAD/RISER/NOSING
Roof Plan reference	Q364

10
S.F.
REPLACE
PRIORITY 4
LEVEL 2

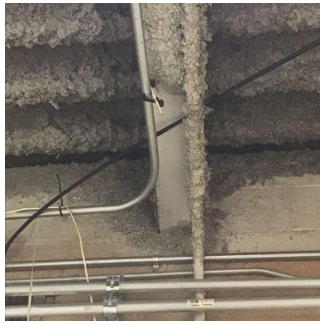
Violations	Facade B No violations recorded.
WINDOWS	Inspected
Replacement Quantity	1,800
Replacement Uom	S.F.
EXTERIOR GUARDS	Does not Exist
LINTELS	Inspected
Condition	2 - Between Good and Fair
Deficiency	No deficiencies recorded
WINDOWS	Inspected
Material Type(s)	Aluminum
Instance on Aluminum - Double Hung: Facades A and B	Inspected
Instance Condition	2 - Between Good and Fair
Instance Quantity	1,800
Instance Quantity Uom	S.F.
Are these windows insulated	Yes
Installation Year	2010
Source of Installation	Custodial Staff
Deficiency	No deficiencies recorded
INTERIOR	Inspected
POOLS	Does not Exist
STRUCTURAL	Inspected
COLUMNS/BEAMS/BEARING WALLS	Inspected
Condition	2 - Between Good and Fair
Deficiency	STEEL COLUMNS/BEAMS: DETERIORATED/MISSING SPRAY-ON FIREPROOFING
Deficiency Location/Instance	Basement - Electrical Panel Room
Deficiency Quantity	10

Quantity Uom	S.F.
Potential Action	REPLACE
Urgency of Action	PRIORITY 3
Purpose of Action	LEVEL 5

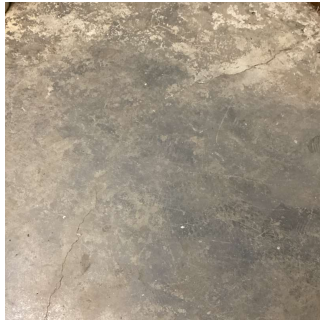
Violations	Basement - Electrical Panel Room No violations recorded.
FLOOR STRUCTURE	Inspected
Condition	3 - Fair
Deficiency	CONCRETE SLAB ON GRADE: THRU CRACKS
Deficiency Location/Instance	Basement - Electrical Panel Room
Deficiency Quantity	100
Quantity Uom	S.F.
Potential Action	REPAIR
Urgency of Action	PRIORITY 3
Purpose of Action	LEVEL 5
Deficiency Photo1

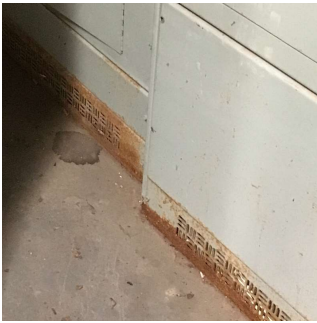
Violations	Basement - Electrical Panel Room No violations recorded.
FOUNDATION WALLS	Inspected
Material Type(s)	Concrete
Condition	4 - Between Fair and Poor
Deficiency	CONCRETE: WATER INFILTRATION IN ELECTRICAL PANEL ROOM
Deficiency Location/Instance	Basement - Electrical Panel Room
Deficiency Quantity	100
Quantity Uom	S.F.
Potential Action	INSTALL WATERPROOFING
Urgency of Action	PRIORITY 5
Purpose of Action	LEVEL 6

Basement - Electrical Panel Room - rusted electrical panel serving the 2nd floor only
Violations	No violations recorded.
ROOF STRUCTURE	Not Required
VAULTS-BUNKERS	Does not Exist
AUDITORIUM	Does not Exist
CAFETERIA	Does not Exist
CLASSROOMS/CORRIDORS/ADMIN SPACES	Inspected
Ceiling	Inspected
Condition	1 - Good
Deficiency	No deficiencies recorded
Door(s)	Inspected
Condition	1 - Good
Deficiency	No deficiencies recorded
Floor Finish	Inspected
Condition	2 - Between Good and Fair
Deficiency	VINYL TILES: DETERIORATED SUBSTRATE
Deficiency Location/Instance	Room 212A
Deficiency Quantity	10
Quantity Uom	S.F.
Potential Action	REPLACE
Urgency of Action	PRIORITY 3
Purpose of Action	LEVEL 2
Deficiency Photo1
