**NYC Department of Education**  
**Building Condition Assessment Survey 2023 - 2024**

Architectural Inspection

**Asset:**        **PRE-K CENTER @ 54-25 101ST STREET - QUEENS, 54-25 101ST STREET, New York, 11368**

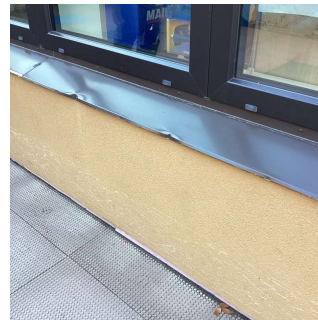
Facade B

STUCCO CEMENT SURFACE: DETERIORATED FLASHING

REPLACE

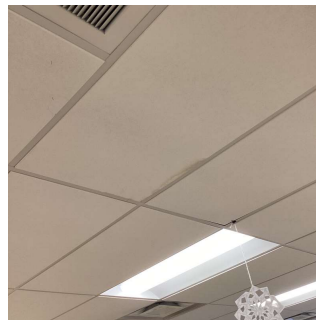
<b>Ceiling</b>	Inspected
Condition	2 - Between Good and Fair
Deficiency	ACOUSTIC TILES: DAMAGED/MISSING
Deficiency Location/Instance	Room 102
Deficiency Quantity	10
Quantity Uom	S.F.
Potential Action	REPLACE
Urgency of Action	PRIORITY 3
Purpose of Action	LEVEL 2
Deficiency Photo1

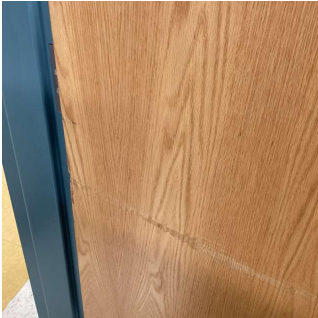
Question	Response
<b>INTERIOR</b>	
<b>INTERIOR DOOR HARDWARE</b>	Inspected
Condition	2 - Between Good and Fair
Deficiency	No deficiencies recorded
<b>INTERIOR GUARDS</b>	Does not Exist
<b>KITCHEN</b>	Inspected
Instance on 1st Floor	Inspected
<b>Ceiling</b>	
Instance on 1st Floor	Inspected
Condition	2 - Between Good and Fair
Deficiency	No deficiencies recorded
<b>Door(s)</b>	
Instance on 1st Floor	Inspected
Condition	3 - Fair
Deficiency	WOOD: DETERIORATED DOOR
Deficiency Location/Instance	Main Entrance
Deficiency Quantity	1
Quantity Uom	EACH
Potential Action	MAINTENANCE
Urgency of Action	PRIORITY 3
Purpose of Action	LEVEL 2
Deficiency Photo1

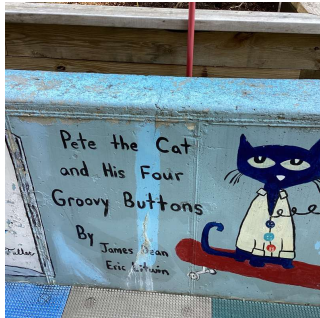
Question	Response
<b>SITE</b>	
<b>RETAINING WALLS</b>	Inspected
Are there any Retaining Walls 6' OR higher facing public street/sidewalk?	No
Condition	3 - Fair
Deficiency	CAST IN PLACE CONCRETE: CRACKS/SPALLING - MAJOR
Deficiency Location/Instance	Playground area
Deficiency Quantity	30
Quantity Uom	S.F.
Potential Action	REPLACE
Urgency of Action	PRIORITY 3
Purpose of Action	LEVEL 2
Deficiency Photo1

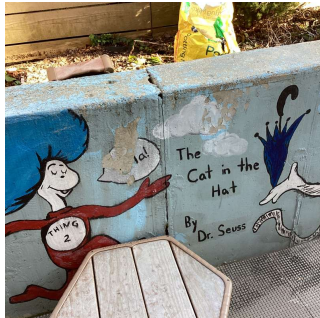
Violations	Playground area No violations recorded.
Deficiency	CAST IN PLACE CONCRETE: DETERIORATED CONTROL/EXPANSION JOINT
Deficiency Location/Instance	Playground area
Deficiency Quantity	15
Quantity Uom	L.F.
Potential Action	REPLACE
Urgency of Action	PRIORITY 3
Purpose of Action	LEVEL 2
Deficiency Photo1
