NYC Department of Education
Building Condition Assessment Survey 2023 - 2024

Architectural Inspection

Asset: **PRE-K CENTER @ 104-04 CORONA AVENUE - QUEENS, 104-04 CORONA AVENUE, 11368**

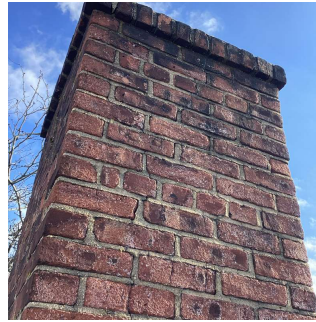
CH

Question	Response
Architectural	
EXTERIOR	Inspected
AREAWAY	Inspected
Instance on AW1-AW2	Inspected
Instance Condition	1 - Good
Instance Quantity	2
Instance Quantity Uom	EACH
Deficiency	No deficiencies recorded
AWNINGS AND CANOPIES	Does not Exist
CHIMNEY	Inspected
Material Type(s)	Masonry
Condition	3 - Fair
Deficiency	BRICK: MINOR CRACKS AND SPALLING
Roof Plan reference

Deficiency Quantity	40
Quantity Uom	S.F.
Potential Action	RESTITCH
Urgency of Action	PRIORITY 3
Purpose of Action	LEVEL 2

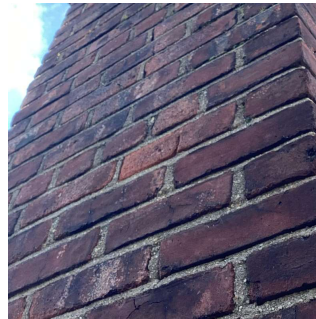
CH

BRICK: DETERIORATED JOINTS

REPOINT

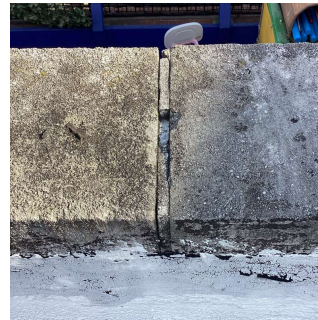
Roof 1

CAST STONE: DETERIORATED TRANSVERSE JOINTS

MAINTENANCE

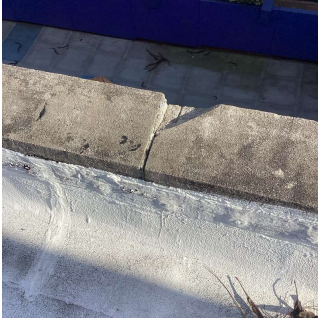
CAST STONE: CRACKED/BROKEN PIECES

REPLACE-IN-KIND

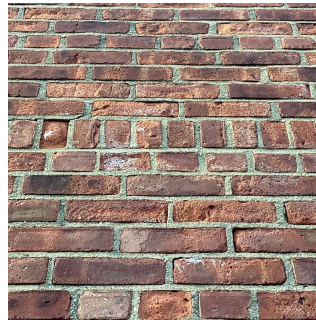
Facade C

Violations	Roof 1 No violations recorded.
CORNICE	Does not Exist
DOORS	Inspected
DOORS AND FRAMES	Inspected
Condition	1 - Good
Deficiency	No deficiencies recorded
DOOR HARDWARE	Inspected
Condition	1 - Good
Deficiency	No deficiencies recorded
LINTELS	Inspected
Condition	2 - Between Good and Fair
Deficiency	No deficiencies recorded
TRANSOM/SIDE LIGHT	Inspected
Condition	1 - Good
Deficiency	No deficiencies recorded
EXTERIOR WALLS	Inspected
Material Type(s)	Masonry
Replacement Quantity	3,000
Replacement Uom	S.F.
Instance on All Facades	Inspected
Instance Condition	4 - Between Fair and Poor
Instance Quantity	3,000
Instance Quantity Uom	S.F.
Deficiency	BRICK: MINOR CRACKS AND SPALLING
Roof Plan reference

RESTITCH

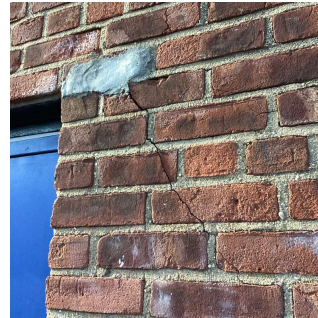
Facade C

BRICK: MAJOR / THRU CRACKS

REMOVE AND REBUILD

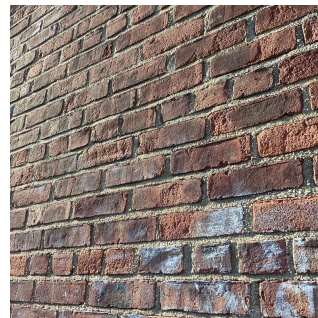
Facade B

BRICK: DETERIORATED JOINTS

REPOINT

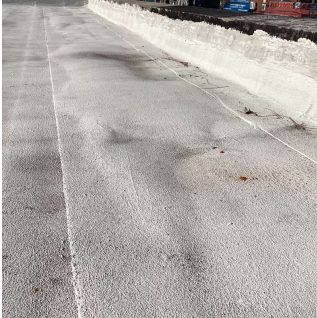
Do solar panels exist on these roofs?	No
Is/Are the roof(s) suitable for Solar Panel installation?	No
Installation Year	2018
Source of Installation	Custodial Staff
Deficiency	MODIFIED BITUMEN: ROOFING: DELAMINATION
Roof Plan reference

Question	Response
EXTERIOR	
ROOF	
Roofing	
ROOFING	
Deficiency Quantity	100
Quantity Uom	S.F.
Potential Action	REPLACE ROOFING WITHOUT MAJOR EQUIPMENT REMOVAL
Urgency of Action	PRIORITY 4
Purpose of Action	LEVEL 2
Deficiency Photo1

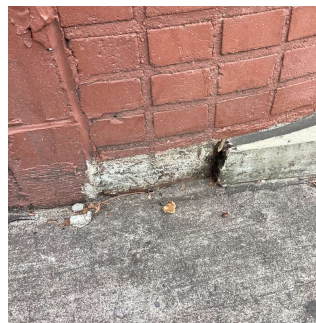
Facade A

Deficiency Quantity	1
Quantity Uom	EACH
Potential Action	MAINTENANCE
Urgency of Action	PRIORITY 5
Purpose of Action	LEVEL 2
Deficiency Photo1	No photo recorded
Violations	No violations recorded.
Specialties	Does not Exist
STAIRS/RAMPS: EXTERIOR	Inspected
BUILDING CHEEK/FLANK WALLS	Does not Exist
RAILINGS	Inspected
Condition	1 - Good
Deficiency	No deficiencies recorded
STAIRS/RAMPS	Inspected
Condition	3 - Fair
Deficiency	CONCRETE: CRACKS/SPALLING - MAJOR

10
S.F.
REPLACE
PRIORITY 4
LEVEL 2

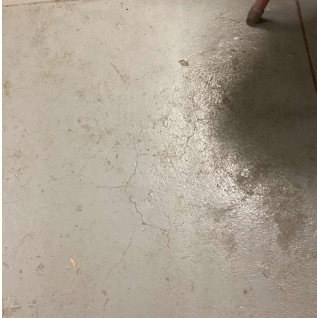
Question	Response
EXTERIOR	
WINDOWS	
WINDOWS	
Elevation	 
Deficiency Quantity	20
Quantity Uom	S.F.
Potential Action	REPLACE WINDOW
Urgency of Action	PRIORITY 4
Purpose of Action	LEVEL 2
Deficiency Photo1	 
Violations	Facade D - AW1 No violations recorded.
Instance on Aluminum - Other: All Facades	Inspected
Instance Condition	3 - Fair
Instance Quantity	400
Instance Quantity Uom	S.F.
Are these windows insulated	Yes
Installation Year	2000
Source of Installation	Inspector Estimate
Deficiency	No deficiencies recorded
INTERIOR	Inspected
POOLS	Does not Exist
STRUCTURAL	Inspected
COLUMNS/BEAMS/BEARING WALLS	Inspected
Condition	2 - Between Good and Fair
Deficiency	No deficiencies recorded
FLOOR STRUCTURE	Inspected
Condition	3 - Fair
Deficiency	CONCRETE SLAB ON GRADE: THRU CRACKS
Deficiency Location/Instance	Basement
Deficiency Quantity	40
Quantity Uom	S.F.
Potential Action	REPAIR

Question	Response
INTERIOR	
STRUCTURAL	
FLOOR STRUCTURE	
Urgency of Action	PRIORITY 3
Purpose of Action	LEVEL 5
Deficiency Photo1

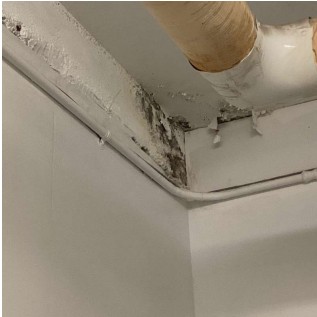
Violations	Basement No violations recorded.
FOUNDATION WALLS	
Material Type(s)	Inspected Concrete
Condition	4 - Between Fair and Poor
Deficiency	CONCRETE: WATER INFILTRATION IN NON- INSTRUCTIONAL SPACE
Deficiency Location/Instance	Boiler Room
Deficiency Quantity	100
Quantity Uom	S.F.
Potential Action	INSTALL WATERPROOFING
Urgency of Action	PRIORITY 5
Purpose of Action	LEVEL 5
Deficiency Photo1

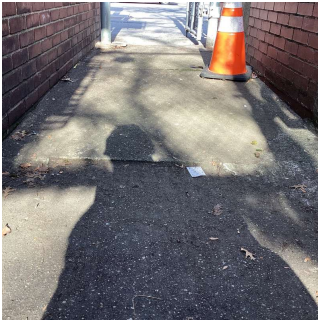
Question	Response
SITE	
PAVING	
Site Sidewalks & Walkways	Inspected
Asphalt	Does not Exist
Concrete	Inspected
Condition	3 - Fair
Deficiency	HEAVING
Deficiency Location/Instance	Corona Avenue
Deficiency Quantity	25
Quantity Uom	S.F.
Potential Action	REPLACE
Urgency of Action	PRIORITY 3
Purpose of Action	LEVEL 2
Deficiency Photo1

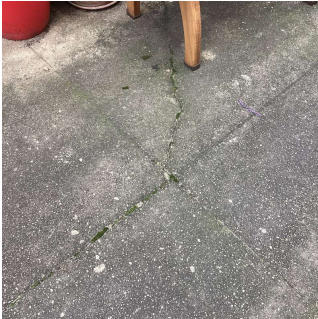
Violations	Corona Avenue No violations recorded.
Deficiency	CRACKS - MAJOR
Deficiency Location/Instance	104th Street Entrance, Corona Avenue Entrance
Deficiency Quantity	75
Quantity Uom	S.F.
Potential Action	REPLACE
Urgency of Action	PRIORITY 3
Purpose of Action	LEVEL 2
Deficiency Photo1

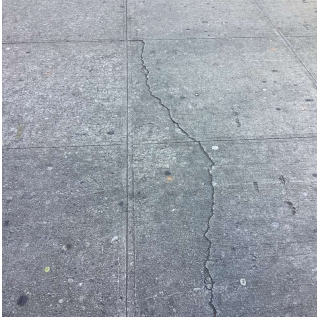
Question	Response
SITE	
PAVING	
DOT Sidewalk	
Concrete	
Deficiency Quantity	25
Quantity Uom	S.F.
Potential Action	REPLACE
Urgency of Action	PRIORITY 3
Purpose of Action	LEVEL 2
Deficiency Photo1	 
	Corona Avenue
Violations	No violations recorded.
Deficiency	DAMAGED CURBS
Deficiency Location/Instance	Corona Avenue, 104th Street
Deficiency Quantity	20
Quantity Uom	L.F.
Potential Action	REPLACE
Urgency of Action	PRIORITY 3
Purpose of Action	LEVEL 2
Deficiency Photo1	 
	Corona Avenue
Violations	No violations recorded.
Deficiency	DAMAGED/DETERIORATED/MISSING SECTIONS
Deficiency Location/Instance	Corona Avenue, 104th Street
Deficiency Quantity	375
Quantity Uom	S.F.
Potential Action	REPLACE
Urgency of Action	PRIORITY 3
Purpose of Action	LEVEL 2

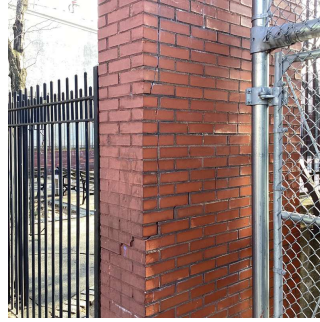
Priority Condition Exist Last Year?	Priority Category	Condition Description	Component Affected	Location Description	Person(s) Notified	Person(s) Title	PhotoImage
No	Potential Falling Debris	Severely damaged brick site wall with large cracks is a potential safety hazard.	SITE SITE WALLS (NOT RETAINING WALLS)	Corona Avenue near Playground entrance	Vincenzo Quartuccia	Handyman

Violations	Corona Avenue No violations recorded.
Pavers	Does not Exist
PLAYGROUNDS	Inspected
Instance on Rear Of Building	Inspected
Benches	
Instance on Rear Of Building	Does not Exist
Fence	
Instance on Rear Of Building	Inspected
Condition	2 - Between Good and Fair
Deficiency	No deficiencies recorded
Pavement	
Instance on Rear Of Building	Does not Exist
Play Equipment	
Instance on Rear Of Building	Does not Exist
Safety Surfacing	
Instance on Rear Of Building	Inspected
Condition	2 - Between Good and Fair
Deficiency	No deficiencies recorded
Unpaved Area	
Instance on Rear Of Building	Does not Exist
PLAYING SURFACE	Does not Exist
RETAINING WALLS	Does not Exist
SEATING	Does not Exist
SITE WALLS (NOT RETAINING WALLS)	Inspected
Condition	3 - Fair
Deficiency	BRICK: BULGING/DISPLACED
Deficiency Location/Instance	Corona Avenue near Playground entrance

Deficiency Quantity	80
Quantity Uom	S.F.
Potential Action	REPLACE
Urgency of Action	PRIORITY 5
Purpose of Action	LEVEL 6
