**NYC Department of Education**  
**Building Condition Assessment Survey 2023 - 2024**

Architectural Inspection

**Asset:**        **PRE-K CENTER @ 46-16 76TH STREET - QUEENS, 46-16 76 STREET, New York, 11373**

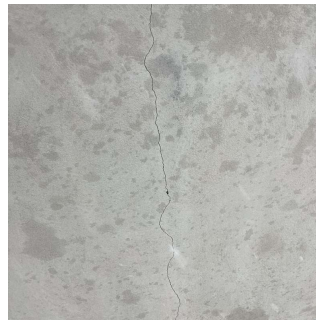
Roof 1  
 No violations recorded.

Instance Condition	3 - Fair
Instance Quantity	800
Instance Quantity Uom	C.F.
Deficiency	CONCRETE: MINOR CRACKS, SPALLING
Roof Plan reference	Q378

Deficiency Quantity	20
Quantity Uom	S.F.
Potential Action	REPAIR
Urgency of Action	PRIORITY 3
Purpose of Action	LEVEL 2
Deficiency Photo1

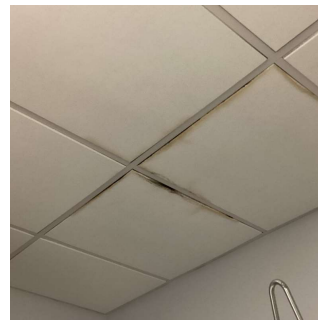
Roof 1 - Room 108A

Deficiency	MODIFIED BITUMEN: ROOFING: MAJOR ACTIVE ROOF LEAKS IN INSTRUCTIONAL SPACE
------------	---

Deficiency Quantity	100
Quantity Uom	S.F.
Potential Action	REPLACE ROOFING WITHOUT MAJOR EQUIPMENT REMOVAL
Urgency of Action	PRIORITY 5
Purpose of Action	LEVEL 2
Deficiency Photo1

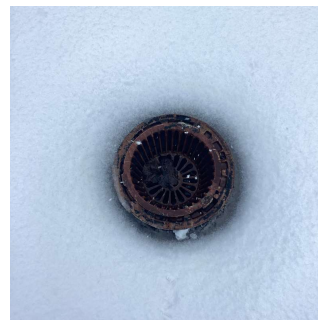
Roof 1  
No violations recorded.

Condition	4 - Between Fair and Poor
-----------	---------------------------

Deficiency	DETERIORATED
------------	--------------

2  
EACH  
REPLACE  
PRIORITY 4  
LEVEL 2

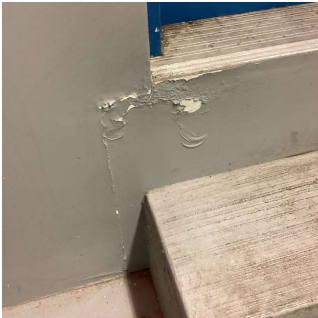
BULKHEAD/PENTHOUSE WALLS/INTERIOR: GYPSUM BOARD DAMAGED/DETERIORATED

10  
S.F.  
REPLACE  
PRIORITY 3  
LEVEL 2

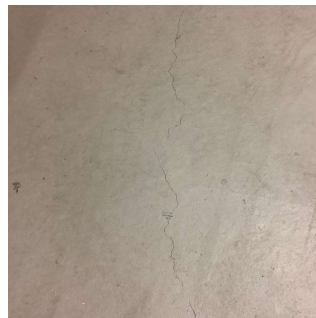
Deficiency	No deficiencies recorded
<b>FLOOR STRUCTURE</b>	Inspected
Condition	3 - Fair
Deficiency	CONCRETE: CRACKS/SPALLED/REINFORCEMENT EXPOSED
Deficiency Location/Instance	PH
Deficiency Quantity	20
Quantity Uom	S.F.
Potential Action	REPAIR
Urgency of Action	PRIORITY 3
Purpose of Action	LEVEL 5
Deficiency Photo1

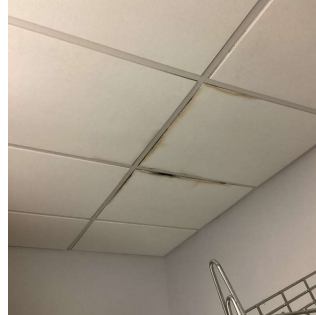
Room 108B

Deficiency	ACOUSTIC TILES: DAMAGED/MISSING - ACTIVE LEAK
Deficiency Location/Instance	Room 108A
Deficiency Quantity	10
Quantity Uom	S.F.
Potential Action	REPLACE

Urgency of Action	PRIORITY 5
Purpose of Action	LEVEL 2
Deficiency Photo1

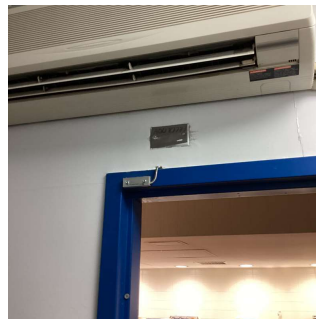
Instance on 1st Floor	Inspected
Condition	2 - Between Good and Fair
Deficiency	GYPSUM BOARD: DETERIORATED
Deficiency Location/Instance	Room 108B
Deficiency Quantity	10
Quantity Uom	S.F.
Potential Action	REPLACE
Urgency of Action	PRIORITY 3
Purpose of Action	LEVEL 2
Deficiency Photo1

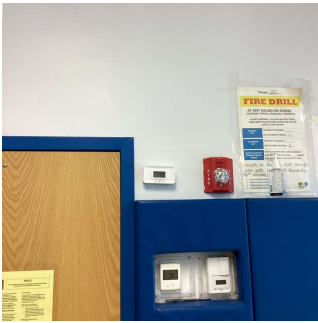
Deficiency	GYPSUM BOARD: DETERIORATED
Deficiency Location/Instance	Near Entrance
Deficiency Quantity	10
Quantity Uom	S.F.
Potential Action	REPLACE
Urgency of Action	PRIORITY 3
Purpose of Action	LEVEL 2

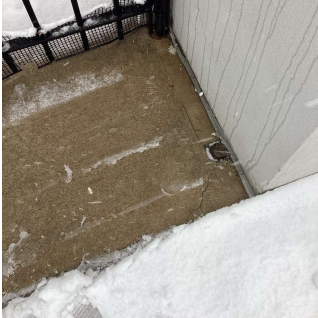
<b>Asphalt</b>	Does not Exist
<b>Concrete</b>	Inspected
Condition	2 - Between Good and Fair
Deficiency	CRACKS - MAJOR
Deficiency Location/Instance	76th Street
Deficiency Quantity	25
Quantity Uom	S.F.
Potential Action	REPLACE
Urgency of Action	PRIORITY 3
Purpose of Action	LEVEL 2
Deficiency Photo1

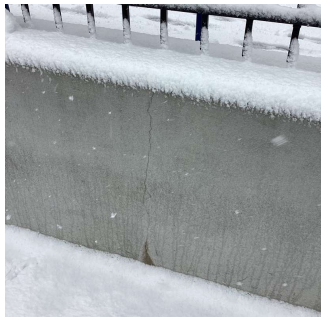
Question	Response
<b>SITE</b>	
<b>PAVING</b>	Inspected
<b>DOT Sidewalk</b>	
<b>Asphalt</b>	Does not Exist
<b>Concrete</b>	Inaccessible
<b>Pavers</b>	Does not Exist
<b>PLAYGROUNDS</b>	Inspected
Instance on Main Entrance	Inspected
<b>Benches</b>	
Instance on Main Entrance	Inspected
Condition	2 - Between Good and Fair
Deficiency	No deficiencies recorded
<b>Fence</b>	
Instance on Main Entrance	Inspected
Condition	2 - Between Good and Fair
Deficiency	No deficiencies recorded
<b>Pavement</b>	
Instance on Main Entrance	Inaccessible
<b>Play Equipment</b>	
Instance on Main Entrance	Inaccessible
<b>Safety Surfacing</b>	
Instance on Main Entrance	Inaccessible
<b>Unpaved Area</b>	
Instance on Main Entrance	Does not Exist
<b>PLAYING SURFACE</b>	Does not Exist
<b>RETAINING WALLS</b>	Inspected
Are there any Retaining Walls 6' OR higher facing public street/sidewalk?	No
Condition	3 - Fair
Deficiency	CAST IN PLACE CONCRETE: CRACKS/SPALLING - MAJOR

Deficiency Location/Instance	76th Street
Deficiency Quantity	80
Quantity Uom	S.F.
Potential Action	REPLACE
Urgency of Action	PRIORITY 3
Purpose of Action	LEVEL 2
Deficiency Photo1
