NYC Department of Education
Building Condition Assessment Survey 2023 - 2024

Architectural Inspection

Asset: **PRE-K CENTER @ 168-42 JAMAICA AVENUE - QUEENS, 168-42 JAMAICA AVENUE, New York, 11432**

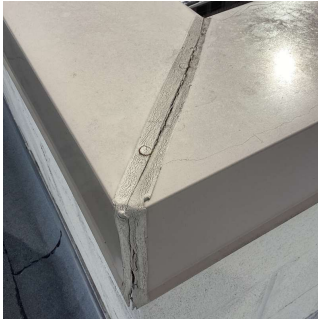
Question	Response
Architectural	
EXTERIOR	Inspected
AREAWAY	Does not Exist
AWNINGS AND CANOPIES	Does not Exist
CHIMNEY	Inspected
Material Type(s)	Metal
Condition	2 - Between Good and Fair
Deficiency	No deficiencies recorded
COPING	Inspected
Condition	2 - Between Good and Fair
Deficiency	METAL: DETERIORATED TRANSVERSE JOINTS
Roof Plan reference

30
L.F.
MAINTENANCE
PRIORITY 3
LEVEL 2

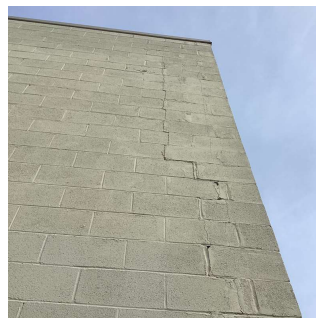
Question	Response
EXTERIOR	
DOORS	
LINTELS	Inspected
Condition	2 - Between Good and Fair
Deficiency	No deficiencies recorded
TRANSOM/SIDE LIGHT	Inspected
Condition	2 - Between Good and Fair
Deficiency	No deficiencies recorded
EXTERIOR WALLS	Inspected
Material Type(s)	Masonry, Concrete
Replacement Quantity	7,500
Replacement Uom	S.F.
Instance on All Facades	Inspected
Instance Condition	4 - Between Fair and Poor
Instance Quantity	7,500
Instance Quantity Uom	S.F.
Deficiency	CONCRETE MASONRY UNIT: MAJOR / THRU CRACKS
Roof Plan reference

100
S.F.
REMOVE AND REBUILD
PRIORITY 4
LEVEL 2

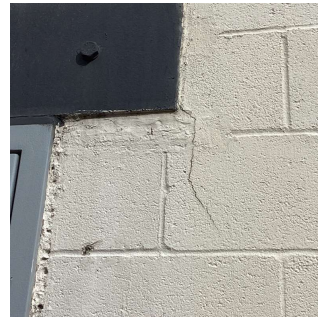
Facade D

CONCRETE MASONRY UNIT: MINOR CRACKS AND SPALLING

50

RESTITCH

PRIORITY 3

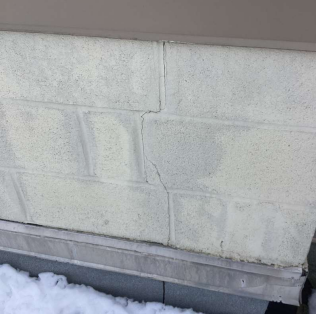
Question	Response
EXTERIOR	
PARAPETS	
Instance on All Facades	Inspected
Instance Condition	3 - Fair
Instance Quantity	1,850
Instance Quantity Uom	C.F.
Deficiency	CONCRETE MASONRY UNITS: MINOR CRACKS, SPALLING
Roof Plan reference

Deficiency Quantity	30
Quantity Uom	S.F.
Potential Action	REPAIR
Urgency of Action	PRIORITY 3
Purpose of Action	LEVEL 2
Deficiency Photo1

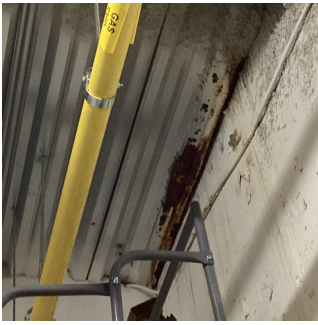
Question	Response
EXTERIOR	
WINDOWS	
WINDOWS	Inspected
Material Type(s)	Aluminum
Instance on Aluminum - Other: Facades A, C	Inspected
Instance Condition	2 - Between Good and Fair
Instance Quantity	600
Instance Quantity Uom	S.F.
Are these windows insulated	Yes
Installation Year	2015
Source of Installation	Custodial Staff
Deficiency	No deficiencies recorded
INTERIOR	Inspected
POOLS	Does not Exist
STRUCTURAL	Inspected
COLUMNS/BEAMS/BEARING WALLS	Inspected
Condition	2 - Between Good and Fair
Deficiency	No deficiencies recorded
FLOOR STRUCTURE	Inspected
Condition	2 - Between Good and Fair
Deficiency	METAL DECK AND CONCRETE: DETERIORATED
Deficiency Location/Instance	Basement - Water/Gas Meter Room
Deficiency Quantity	10
Quantity Uom	S.F.
Potential Action	REPAIR
Urgency of Action	PRIORITY 3
Purpose of Action	LEVEL 5
Deficiency Photo1

Violations	Basement - Water/Gas Meter Room No violations recorded.
FOUNDATION WALLS	Inspected

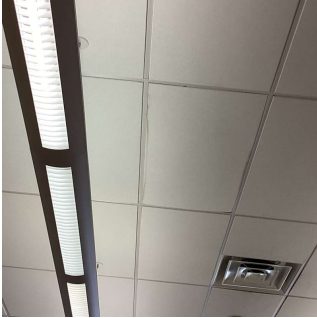
Question	Response
INTERIOR	
CLASSROOMS/CORRIDORS/ADMIN SPACES	
Ceiling	Inspected
Condition	2 - Between Good and Fair
Deficiency	ACOUSTIC TILES: DAMAGED/MISSING
Deficiency Location/Instance	Room 103
Deficiency Quantity	10
Quantity Uom	S.F.
Potential Action	REPLACE
Urgency of Action	PRIORITY 3
Purpose of Action	LEVEL 2
Deficiency Photo1

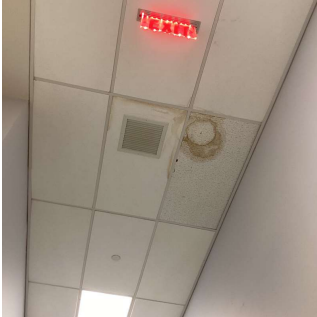
Violations	Room 103 No violations recorded.
Deficiency	ACOUSTIC TILES: DAMAGED/MISSING - ACTIVE LEAK
Deficiency Location/Instance	Corridor near Room 108
Deficiency Quantity	40
Quantity Uom	S.F.
Potential Action	REPLACE
Urgency of Action	PRIORITY 5
Purpose of Action	LEVEL 2
Deficiency Photo1

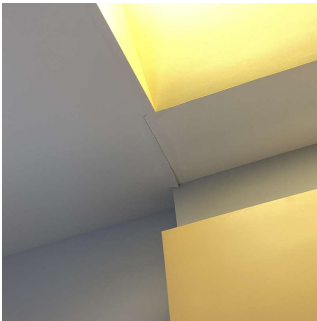
Violations	Corridor near Room 108 No violations recorded.
Deficiency	GYPSUM BOARD: DAMAGED/DETERIORATED - ACTIVE LEAK
Deficiency Location/Instance	Corridor near Room 105
Deficiency Quantity	20
Quantity Uom	S.F.
Potential Action	REPLACE
Urgency of Action	PRIORITY 5
Purpose of Action	LEVEL 2

Violations	Corridor near Room 105 No violations recorded.
Door(s)	Inspected
Condition	2 - Between Good and Fair
Deficiency	No deficiencies recorded
Floor Finish	Inspected
Condition	2 - Between Good and Fair
Deficiency	VINYL TILES: DETERIORATED SUBSTRATE
Deficiency Location/Instance	Corridor near Room 119
Deficiency Quantity	10
Quantity Uom	S.F.
Potential Action	REPLACE
Urgency of Action	PRIORITY 3
Purpose of Action	LEVEL 2
Deficiency Photo1

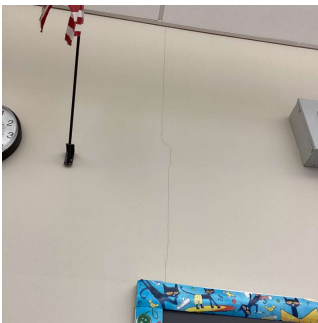
Violations	Corridor near Room 119 No violations recorded.
Walls	Inspected
Condition	2 - Between Good and Fair
Deficiency	GYPSUM BOARD: DETERIORATED
Deficiency Location/Instance	Room 119, Vestibule Playground Exit
Deficiency Quantity	20
Quantity Uom	S.F.
Potential Action	REPLACE
Urgency of Action	PRIORITY 3
Purpose of Action	LEVEL 2

Violations	Room 119 No violations recorded.
Specialties	Does not Exist
GYMNASIUM	Does not Exist
INTERIOR DOOR HARDWARE	Inspected
Condition	2 - Between Good and Fair
Deficiency	No deficiencies recorded
INTERIOR GUARDS	Does not Exist
KITCHEN	Inspected
Instance on 1st Floor	Inspected
Ceiling	
Instance on 1st Floor	Inspected
Condition	2 - Between Good and Fair
Deficiency	No deficiencies recorded
Door(s)	
Instance on 1st Floor	Inspected
Condition	2 - Between Good and Fair
Deficiency	No deficiencies recorded
Floor Finish	
Instance on 1st Floor	Inspected
Condition	2 - Between Good and Fair
Deficiency	No deficiencies recorded
Walls	
Instance on 1st Floor	Inspected
Condition	2 - Between Good and Fair
Deficiency	No deficiencies recorded
LIBRARY	Does not Exist
LOCKER ROOM	Does not Exist
MULTI-PURPOSE ROOM	Inspected
Instance on 1st Floor	Inspected

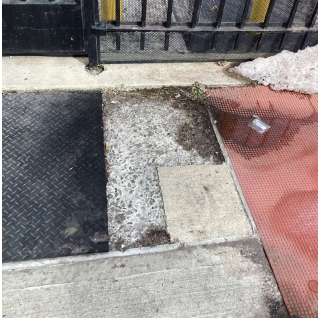
Question	Response
SITE	
DRINKING FOUNTAINS	Does not Exist
FENCES	Inspected
Condition	2 - Between Good and Fair
Deficiency	No deficiencies recorded
IRRIGATION SYSTEM	Does not Exist
PAVING	Inspected
Student Non-Use	Does not Exist
Student Use	Does not Exist
Site Sidewalks & Walkways	Inspected
Asphalt	Does not Exist
Concrete	Inspected
Condition	2 - Between Good and Fair
Deficiency	No deficiencies recorded
Pavers	Does not Exist
DOT Sidewalk	Does not Exist
PLAYGROUNDS	Inspected
Instance on Rear of Building	Inspected
Benches	
Instance on Rear of Building	Does not Exist
Fence	
Instance on Rear of Building	Inspected
Condition	2 - Between Good and Fair
Deficiency	No deficiencies recorded
Pavement	
Instance on Rear of Building	Inspected
Condition	3 - Fair
Deficiency	CONCRETE: DAMAGED/DETERIORATED/MISSING SECTIONS
Deficiency Location/Instance	Near Parking Lot, Ramp
Deficiency Quantity	50
Quantity Uom	S.F.
Potential Action	REPLACE
Urgency of Action	PRIORITY 3

Violations	Near Parking Lot No violations recorded.
Play Equipment	
Instance on Rear of Building	Inspected
Condition	2 - Between Good and Fair
Deficiency	No deficiencies recorded

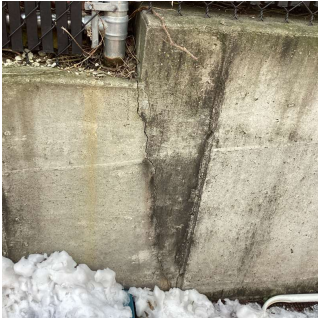
Question	Response
SITE	
PLAYGROUNDS	
Safety Surfacing	
Instance on Rear of Building	Inspected
Condition	2 - Between Good and Fair
Deficiency	No deficiencies recorded
Unpaved Area	
Instance on Rear of Building	Does not Exist
PLAYING SURFACE	
	Does not Exist
RETAINING WALLS	
Are there any Retaining Walls 6' OR higher facing public street/sidewalk?	Inspected Yes
Condition	3 - Fair
Deficiency	CAST IN PLACE CONCRETE: CRACKS/SPALLING - MAJOR
Deficiency Location/Instance	Near Playground Stairs, Slider, Ramp
Deficiency Quantity	30
Quantity Uom	S.F.
Potential Action	REPLACE
Urgency of Action	PRIORITY 3
Purpose of Action	LEVEL 2
Deficiency Photo1

Near Slider
Violations	No violations recorded.
SEATING	
	Does not Exist
SITE WALLS (NOT RETAINING WALLS)	
	Does not Exist
STAIRS/RAMPS: EXTERIOR	
Railings	
	Inspected
Condition	2 - Between Good and Fair
Deficiency	No deficiencies recorded
Site Cheek/flank Walls	
Condition	Inspected 2 - Between Good and Fair

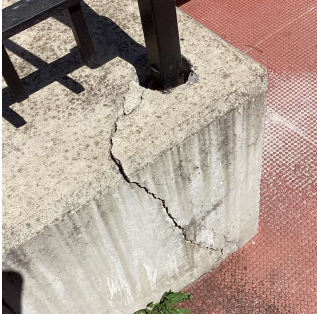
Deficiency	CAST IN PLACE CONCRETE: CRACKS/SPALLING - MAJOR
Deficiency Location/Instance	Ramp at Playground
Deficiency Quantity	20
Quantity Uom	S.F.
Potential Action	REPLACE
Urgency of Action	PRIORITY 3
Purpose of Action	LEVEL 2

Violations	Ramp at Playground No violations recorded.
Stairs/ramps	Inspected
Condition	2 - Between Good and Fair
Deficiency	CAST IN PLACE CONCRETE: CRACKS/SPALLING - MINOR
Deficiency Location/Instance	Ramp at Playground
Deficiency Quantity	10
Quantity Uom	S.F.
Potential Action	REPAIR
Urgency of Action	PRIORITY 3
Purpose of Action	LEVEL 2
Deficiency Photo1	No photo recorded
Violations	No violations recorded.
ARTWORK	Does not Exist
