NYC Department of Education
Building Condition Assessment Survey 2023 - 2024

Architectural Inspection

Q382

Asset: **PRE-K CENTER @ 89-14 PARSONS BOULEVARD - QUEENS, 89-14 PARSONS BOULEVARD, New York, 11432**

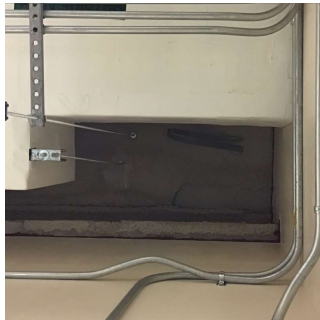
Question	Response
EXTERIOR	
WINDOWS	
WINDOWS	
Instance Quantity	480
Instance Quantity Uom	S.F.
Are these windows insulated	Yes
Installation Year	2015
Source of Installation	Custodial Staff
Deficiency	No deficiencies recorded
INTERIOR	Inspected
POOLS	Does not Exist
STRUCTURAL	Inspected
COLUMNS/BEAMS/BEARING WALLS	Inspected
Condition	2 - Between Good and Fair
Deficiency	No deficiencies recorded
FLOOR STRUCTURE	Inspected
Condition	2 - Between Good and Fair
Deficiency	CONCRETE: CRACKS/SPALLED/REINFORCEMENT EXPOSED
Deficiency Location/Instance	Room 112
Deficiency Quantity	20
Quantity Uom	S.F.
Potential Action	REPAIR
Urgency of Action	PRIORITY 3
Purpose of Action	LEVEL 5
Deficiency Photo1

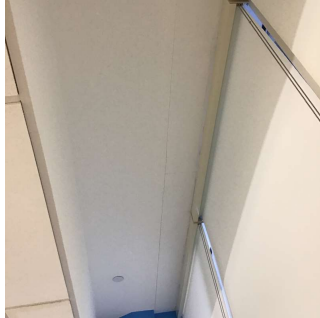
Condition	2 - Between Good and Fair
Deficiency	GYPSON BOARD: DAMAGED/DETERIORATED
Deficiency Location/Instance	Room 105
Deficiency Quantity	20
Quantity Uom	S.F.
Potential Action	REPLACE
Urgency of Action	PRIORITY 3

Question	Response
INTERIOR	
CLASSROOMS/CORRIDORS/ADMIN SPACES	
Ceiling	
Purpose of Action	LEVEL 2
Deficiency Photo1

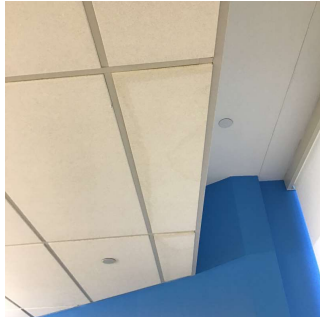
Violations	Room 105 No violations recorded.
Deficiency	ACOUSTIC TILES: DAMAGED/MISSING
Deficiency Location/Instance	Room 105
Deficiency Quantity	10
Quantity Uom	S.F.
Potential Action	REPLACE
Urgency of Action	PRIORITY 3
Purpose of Action	LEVEL 2
Deficiency Photo1

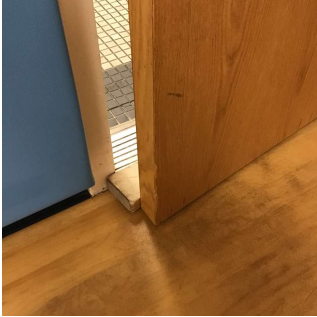
Question	Response
INTERIOR	
TOILET ROOMS - STAFF	Inspected
Walls	Inspected
Condition	2 - Between Good and Fair
Deficiency	No deficiencies recorded
TOILET ROOMS - STUDENTS	Inspected
Ceiling	Inspected
Condition	2 - Between Good and Fair
Deficiency	No deficiencies recorded
Door(s)	Inspected
Condition	5 - Poor
Deficiency	WOOD: DETERIORATED DOOR
Deficiency Location/Instance	Room 102A
Deficiency Quantity	1
Quantity Uom	EACH
Potential Action	MAINTENANCE
Urgency of Action	PRIORITY 3
Purpose of Action	LEVEL 2
Deficiency Photo1
