**NYC Department of Education**  
**Building Condition Assessment Survey 2023 - 2024**

Architectural Inspection

Q383

**Asset:**        **PRE-K CENTER @ 132-10 JAMAICA AVENUE - QUEENS, 132-10 JAMAICA AVENUE,  
New York, 11418**

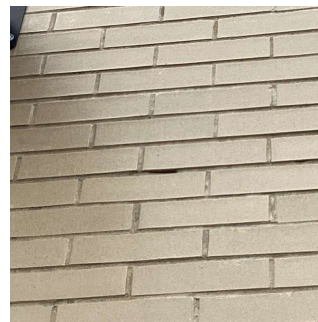
Facade A

BRICK: DETERIORATED JOINTS

Deficiency Quantity

10

REPOINT

PRIORITY 3

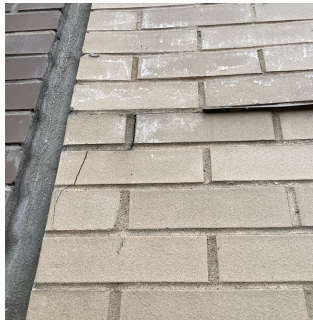
Facade A

BRICK: MINOR CRACKS AND SPALLING

Deficiency Quantity

20

RESTITCH

PRIORITY 3

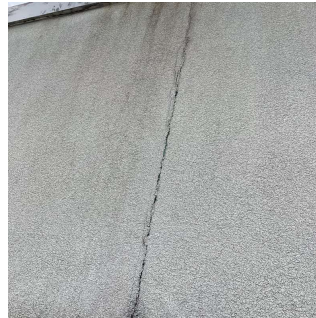
Facade J

STUCCO CEMENT SURFACE: CRACKS, SPALLING

Deficiency Quantity

30

REPLACE

PRIORITY 4  
LEVEL 2

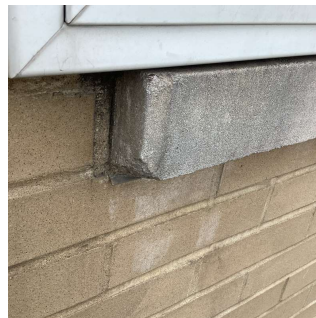
Facade A

**BRICK: DETERIORATED MASONRY SILLS - MINOR**

Deficiency Quantity

10

REPAIR

PRIORITY 3

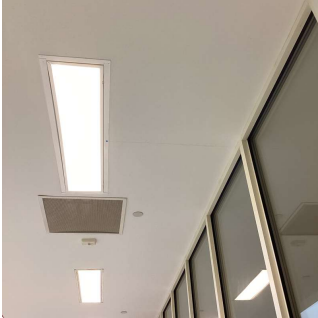
Question	Response
<b>INTERIOR</b>	
<b>STRUCTURAL</b>	Inspected
<b>ROOF STRUCTURE</b>	Inspected
Condition	2 - Between Good and Fair
Deficiency	No deficiencies recorded
<b>VAULTS-BUNKERS</b>	Does not Exist
<b>AUDITORIUM</b>	Does not Exist
<b>CAFETERIA</b>	Does not Exist
<b>CLASSROOMS/CORRIDORS/ADMIN SPACES</b>	Inspected
<b>Ceiling</b>	Inspected
Condition	2 - Between Good and Fair
Deficiency	GYPSUM BOARD: DAMAGED/DETERIORATED
Deficiency Location/Instance	Corridor near Rooms 114, 109, 108, Main Entrance Lobby
Deficiency Quantity	40
Quantity Uom	S.F.
Potential Action	REPLACE
Urgency of Action	PRIORITY 3
Purpose of Action	LEVEL 2
Deficiency Photo1

Violations	Corridor near Room 109 No violations recorded.
<b>Door(s)</b>	Inspected
Condition	2 - Between Good and Fair
Deficiency	No deficiencies recorded
<b>Floor Finish</b>	Inspected
Condition	2 - Between Good and Fair
Deficiency	VINYL TILES: DETERIORATED SUBSTRATE
Deficiency Location/Instance	Corridor near Room 109, Atrium, Main Entrance Lobby, Room 114

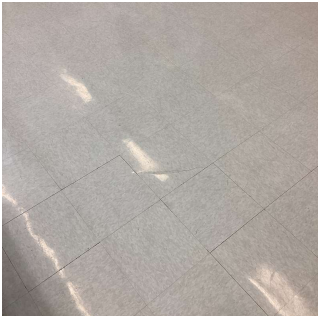
Deficiency Quantity	40
Quantity Uom	S.F.
Potential Action	REPLACE
Urgency of Action	PRIORITY 3
Purpose of Action	LEVEL 2
Deficiency Photo1

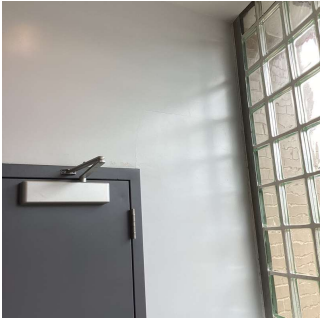
Question	Response
<b>INTERIOR</b>	
<b>CLASSROOMS/CORRIDORS/ADMIN SPACES</b>	
<b>Floor Finish</b>	Inspected
	Corridor near Room 109
Violations	No violations recorded.
<b>Walls</b>	Inspected
Condition	2 - Between Good and Fair
Deficiency	GYPSUM BOARD: DETERIORATED
Deficiency Location/Instance	Corridor near Room 101
Deficiency Quantity	10
Quantity Uom	S.F.
Potential Action	REPLACE
Urgency of Action	PRIORITY 3
Purpose of Action	LEVEL 2
Deficiency Photo1

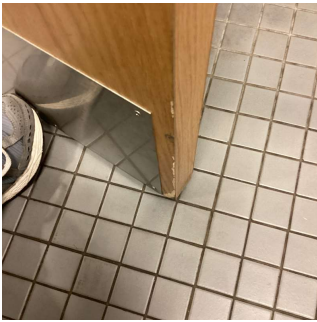
Question	Response
<b>INTERIOR</b>	
<b>STAIRS/RAMPS: INTERIOR</b>	Does not Exist
<b>TOILET ROOMS - STAFF</b>	Inspected
<b>Ceiling</b>	Inspected
Condition	2 - Between Good and Fair
Deficiency	No deficiencies recorded
<b>Door(s)</b>	Inspected
Condition	5 - Poor
Deficiency	WOOD: DETERIORATED DOOR
Deficiency Location/Instance	Room 117
Deficiency Quantity	1
Quantity Uom	EACH
Potential Action	MAINTENANCE
Urgency of Action	PRIORITY 3
Purpose of Action	LEVEL 2
Deficiency Photo1

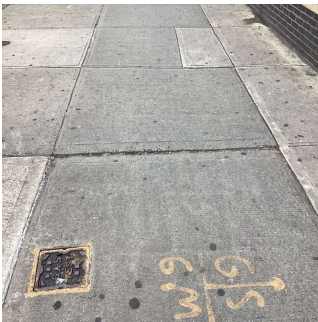
<b>Concrete</b>	Inspected
Condition	3 - Fair
Deficiency	HEAVING
Deficiency Location/Instance	Jamaica Avenue
Deficiency Quantity	50
Quantity Uom	S.F.
Potential Action	REPLACE
Urgency of Action	PRIORITY 3
Purpose of Action	LEVEL 2
Deficiency Photo1

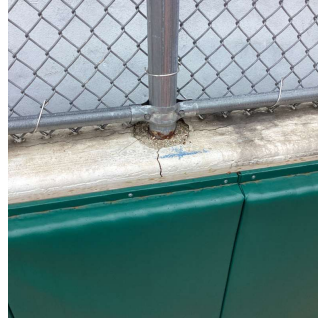
Question	Response
<b>SITE</b>	
<b>PAVING</b>	
<b>DOT Sidewalk</b>	
<b>Concrete</b>	
Potential Action	REPLACE
Urgency of Action	PRIORITY 3
Purpose of Action	LEVEL 2
Deficiency Photo1	 
	Jamaica Avenue
Violations	No violations recorded.
<b>Pavers</b>	Does not Exist
<b>PLAYGROUNDS</b>	Inspected
Instance on Rear Yard	Inspected
<b>Benches</b>	
Instance on Rear Yard	Does not Exist
<b>Fence</b>	
Instance on Rear Yard	Does not Exist
<b>Pavement</b>	
Instance on Rear Yard	Does not Exist
<b>Play Equipment</b>	
Instance on Rear Yard	Does not Exist
<b>Safety Surfacing</b>	
Instance on Rear Yard	Inspected
Condition	2 - Between Good and Fair
Deficiency	No deficiencies recorded
<b>Unpaved Area</b>	
Instance on Rear Yard	Does not Exist
<b>PLAYING SURFACE</b>	Does not Exist
<b>RETAINING WALLS</b>	Does not Exist
<b>SEATING</b>	Does not Exist
<b>SITE WALLS (NOT RETAINING WALLS)</b>	Inspected
Condition	3 - Fair
Deficiency	CAST IN PLACE CONCRETE: CRACKS/SPALLING - MAJOR

Deficiency Location/Instance	Playground Area
Deficiency Quantity	40
Quantity Uom	S.F.
Potential Action	REPLACE
Urgency of Action	PRIORITY 3
Purpose of Action	LEVEL 2
