NYC Department of Education
Building Condition Assessment Survey 2023 - 2024

Architectural Inspection

Q387

Asset: **PRE-K CENTER @ 100-01 SPRINGFIELD BOULEVARD - QUEENS, 100-01**
SPRINGFIELD BOULEVARD, New York, 10429

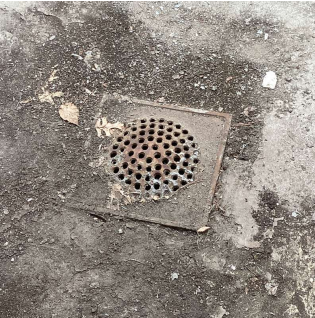
Question	Response
EXTERIOR	
AREAWAY	
Instance Quantity	3
Instance Quantity Uom	EACH
Deficiency	AREAWAY DRAINS: CLOGGED
Roof Plan reference

Deficiency Quantity	1
Quantity Uom	EACH
Potential Action	MAINTENANCE
Urgency of Action	PRIORITY 5
Purpose of Action	LEVEL 2
Deficiency Photo1

Violations	<p>Facade C - AW1</p> <p>No violations recorded.</p>
AWNINGS AND CANOPIES	
Condition	Inspected
Deficiency	2 - Between Good and Fair
Deficiency	No deficiencies recorded
CHIMNEY	
Material Type(s)	Inspected
Condition	Masonry
Condition	3 - Fair
Deficiency	BRICK: DETERIORATED JOINTS
Roof Plan reference

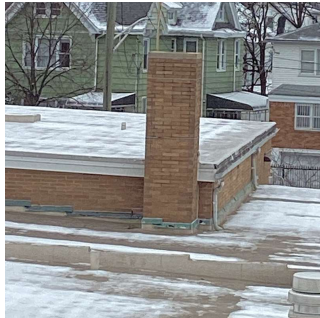
Deficiency Quantity	30
Quantity Uom	S.F.
Potential Action	REPOINT

Question	Response
EXTERIOR	
CHIMNEY	
Urgency of Action	PRIORITY 3
Purpose of Action	LEVEL 2
Deficiency Photo1

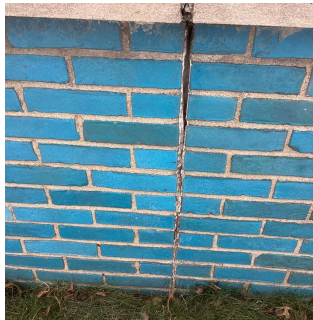
Facade B

Deficiency Quantity

10

Potential Action

MAINTENANCE

PRIORITY 3

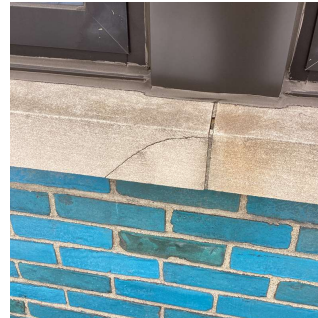
Facade B

BRICK: DETERIORATED MASONRY SILLS - MINOR

REPAIR

PRIORITY 3
LEVEL 2

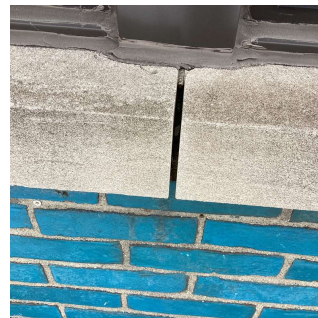
Facade B

BRICK: MASONRY SILLS - DETERIORATED JOINTS

REPOINT

PRIORITY 3

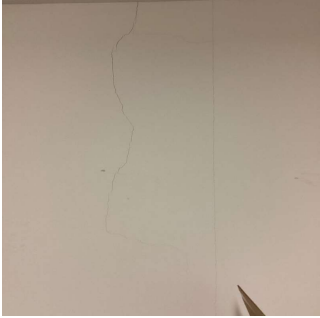
Question	Response
INTERIOR	
KITCHEN	
Floor Finish	
Instance on 1st Floor	Inspected
Condition	2 - Between Good and Fair
Deficiency	No deficiencies recorded
Walls	
Instance on 1st Floor	Inspected
Condition	2 - Between Good and Fair
Deficiency	GYPSUM BOARD: DETERIORATED
Deficiency Location/Instance	Room 1-3B
Deficiency Quantity	10
Quantity Uom	S.F.
Potential Action	REPLACE
Urgency of Action	PRIORITY 3
Purpose of Action	LEVEL 2
Deficiency Photo1

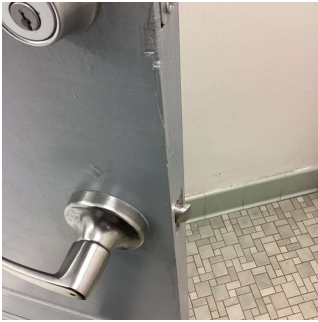
Room 1-13
Violations	No violations recorded.
Floor Finish	
Floor Finish	Inspected
Condition	3 - Fair
Deficiency	CERAMIC TILE: BROKEN/MISSING TILES
Deficiency Location/Instance	Room 1-25
Deficiency Quantity	10
Quantity Uom	S.F.
Potential Action	REPLACE

Question	Response
INTERIOR	
STAIRS/RAMPS: INTERIOR	
Railings	Inspected
Condition	2 - Between Good and Fair
Deficiency	No deficiencies recorded
Stairs and Landings	Inspected
Condition	2 - Between Good and Fair
Deficiency	No deficiencies recorded
Walls	Inspected
Condition	2 - Between Good and Fair
Deficiency	No deficiencies recorded
TOILET ROOMS - STAFF	
Ceiling	Inspected
Condition	2 - Between Good and Fair
Deficiency	No deficiencies recorded
Door(s)	Inspected
Condition	5 - Poor
Deficiency	WOOD: DETERIORATED DOOR
Deficiency Location/Instance	Room 1-13
Deficiency Quantity	1
Quantity Uom	EACH
Potential Action	MAINTENANCE
Urgency of Action	PRIORITY 3
Purpose of Action	LEVEL 2
Deficiency Photo1

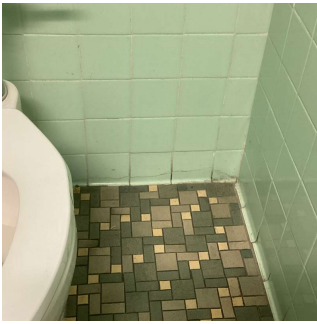
Room 1-23
Violations	No violations recorded.
Deficiency	PLASTER: CRACKS/SPALLING
Deficiency Location/Instance	Rooms 1-11, 1-13
Deficiency Quantity	20
Quantity Uom	S.F.
Potential Action	REPLACE
Urgency of Action	PRIORITY 3
Purpose of Action	LEVEL 2

Room 1-25
Violations	No violations recorded.
Stalls	Inspected
Condition	2 - Between Good and Fair
Deficiency	No deficiencies recorded
Walls	Inspected
Condition	2 - Between Good and Fair
Deficiency	CERAMIC TILE: BROKEN/ MISSING
Deficiency Location/Instance	Rooms 1-23, 1-25
Deficiency Quantity	10
Quantity Uom	S.F.
Potential Action	REPLACE
Urgency of Action	PRIORITY 3
Purpose of Action	LEVEL 2
Deficiency Photo1

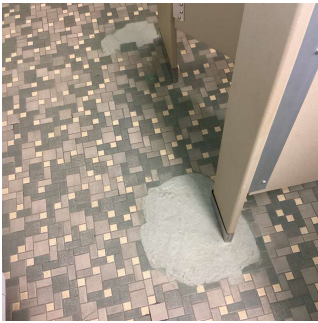
Question	Response
INTERIOR	
TOILET ROOMS - STUDENTS	
Floor Finish	
Deficiency Photo1

Violations	Room 2-3 No violations recorded.
Stalls	Inspected
Condition	2 - Between Good and Fair
Deficiency	No deficiencies recorded
Walls	Inspected
Condition	2 - Between Good and Fair
Deficiency	PLASTER: CRACKS/SPALLING
Deficiency Location/Instance	Room 1-15
Deficiency Quantity	10
Quantity Uom	S.F.
Potential Action	REPLACE
Urgency of Action	PRIORITY 3
Purpose of Action	LEVEL 2
Deficiency Photo1

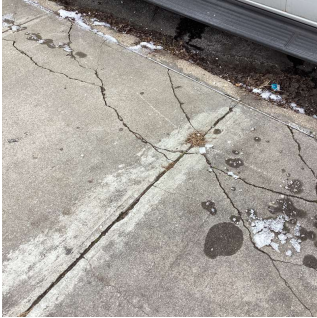
Question	Response
SITE	
PAVING	
Student Non-Use	
Asphalt	
Deficiency Photo1	 
	Rear of Building
Violations	No violations recorded.
Concrete	Inspected
Condition	2 - Between Good and Fair
Deficiency	No deficiencies recorded
Pavers	Does not Exist
Student Use	Does not Exist
Site Sidewalks & Walkways	Inspected
Asphalt	Does not Exist
Concrete	Inspected
Condition	3 - Fair
Deficiency	DAMAGED/DETERIORATED/MISSING SECTIONS
Deficiency Location/Instance	Near Main Entrance, 100th Avenue
Deficiency Quantity	100
Quantity Uom	S.F.
Potential Action	REPLACE
Urgency of Action	PRIORITY 3
Purpose of Action	LEVEL 2
Deficiency Photo1	 
	Near Main Entrance
Violations	No violations recorded.
Pavers	Does not Exist
DOT Sidewalk	Inspected
Asphalt	Does not Exist
Concrete	Inspected
Condition	4 - Between Fair and Poor
Deficiency	DAMAGED/DETERIORATED/MISSING SECTIONS
Deficiency Location/Instance	100th Avenue

Question	Response
SITE	
PAVING	
DOT Sidewalk	
Concrete	
Deficiency Quantity	625
Quantity Uom	S.F.
Potential Action	REPLACE
Urgency of Action	PRIORITY 3
Purpose of Action	LEVEL 2
Deficiency Photo1
