NYC Department of Education
Building Condition Assessment Survey 2023 - 2024

Architectural Inspection

Asset: **PRE-K CENTER @ 96-10 23RD AVENUE - QUEENS, 96-10 23 AVENUE, New York, 11369**

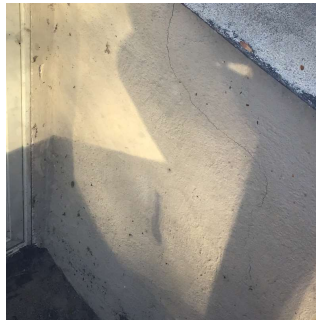
AW4
No violations recorded.

Question	Response
Architectural	
EXTERIOR	Inspected
AREAWAY	Inspected
Instance on AW1 - AW6	Inspected
Instance Condition	3 - Fair
Instance Quantity	6
Instance Quantity Uom	EACH
Deficiency	AREAWAY WALLS: CRACKS AND SPALLING

10
S.F.
REPLACE
PRIORITY 4
LEVEL 2

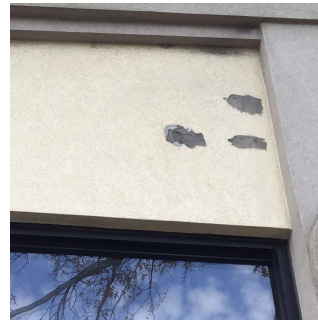
Facade A

Question	Response
EXTERIOR	
EXTERIOR WALLS	
Replacement Uom	S.F.
Instance on All Facades	Inspected
Instance Condition	3 - Fair
Instance Quantity	6,000
Instance Quantity Uom	S.F.
Deficiency	CONCRETE MASONRY UNIT: MAJOR / THRU CRACKS
Roof Plan reference	 
Elevation	 
Deficiency Quantity	30
Quantity Uom	S.F.
Potential Action	REMOVE AND REBUILD
Urgency of Action	PRIORITY 4
Purpose of Action	LEVEL 2
Deficiency Photo1	 
Violations	Facade C No violations recorded.
Deficiency	STUCCO CEMENT SURFACE: CRACKS, SPALLING

30

REPLACE

PRIORITY 4

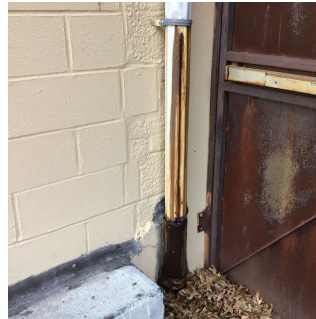
Facade C
No violations recorded.

Question	Response
EXTERIOR	
PARAPETS	Inspected
Deficiency	No deficiencies recorded
PLAZA DECK	Does not Exist
ROOF	Inspected
Roofing	Inspected
Replacement Quantity	11,000
Replacement Uom	S.F.
ROOF HATCH/SMOKE HATCH	Inspected
Condition	2 - Between Good and Fair
Deficiency	No deficiencies recorded
LEADERS, GUTTERS, DOWNSPOUTS, SCUPPERS	Inspected
Condition	3 - Fair
Deficiency	DAMAGED/MISSING
Roof Plan reference

10
L.F.
REPLACE
PRIORITY 4
LEVEL 2

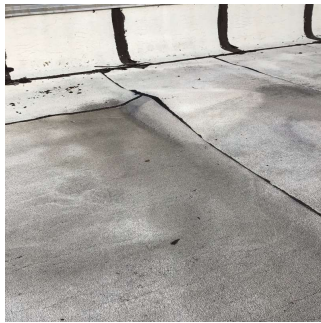
Roof 1
Violations	No violations recorded.
Deficiency	MODIFIED BITUMEN: ROOFING: MAJOR ACTIVE ROOF LEAKS IN NON-INSTRUCTIONAL SPACE

Roof 1
Instance Quantity	11,000
Instance Quantity Uom	S.F.
Does the roof have major mechanical equipment sitting on Dunnage Steel less than 18" above the Roofing?	Yes
Does this roof instance have a Sustainable Roof System?	Yes
Sustainable Roof Type	White Roof
Sustainable Roof Location (Roof Number)	Roof 1
Do solar panels exist on these roofs?	No
Is/Are the roof(s) suitable for Solar Panel installation?	Yes
Installation Year	2015
Source of Installation	Custodial Staff
Deficiency	MODIFIED BITUMEN: ROOFING: DELAMINATION
Roof Plan reference

Deficiency Quantity	300
Quantity Uom	S.F.
Potential Action	REPLACE ROOFING WITHOUT MAJOR EQUIPMENT REMOVAL
Urgency of Action	PRIORITY 4
Purpose of Action	LEVEL 2
Deficiency Photo1

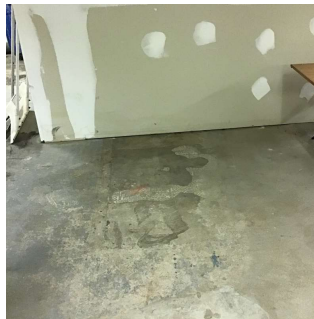
Roof 1 - Basement Elevator Shaft
No violations recorded.

100
S.F.
REPLACE ROOFING WITHOUT MAJOR EQUIPMENT
REMOVAL
PRIORITY 5
LEVEL 2

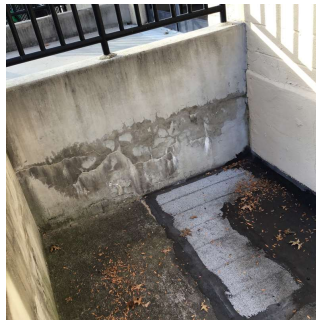
Facade C
No violations recorded.

Question	Response
EXTERIOR	
ROOF	Inspected
Specialties	Inspected
ROOF/GRAVITY TANK	Does not Exist
STAIRS/RAMPS: EXTERIOR	Inspected
BUILDING CHEEK/FLANK WALLS	Inspected
Condition	3 - Fair
Deficiency	CAST IN PLACE CONCRETE: CRACKS/SPALLING - MAJOR
Roof Plan reference

15
S.F.
REPLACE
PRIORITY 4
LEVEL 2

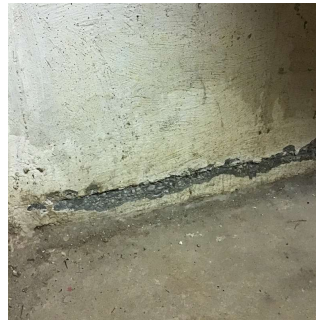
Basement - Electrical Room

CONCRETE: CRACKED/SPALLED/REINFORCEMENT EXPOSED

Basement - Boiler Room, Electrical Room

REPAIR

PRIORITY 3

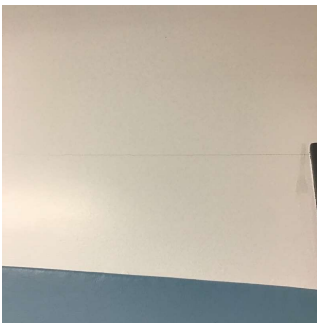
Walls	
Instance on 1st Floor (900 SF)	Inspected
Condition	2 - Between Good and Fair
Deficiency	PLASTER: CRACKS/SPALLING
Deficiency Location/Instance	Near Entrance
Deficiency Quantity	10
Quantity Uom	S.F.
Potential Action	REPLACE
Urgency of Action	PRIORITY 3
Purpose of Action	LEVEL 2

Violations	Near Entrance No violations recorded.
Window Curtains/Shades/Blinds	
Instance on 1st Floor (900 SF)	Does not Exist
SCIENCE DEMO ROOM	Does not Exist
SCIENCE LAB	Does not Exist
SCIENCE PREP ROOM	Does not Exist
SHOWER ROOM	Does not Exist
STAIRS/RAMPS: INTERIOR	
Do Letter Stair Signs Exist?	Inspected No
Ceiling	Does not Exist
Door(s)	Does not Exist
Partition	Does not Exist
Railings	Does not Exist
Stairs and Landings	Does not Exist
Walls	Does not Exist
TOILET ROOMS - STAFF	
Ceiling	Inspected
Condition	2 - Between Good and Fair
Deficiency	ACOUSTIC TILES: DAMAGED/MISSING
Deficiency Location/Instance	Room 118
Deficiency Quantity	10
Quantity Uom	S.F.
Potential Action	REPLACE
Urgency of Action	PRIORITY 3
Purpose of Action	LEVEL 2
Deficiency Photo1

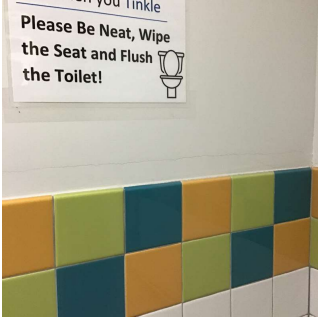
Question	Response
INTERIOR	
TOILET ROOMS - STAFF	
Door(s)	Inspected
Condition	2 - Between Good and Fair
Deficiency	No deficiencies recorded
Floor Finish	Inspected
Condition	2 - Between Good and Fair
Deficiency	No deficiencies recorded
Stalls	Does not Exist
Walls	Inspected
Condition	2 - Between Good and Fair
Deficiency	GYPSUM BOARD: DETERIORATED
Deficiency Location/Instance	Rooms 112, 117
Deficiency Quantity	40
Quantity Uom	S.F.
Potential Action	REPLACE
Urgency of Action	PRIORITY 3
Purpose of Action	LEVEL 2
Deficiency Photo1

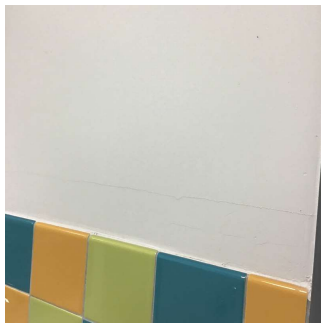
Deficiency	GYPSUM BOARD: DETERIORATED
Deficiency Location/Instance	Rooms 126, 127, 134
Deficiency Quantity	60
Quantity Uom	S.F.
Potential Action	REPLACE
Urgency of Action	PRIORITY 3
Purpose of Action	LEVEL 2

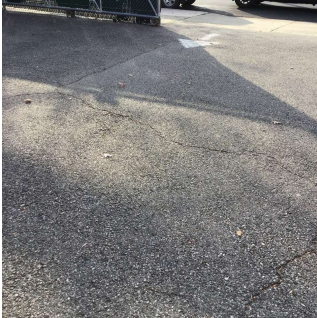
Violations	Room 127 No violations recorded.
LIFE SAFETY	Inspected
F.D. HOLDING AREA	Does not Exist
STEEL STAIRS	Does not Exist
SITE	Inspected
CONTAINERIZATION	Does not Exist
Drainage System for Asphalt	Does not Exist
Drainage System for Concrete	Inspected
Catch Basins/Manhole - Surrounded by concrete	Inspected
Condition	2 - Between Good and Fair
Deficiency	No deficiencies recorded
Culverts - Concrete Covering	Does not Exist
Drainage System for Soil	Does not Exist
DRINKING FOUNTAINS	Does not Exist
FENCES	Inspected
Condition	2 - Between Good and Fair
Deficiency	No deficiencies recorded
IRRIGATION SYSTEM	Does not Exist
PAVING	Inspected
Student Non-Use	Inspected
Gravel Exists?	No
Asphalt	Inspected
Condition	3 - Fair
Deficiency	CRACKS - MAJOR
Deficiency Location/Instance	Parking lot, Driveway
Deficiency Quantity	200
Quantity Uom	S.F.
Potential Action	REPLACE

Urgency of Action	PRIORITY 3
Purpose of Action	LEVEL 2

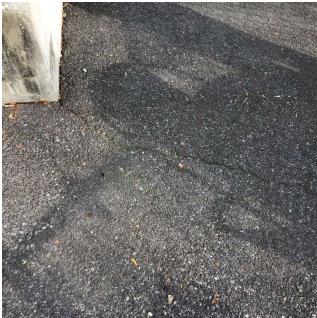
Violations	Near Playground No violations recorded.
Concrete	Does not Exist
Pavers	Does not Exist
DOT Sidewalk	Does not Exist
PLAYGROUNDS	Inspected
Instance on Rear of the building	Inspected
Benches	
Instance on Rear of the building	Does not Exist
Fence

Violations	Parking lot No violations recorded.
Concrete	Inspected
Condition	2 - Between Good and Fair
Deficiency	No deficiencies recorded
Pavers	Does not Exist
Student Use	Does not Exist
Site Sidewalks & Walkways	Inspected
Asphalt	Inspected
Condition	2 - Between Good and Fair
Deficiency	CRACKS - MAJOR
Deficiency Location/Instance	Near Playground
Deficiency Quantity	20
Quantity Uom	S.F.
Potential Action	REPLACE
Urgency of Action	PRIORITY 3
Purpose of Action	LEVEL 2
Deficiency Photo1

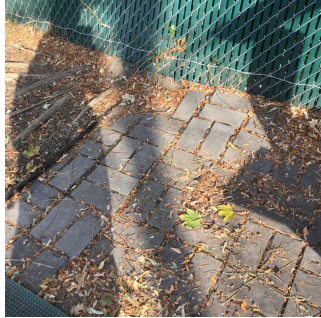
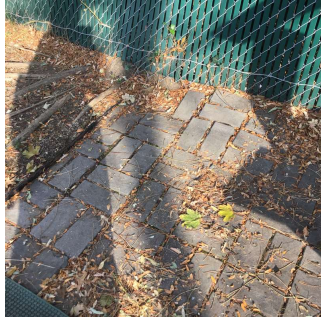
Instance on Rear of the building	Inspected
Condition	2 - Between Good and Fair
Deficiency	PAVERS: HEAVING
Deficiency Location/Instance	Near Neighbors
Deficiency Quantity	10
Quantity Uom	S.F.
Potential Action	REPLACE
Urgency of Action	PRIORITY 3
Purpose of Action	LEVEL 2
Deficiency Photo1

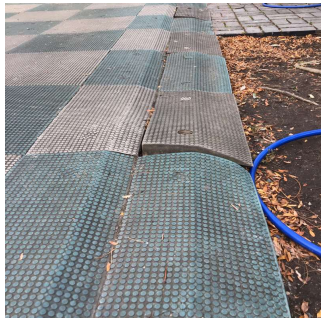
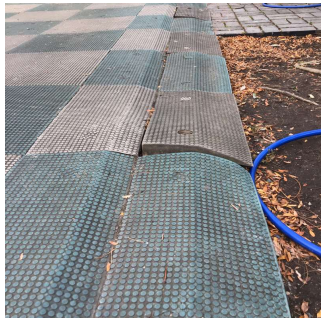
Instance on Rear of the building	Inspected
Condition	3 - Fair
Deficiency	DETERIORATED/MISSING
Deficiency Location/Instance	Near Neighbors
Deficiency Quantity	10
Quantity Uom	S.F.
Potential Action	REPLACE
Urgency of Action	PRIORITY 5
Purpose of Action	LEVEL 6
Deficiency Photo1

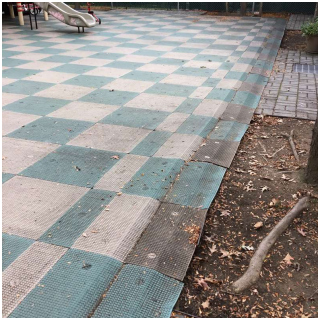
Question	Response
SITE	
PLAYGROUNDS	
Safety Surfacing	
Violations	Near Neighbors No violations recorded.
Deficiency	DETERIORATED/MISSING
Deficiency Location/Instance	Near Parking Lot, Neighbors
Deficiency Quantity	100
Quantity Uom	S.F.
Potential Action	REPLACE
Urgency of Action	PRIORITY 3
Purpose of Action	LEVEL 2
Deficiency Photo1
