**NYC Department of Education**  
**Building Condition Assessment Survey 2023 - 2024**

Architectural Inspection

**Asset:** SAINT TERESA OF AVILA SCHOOL - QUEENS, 109-55 128 STREET, 11420

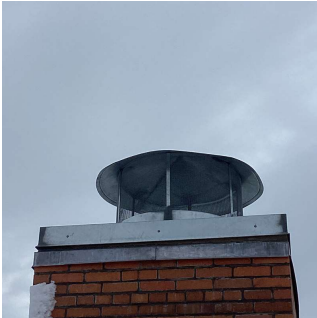
BRICK: DETERIORATED CAP

Violations	Roof 1 - open cap allows water leaks to below No violations recorded.
<b>COPING</b>	
Condition	Inspected
Deficiency	2 - Between Good and Fair
Deficiency	No deficiencies recorded
<b>CORNICE</b>	
Condition	Does not Exist
<b>DOORS</b>	
Condition	Inspected
<b>DOORS AND FRAMES</b>	
Condition	Inspected
Deficiency	4 - Between Fair and Poor
Deficiency	WOOD: DETERIORATED DOOR AND FRAME - MAJOR DETERIORATION
Roof Plan reference	<p>Q390</p>

REPLACE

PRIORITY 4

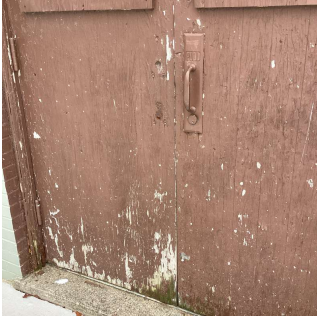
Violations	Facade E No violations recorded.
<b>DOOR HARDWARE</b>	
Condition	Inspected
Condition	3 - Fair

Deficiency Quantity	2
Quantity Uom	EACH
Potential Action	REPLACE
Urgency of Action	PRIORITY 4
Purpose of Action	LEVEL 2
Deficiency Photo1

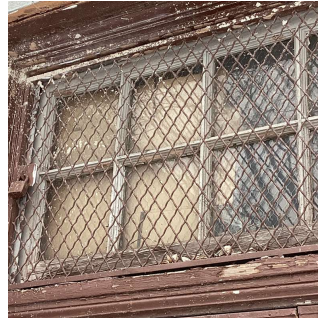
Facade E

WOOD: EXCESSIVELY WEATHERED

REPLACE

PRIORITY 4

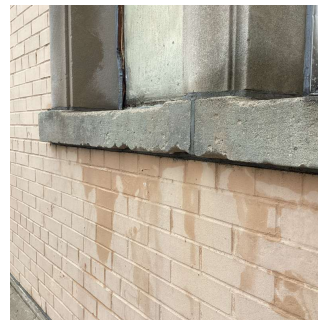
Facade C

BRICK: DETERIORATED MASONRY SILLS - MAJOR

REMOVE AND REPLACE

PRIORITY 4

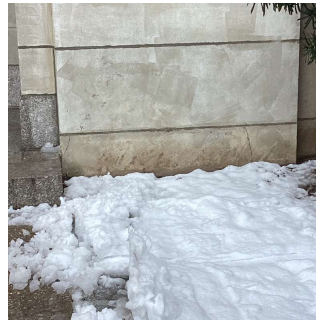
Facade A

STONE: CHIPPED/SPALLED/BROKEN PIECES - MINOR

REPAIR

PRIORITY 3

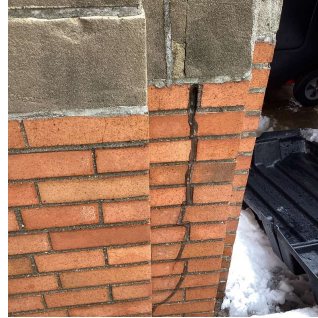
Facade B

BRICK: CRACKS/DISPLACED/SPALLED BRICK AT BUILDING CORNERS

REMOVE AND REBUILD  
PRIORITY 4  
LEVEL 2

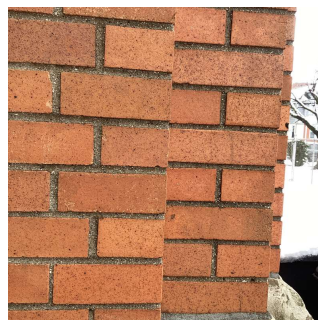
**BRICK: DETERIORATED JOINTS**

2,000  
S.F.  
REPOINT  
PRIORITY 3  
LEVEL 2

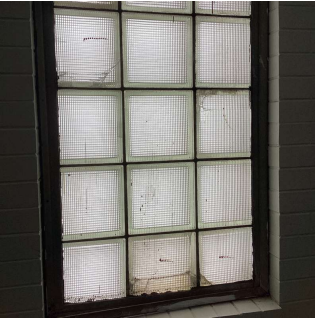
Question	Response
<b>EXTERIOR</b>	
<b>EXTERIOR WALLS</b>	
Violations	Facade B No violations recorded.
Deficiency	GLASS BLOCK: CHIPPED/ BROKEN PIECES
Roof Plan reference	Q390

Violations	Facade A No violations recorded.
<b>EXTERIOR SOFFITS</b>	Does not Exist
<b>LOADING DOCK</b>	Does not Exist
<b>LOUVER</b>	Inspected
Condition	2 - Between Good and Fair
Deficiency	No deficiencies recorded
<b>PARAPETS</b>	Inspected
Material Type(s)	Masonry
Replacement Quantity	2,200
Replacement Uom	C.F.

Deficiency Quantity	100
Quantity Uom	S.F.
Potential Action	REPLACE-IN-KIND
Urgency of Action	PRIORITY 4
Purpose of Action	LEVEL 2
Deficiency Photo1

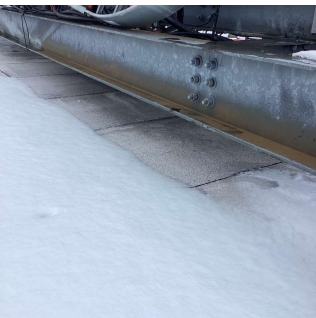
Question	Response
<b>EXTERIOR</b>	
<b>ROOF</b>	
<b>Specialties</b>	
<b>DUNNAGE STEEL</b>	Inspected
Condition	2 - Between Good and Fair
Deficiency	HEIGHT LESS THAN 18"
Roof Plan reference	<p>Q390</p>

Violations	Roof 1 No violations recorded.
<b>SKYLIGHT/ROOF VENT</b>	Does not Exist
<b>ROOF/GRAVITY TANK</b>	Does not Exist
<b>STAIRS/RAMPS: EXTERIOR</b>	Inspected
<b>BUILDING CHEEK/FLANK WALLS</b>	Does not Exist
<b>RAILINGS</b>	Inspected
Condition	2 - Between Good and Fair
Deficiency	No deficiencies recorded
<b>STAIRS/RAMPS</b>	Inspected
Condition	2 - Between Good and Fair
Deficiency	No deficiencies recorded
<b>WINDOWS</b>	Inspected
Replacement Quantity	2,500
Replacement Uom	S.F.
<b>EXTERIOR GUARDS</b>	Inspected
Condition	3 - Fair
Deficiency	DETERIORATED/TORN-OUT/MISSING

Deficiency Quantity	40
Quantity Uom	L.F.
Potential Action	REPLACE
Urgency of Action	PRIORITY 3
Purpose of Action	LEVEL 2
Deficiency Photo1

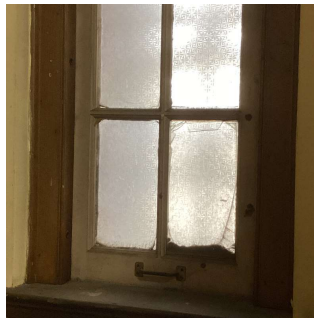
Facade C  
No violations recorded.

Deficiency	No deficiencies recorded
Instance on Wood: Facade C	Inspected
Instance Condition	5 - Poor
Instance Quantity	100
Instance Quantity Uom	S.F.
Are these windows insulated	No
Installation Year	1953
Source of Installation	Custodial Staff

Deficiency **WOOD: DETERIORATED**

100  
S.F.  
REPLACE WINDOW  
PRIORITY 4  
LEVEL 2

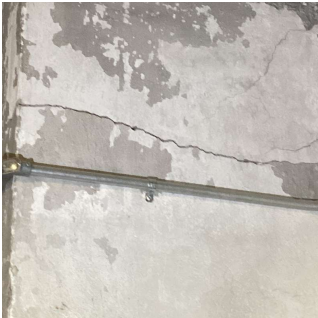
Question	Response
<b>INTERIOR</b>	
<b>STRUCTURAL</b>	
<b>COLUMNS/BEAMS/BEARING WALLS</b>	Inspected
Condition	2 - Between Good and Fair
Deficiency	STEEL COLUMNS/BEAMS: DETERIORATED CONCRETE FIREPROOFING
Deficiency Location/Instance	Basement - Boiler Room
Deficiency Quantity	10
Quantity Uom	S.F.
Potential Action	REPLACE
Urgency of Action	PRIORITY 3
Purpose of Action	LEVEL 5
Deficiency Photo1

Violations	Basement - Boiler Room No violations recorded.
<b>FLOOR STRUCTURE</b>	Inspected
Condition	2 - Between Good and Fair
Deficiency	No deficiencies recorded
<b>FOUNDATION WALLS</b>	Inspected
Material Type(s)	Concrete
Condition	2 - Between Good and Fair
Deficiency	No deficiencies recorded
<b>ROOF STRUCTURE</b>	Inspected
Condition	2 - Between Good and Fair
Deficiency	No deficiencies recorded
<b>VAULTS-BUNKERS</b>	Does not Exist
<b>AUDITORIUM</b>	Does not Exist
<b>CAFETERIA</b>	Inspected
Instance on Basement	Inspected
<b>Ceiling</b>

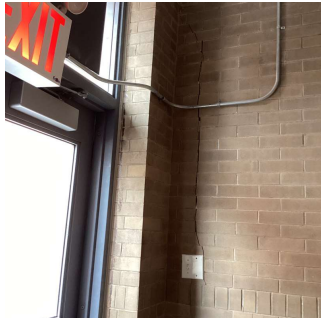
Question	Response
<b>INTERIOR</b>	
<b>GYMNASIUM</b>	
<b>Walls</b>	
Violations	No violations recorded.
Deficiency	BRICK: CRACKS/SPALLING
Deficiency Location/Instance	Near Emergency Exit
Deficiency Quantity	10
Quantity Uom	S.F.
Potential Action	REPLACE
Urgency of Action	PRIORITY 3
Purpose of Action	LEVEL 2
Deficiency Photo1

Violations	Near Emergency Exit No violations recorded.
<b>Window Curtains/Shades/Blinds</b>	
Instance on 1st Floor	Inspected
Condition	1 - Good
Deficiency	No deficiencies recorded
<b>INTERIOR DOOR HARDWARE</b>	
Condition	Inspected
Deficiency	1 - Good
Deficiency	No deficiencies recorded
<b>INTERIOR GUARDS</b>	
Condition	Inspected
Deficiency	2 - Between Good and Fair
Deficiency	No deficiencies recorded
<b>KITCHEN</b>	
Instance on Basement	Inspected
<b>Ceiling</b>	
Instance on Basement	Inspected
Condition	1 - Good
Deficiency	No deficiencies recorded
<b>Door(s)</b>	
Instance on Basement	Inspected
Condition	1 - Good

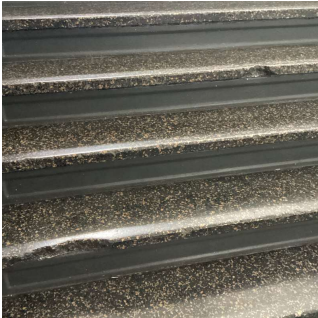
Question	Response
<b>INTERIOR</b>	
<b>LIBRARY</b>	Does not Exist
<b>LOCKER ROOM</b>	Does not Exist
<b>MULTI-PURPOSE ROOM</b>	Does not Exist
<b>SCIENCE DEMO ROOM</b>	Does not Exist
<b>SCIENCE LAB</b>	Does not Exist
<b>SCIENCE PREP ROOM</b>	Does not Exist
<b>SHOWER ROOM</b>	Does not Exist
<b>STAIRS/RAMPS: INTERIOR</b>	Inspected
Do Letter Stair Signs Exist?	Partially
<b>Ceiling</b>	Inspected
Condition	2 - Between Good and Fair
Deficiency	No deficiencies recorded
<b>Door(s)</b>	Inspected
Condition	1 - Good
Deficiency	No deficiencies recorded
<b>Partition</b>	Does not Exist
<b>Railings</b>	Inspected
Condition	2 - Between Good and Fair
Deficiency	No deficiencies recorded
<b>Stairs and Landings</b>	Inspected
Condition	2 - Between Good and Fair
Deficiency	TERRAZZO: CRACKS
Deficiency Location/Instance	Stair A/Basement
Deficiency Quantity	10
Quantity Uom	S.F.
Potential Action	REPLACE
Urgency of Action	PRIORITY 5
Purpose of Action	LEVEL 6

Violations	Stair A/ Basement No violations recorded.
Deficiency	WOOD: BROKEN/DETERIORATED
Deficiency Location/Instance	Stair C/1
Deficiency Quantity	20
Quantity Uom	S.F.
Potential Action	REPLACE
Urgency of Action	PRIORITY 3
Purpose of Action	LEVEL 2

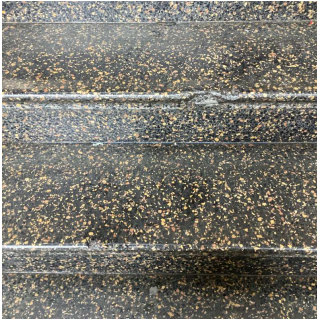
Violations	Stair C/1 No violations recorded.
Deficiency	TERRAZZO: CRACKS
Deficiency Location/Instance	Main Entrance lobby, Stairs A/Basement, B/Basement, 1
Deficiency Quantity	40
Quantity Uom	S.F.
Potential Action	REPLACE
Urgency of Action	PRIORITY 3
Purpose of Action	LEVEL 2
Deficiency Photo1

Violations	Main Entrance lobby No violations recorded.
<b>Walls</b>	Inspected
Condition	2 - Between Good and Fair
Deficiency	No deficiencies recorded
<b>TOILET ROOMS - STAFF</b>	Inspected
<b>Ceiling</b>	Inspected
Condition	4 - Between Fair and Poor
Deficiency	PLASTER: CRACKS/SPALLING
Deficiency Location/Instance	Staff A and B - 3rd Floor
Deficiency Quantity	20
Quantity Uom	S.F.
Potential Action	REPLACE
Urgency of Action	PRIORITY 3
Purpose of Action	LEVEL 2

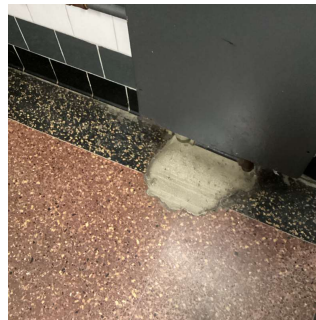
Boys- Basement

TERRAZZO: CRACKS

REPLACE

PRIORITY 3

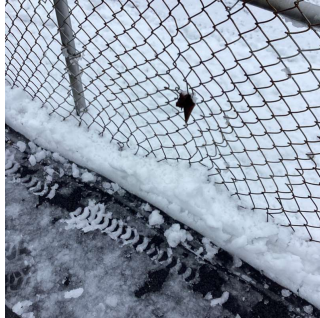
<b>DRINKING FOUNTAINS</b>	Does not Exist
<b>FENCES</b>	Inspected
Condition	4 - Between Fair and Poor
Deficiency	CHAIN LINK: DAMAGED/DETERIORATED
Deficiency Location/Instance	130th Street

Violations	130th Street No violations recorded.
Deficiency	CHAIN LINK: RUST - MAJOR
Deficiency Location/Instance	Near Gas pipes, 111th Avenue, 130th Street
Deficiency Quantity	2,500
Quantity Uom	S.F.
Potential Action	REPLACE
Urgency of Action	PRIORITY 3
Purpose of Action	LEVEL 2
Deficiency Photo1

Question	Response
<b>SITE</b>	
<b>FENCES</b>	
Deficiency Quantity	200
Quantity Uom	S.F.
Potential Action	REPLACE
Urgency of Action	PRIORITY 3
Purpose of Action	LEVEL 2
Deficiency Photo1

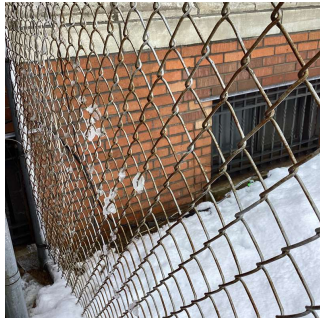
Violations	Near Gas pipes No violations recorded.
<b>IRRIGATION SYSTEM</b>	Does not Exist
<b>PAVING</b>	Inspected
<b>Student Non-Use</b>	Inspected
Gravel Exists?	No
<b>Asphalt</b>	Inaccessible
<b>Concrete</b>	Does not Exist
<b>Pavers</b>	Does not Exist
<b>Student Use</b>	Inspected
Gravel Exists?	No
<b>Asphalt</b>	Does not Exist
<b>Concrete</b>	Inaccessible
<b>Pavers</b>	Does not Exist
<b>Site Sidewalks &amp; Walkways</b>	Inspected
