NYC Department of Education
Building Condition Assessment Survey 2023 - 2024

Architectural Inspection

Q397

Asset: **PRE-K CENTER @ 32-52 37TH STREET - QUEENS, 32-52 37TH STREET, New York, 11103**

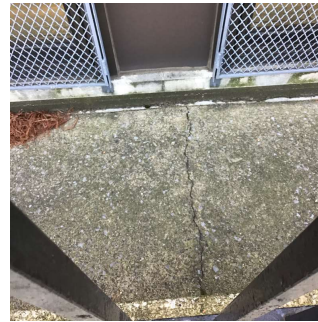
AW2

| Question | Response |
|---|---|
| Deficiency | AREAWAY SLAB: CRACKS AND SPALLING |

REPLACE

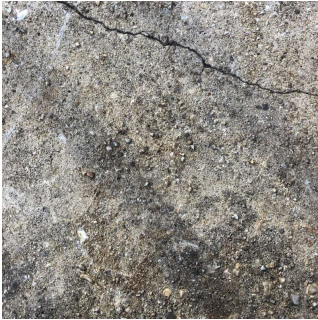
| Question | Response |
|---|--|
| Violations | AW4 No violations recorded. |

AREAWAY WALLS: CRACKS AND SPALLING

REPLACE

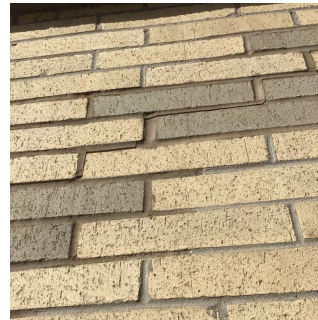
Facade E

| Question | Response |
|---|--|
| Deficiency | BRICK: MAJOR / THRU CRACKS |

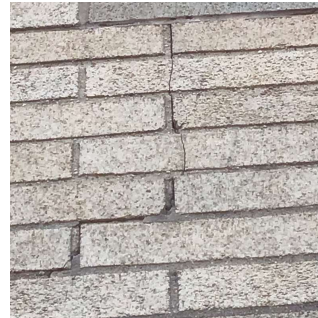
Facade H

BRICK: MINOR CRACKS AND SPALLING

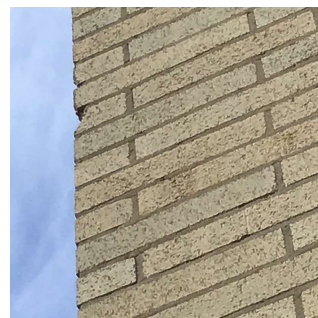
BRICK: CRACKS/DISPLACED/SPALLED BRICK AT BUILDING CORNERS

10
S.F.
REMOVE AND REBUILD
PRIORITY 4
LEVEL 2

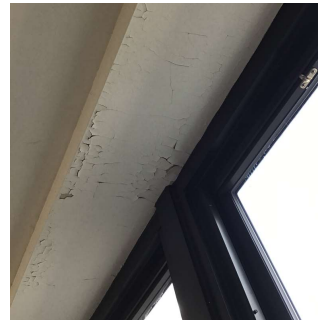
BRICK: WATER INFILTRATION IN INSTRUCTIONAL SPACE

Facade G - Hallway between Exits 5 and 6 along windows shown,

Facade G - Stair D/1

REPAIR

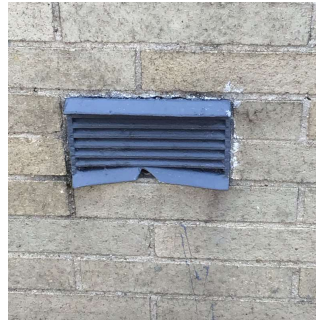
Facade G

BROKEN/ DENTED BLADES

REPLACE

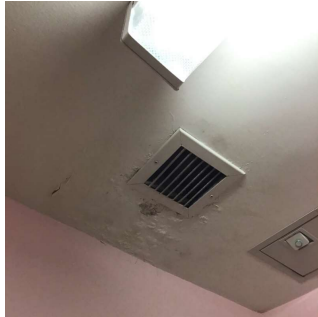
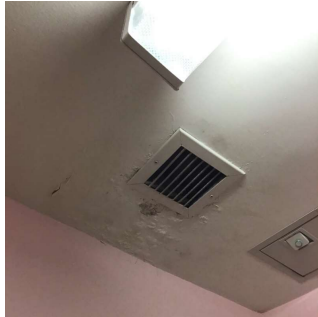
Roof 1 - Room 301C

MODIFIED BITUMEN: ROOFING: MAJOR ACTIVE ROOF LEAKS IN INSTRUCTIONAL SPACE

| Potential Action | REPLACE ROOFING WITHOUT MAJOR EQUIPMENT REMOVAL |

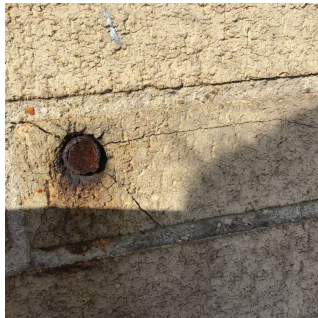
Deficiency BULKHEAD/PENTHOUSE WALLS/EXTERIOR: CRACKS/SPALLING - MINOR

| Potential Action | REPAIR |

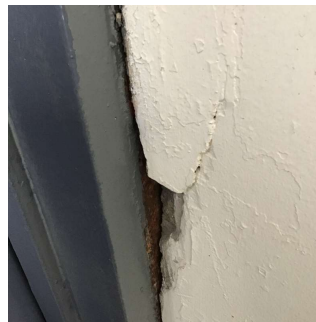
BH2

BULKHEAD/PENTHOUSE DOORS: AIR/WATER INFILTRATION WITH DAMAGED CAULKING

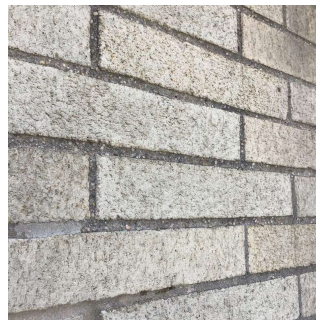
BH2

BULKHEAD/PENTHOUSE WALLS/EXTERIOR: DETERIORATED JOINTS

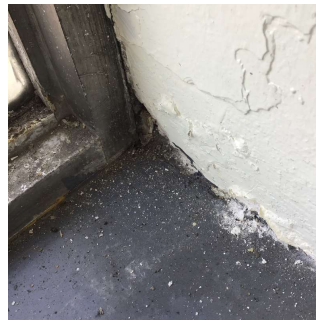
BH1
No violations recorded.

BULKHEAD/PENTHOUSE WINDOWS: AIR/WATER INFILTRATION WITH DAMAGED TRIM OR SILLS

10
L.F.
MAINTENANCE
PRIORITY 3
LEVEL 2

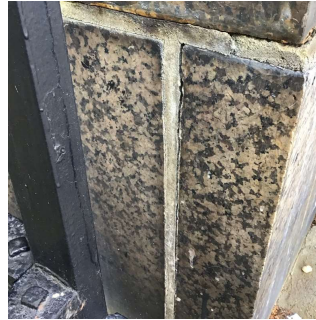
Facade G
No violations recorded.

STONE: DETERIORATED JOINTS

S.F.
REPOINT
PRIORITY 3
LEVEL 2

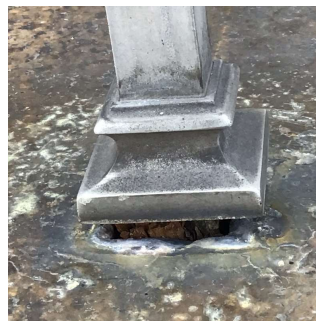
Facade G
No violations recorded.

DAMAGED

10
L.F.
REPLACE
PRIORITY 4
LEVEL 2

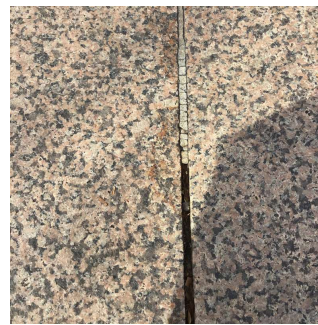
Facade A

STONE: DETERIORATED JOINTS

15
L.F.
REPOINT
PRIORITY 3
LEVEL 2

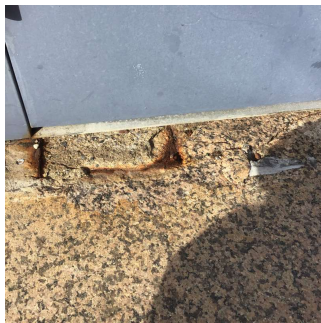
| Question | Response |
|---|--|
| Violations | Facade A No violations recorded. |

STONE: CRACKS/SPALLING - MAJOR

15
S.F.
REPLACE
PRIORITY 4
LEVEL 2

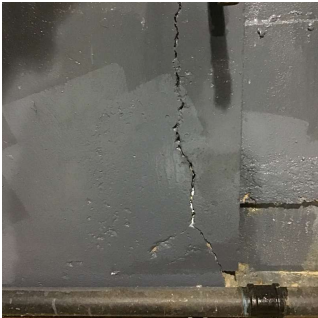
| Question | Response |
|---|--|
| | Basement - Boiler Room |

| Question | Response |
|---|--|
| Deficiency | CONCRETE COLUMNS/BEAMS: CRACKED/SPALLED/REINFORCEMENT EXPOSED |

| Question | Response |
|---|--|
| Potential Action | REPLACE |

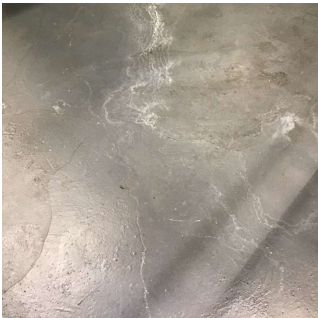
| Question | Response |
|---|--|
| | Basement - Electrical Room |

| Question | Response |
|---|--|
| Deficiency | CONCRETE SLAB ON GRADE: THRU CRACKS |

| Question | Response |
|---|--|
| Potential Action | REPLACE |

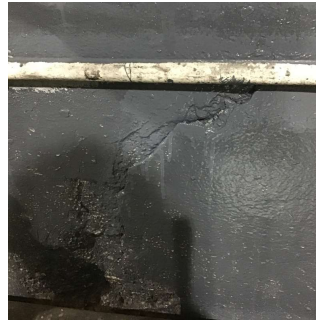
Basement - Boiler Room

| Question | Response |
|---|--|
| Deficiency | CONCRETE: CRACKED/SPALLED/REINFORCEMENT EXPOSED |

| Question | Response |
|---|--|
| Potential Action | REPAIR |

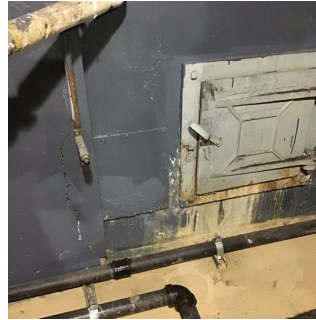
Basement - Boiler Room

CONCRETE: WATER INFILTRATION IN NON- INSTRUCTIONAL SPACE

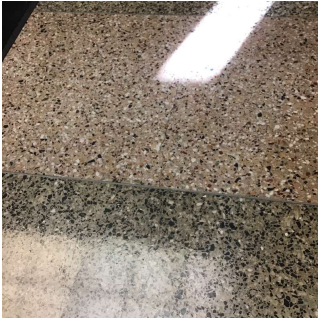
| Question | Response |
|--|--|
| | Main Entrance |

| Question | Response |
|--|--|
| Deficiency | TERRAZZO: CRACKS |

| Question | Response |
|--|--|
| Potential Action | REPLACE |

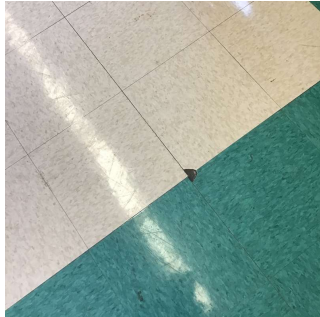
| Question | Response |
|--|--|
| | Room 312 |

| Question | Response |
|--|--|
| Deficiency | VINYL TILES: BROKEN/DETERIORATED/MISSING TILES |

| Question | Response |
|--|--|
| Potential Action | REPLACE |

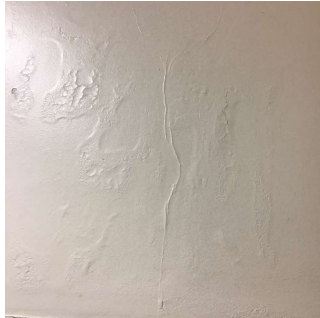
| Question | Response |
|--|--|
| | Corridor near Room 210 |

| Question | Response |
|--|--|
| Deficiency Location/Instance | PLASTER: CRACKS/SPALLING |

| Question | Response |
|--|--|
| Urgency of Action | REPLACE |
