**NYC Department of Education
Building Condition Assessment Survey 2023 - 2024**

Architectural Inspection

Q399

Asset: **3K CENTER @ 61-02/10 LAUREL HILL BLVD - QUEENS, 61-02/10 LAUREL HILL BLVD, 11377**

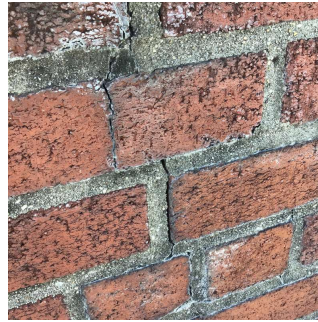
CH

BRICK: MINOR CRACKS AND SPALLING

15
S.F.
RESTITCH
PRIORITY 3
LEVEL 2

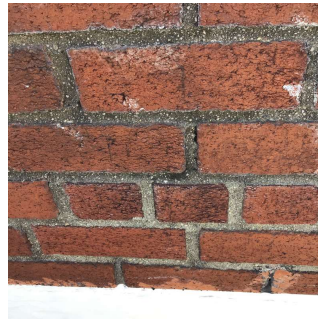
CH

BRICK: DETERIORATED JOINTS

REPOINT

PRIORITY 3

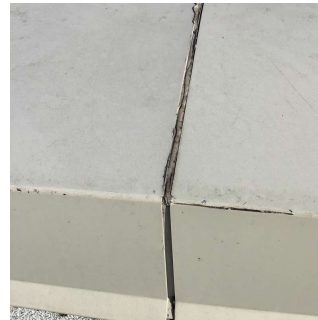
Roof 1

METAL: DETERIORATED TRANSVERSE JOINTS

50
L.F.
MAINTENANCE
PRIORITY 3
LEVEL 2

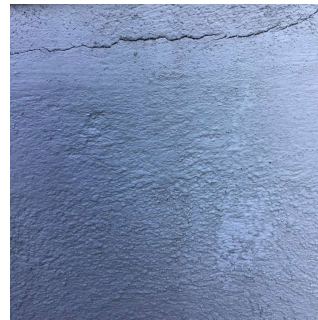
Facade E

STUCCO CEMENT SURFACE: CRACKS, SPALLING

REPLACE

PRIORITY 4

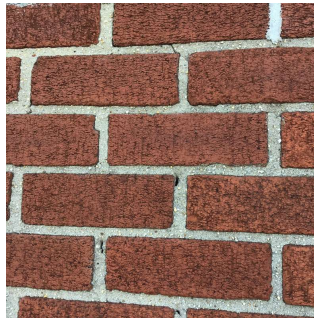
Facade B

BRICK: DETERIORATED JOINTS

REPOINT

PRIORITY 3

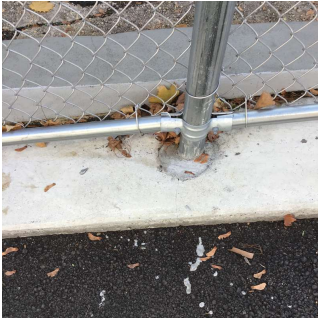
Violations	Playground Area No violations recorded.
Deficiency	CONCRETE CURB: DAMAGED/DETERIORATED
Deficiency Location/Instance	Near Stair A/Basement
Deficiency Quantity	10
Quantity Uom	S.F.
Potential Action	REPLACE
Urgency of Action	PRIORITY 3
Purpose of Action	LEVEL 2
Deficiency Photo1

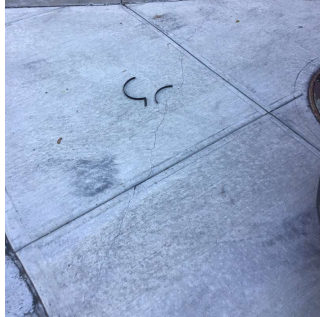
Violations	Near Stair A/Basement No violations recorded.
IRRIGATION SYSTEM	Does not Exist
PAVING	Inspected
Student Non-Use	Does not Exist
Student Use	Does not Exist
Site Sidewalks & Walkways	Inspected
Asphalt	Inspected
Condition	2 - Between Good and Fair
Deficiency	No deficiencies recorded
Concrete	Inspected
Condition	3 - Fair
Deficiency	DAMAGED/DETERIORATED/MISSING SECTIONS
Deficiency Location/Instance	Laurel Hill Boulevard
Deficiency Quantity	75
Quantity Uom	S.F.
Potential Action	REPLACE
Urgency of Action	PRIORITY 3
Purpose of Action	LEVEL 2
