NYC Department of Education
Building Condition Assessment Survey 2023 - 2024

Architectural Inspection

Q401

Asset: AUGUST MARTIN AF - QUEENS, 156-10 BAISLEY BLVD, New York, 11434

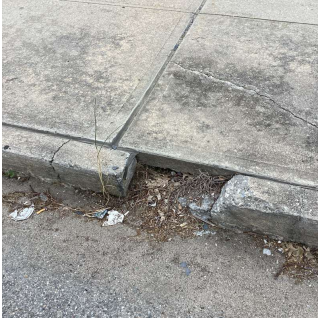
Question	Response
SITE	
Drainage System for Soil	Inspected
Catch Basins/Manhole - Surrounded by Soil	Inspected
Condition	2 - Between Good and Fair
Deficiency	No deficiencies recorded
Culverts - Soil Covering	Does not Exist
DRINKING FOUNTAINS	Under Construction
FENCES	Inaccessible
IRRIGATION SYSTEM	Does not Exist
PAVING	Inspected
Student Non-Use	Does not Exist
Student Use	Under Construction
Site Sidewalks & Walkways	Under Construction
DOT Sidewalk	Inspected
Asphalt	Does not Exist
Concrete	Inspected
Condition	4 - Between Fair and Poor
Deficiency	DAMAGED CURBS
Deficiency Location/Instance	155th Street, 157th Street
Deficiency Quantity	50
Quantity Uom	L.F.
Potential Action	REPLACE
Urgency of Action	PRIORITY 5
Purpose of Action	LEVEL 6
Deficiency Photo1

157th Street
Violations	No violations recorded.
Deficiency	DAMAGED/DETERIORATED/MISSING SECTIONS
Deficiency Location/Instance	155th Street, 157th Street
Deficiency Quantity	1,250

Quantity Uom	S.F.
Potential Action	REPLACE
Urgency of Action	PRIORITY 3
Purpose of Action	LEVEL 2
