**NYC Department of Education**  
**Building Condition Assessment Survey 2023 - 2024**

Architectural Inspection

**Q404**

**Asset: HUNTERS POINT CAMPUS - QUEENS, 1-50 51ST AVENUE, New York, 11101**

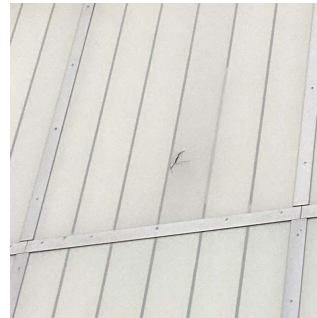
Facade D

Instance Quantity	25,000
Instance Quantity Uom	S.F.
Deficiency	METAL/GLASS CURT WALL: BROKEN GLASS

REPLACE

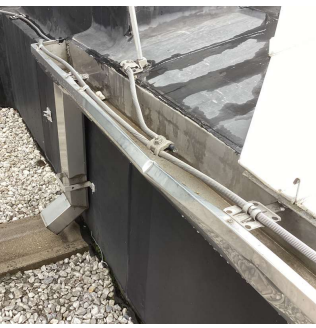
Question	Response
<b>EXTERIOR</b>	
<b>PARAPETS</b>	Inspected
Instance Quantity	9,000
Instance Quantity Uom	C.F.
Deficiency	No deficiencies recorded
<b>PLAZA DECK</b>	Inspected
Instance on Pavers: Roof 4	Inspected
Instance Condition	2 - Between Good and Fair
Instance Quantity	5,000
Instance Quantity Uom	S.F.
Installation Year	2013
Source of Installation	Custodial Staff
Deficiency	No deficiencies recorded
<b>ROOF</b>	Inspected
<b>Roofing</b>	Inspected
Replacement Quantity	35,400
Replacement Uom	S.F.
<b>ROOF HATCH/SMOKE HATCH</b>	Inspected
Condition	2 - Between Good and Fair
Deficiency	No deficiencies recorded
<b>LEADERS, GUTTERS, DOWNSPOUTS, SCUPPERS</b>	Inspected
Condition	3 - Fair
Deficiency	DAMAGED/MISSING
Roof Plan reference

Deficiency Quantity	10
Quantity Uom	L.F.
Potential Action	REPLACE
Urgency of Action	PRIORITY 4
Purpose of Action	LEVEL 2
Deficiency Photo1

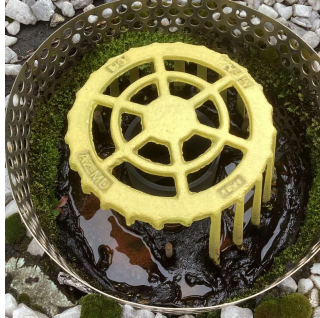
Question	Response
<b>EXTERIOR</b>	
<b>ROOF</b>	
<b>Roofing</b>	
<b>ROOFING</b>	Inspected
Deficiency Photo1	 
	Roof 1 - Cafeteria - Room 540/546, also Cafeteria Room 505, Kitchen Room 534H
Violations	35655212R
Instance on Modified Bitumen: Roof 3	Inspected
Instance Condition	3 - Fair
Instance Photo	 
	Roof 3
Instance Quantity	400
Instance Quantity Uom	S.F.
Does the roof have major mechanical equipment sitting on Dunnage Steel less than 18" above the Roofing?	No
Does this roof instance have a Sustainable Roof System?	No
Do solar panels exist on these roofs?	No
Is/Are the roof(s) suitable for Solar Panel installation?	No
Installation Year	2013
Source of Installation	Custodial Staff
Deficiency	No deficiencies recorded
<b>ROOFING DRAINS</b>	Inspected
Condition	5 - Poor
Deficiency	DETERIORATED
Roof Plan reference	 
Deficiency Quantity	3
Quantity Uom	EACH
Potential Action	REPLACE
Urgency of Action	PRIORITY 4

Question	Response
<b>EXTERIOR</b>	
<b>ROOF</b>	
<b>Roofing</b>	
<b>ROOFING DRAINS</b>	
Purpose of Action	LEVEL 2
Deficiency Photo1

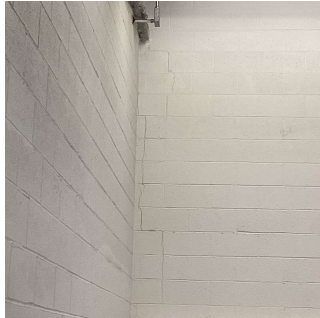
Violations	Roof 1 No violations recorded.
<b>Specialties</b>	Inspected
<b>BULKHEAD/PENTHOUSE</b>	Inspected
Condition	3 - Fair
Deficiency	BULKHEAD/PENTHOUSE WALLS/INTERIOR: CMU CRACKS/SPALLING
Roof Plan reference	 
Deficiency Quantity	20
Quantity Uom	S.F.
Potential Action	REPLACE
Urgency of Action	PRIORITY 3
Purpose of Action	LEVEL 2
Deficiency Photo1

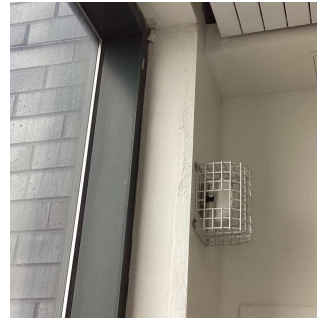
Facade D - Corridor near Room 401, also Facade A - Library Room 205

Deficiency	ALUMINUM - OTHER: AIR/WATER INFILTRATION
------------	--

REPLACE TRIM, SILLS OR WEATHERSTRIPPING

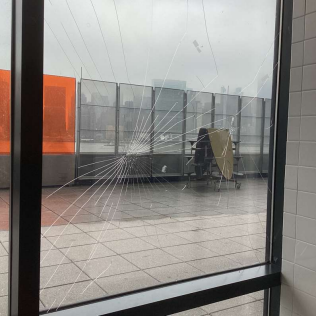
Question	Response
<b>EXTERIOR</b>	
<b>WINDOWS</b>	
<b>WINDOWS</b>	
Elevation	 
Deficiency Quantity	90
Quantity Uom	S.F.
Potential Action	MAINTENANCE
Urgency of Action	PRIORITY 3
Purpose of Action	LEVEL 2
Deficiency Photo1

Violations	Facade D - Cafeteria 540/546 No violations recorded.
<b>INTERIOR</b>	Inspected
<b>POOLS</b>	Does not Exist
<b>STRUCTURAL</b>	Inspected
<b>COLUMNS/BEAMS/BEARING WALLS</b>	Inspected
Condition	2 - Between Good and Fair
Deficiency	No deficiencies recorded
<b>FLOOR STRUCTURE</b>	Inspected
Condition	2 - Between Good and Fair
Deficiency	No deficiencies recorded
<b>FOUNDATION WALLS</b>	Inspected
Material Type(s)	Concrete
Condition	2 - Between Good and Fair
Deficiency	No deficiencies recorded
<b>ROOF STRUCTURE</b>	Inspected
Condition	2 - Between Good and Fair
Deficiency	No deficiencies recorded
<b>VAULTS-BUNKERS</b>	Does not Exist
<b>AUDITORIUM</b>	Inspected
Instance on 3rd Floor (366 Seats)	Inspected

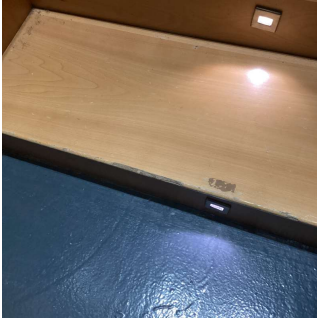
Question	Response
<b>INTERIOR</b>	
<b>AUDITORIUM</b>	
<b>Fixed Seating</b>	
	Seat N/21
Violations	No violations recorded.
<b>Floor Finish</b>	
Instance on 3rd Floor (366 Seats)	Inspected
Condition	2 - Between Good and Fair
Deficiency	No deficiencies recorded
<b>Sliding-folding Partition</b>	
Instance on 3rd Floor (366 Seats)	Does not Exist
<b>Stage</b>	
Instance on 3rd Floor (366 Seats)	Inspected
<b>Stage</b>	
Instance on 3rd Floor (366 Seats)	Inspected
Condition	2 - Between Good and Fair
Deficiency	DAMAGED STEPS
Deficiency Location/Instance	Left Side
Deficiency Quantity	10
Quantity Uom	S.F.
Potential Action	REPLACE
Urgency of Action	PRIORITY 3
Purpose of Action	LEVEL 2
Deficiency Photo1

Left Side
Violations	No violations recorded.
<b>Stage Curtain Rigging</b>	
Instance on 3rd Floor (366 Seats)	Inspected
Condition	2 - Between Good and Fair
Deficiency	No deficiencies recorded
<b>Stage Curtains</b>	
Instance on 3rd Floor (366 Seats)	Inspected

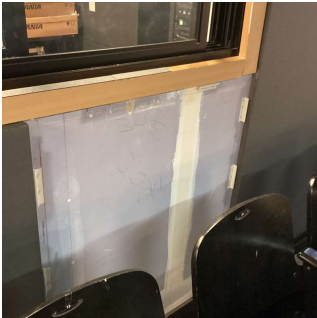
Lateral left Side
Violations	No violations recorded.
<b>Walls</b>	
Instance on 3rd Floor (366 Seats)	Inspected
Condition	2 - Between Good and Fair
Deficiency	WALL PADDING: DETERIORATED
Deficiency Location/Instance	Near Seat N/13
Deficiency Quantity	20
Quantity Uom	S.F.
Potential Action	REPLACE
Urgency of Action	PRIORITY 3
Purpose of Action	LEVEL 2
Deficiency Photo1

Near Seat N/13
Violations	No violations recorded.
<b>Window Curtains/Shades/Blinds</b>	
Instance on 3rd Floor (366 Seats)	Does not Exist
<b>CAFETERIA</b>	
Instance on 5th Floor - Room 505	Inspected
Instance on 5th Floor - Room 540/546	Inspected
<b>Ceiling</b>	
Instance on 5th Floor - Room 540/546	Inspected
Condition	2 - Between Good and Fair
Deficiency	ACOUSTIC TILES: DAMAGED/MISSING - ACTIVE LEAK
Deficiency Location/Instance	Near Entrance

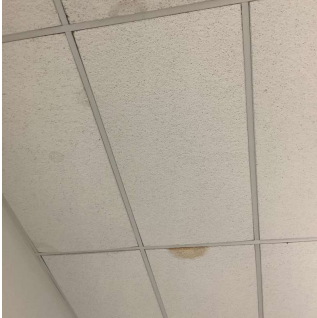
Question	Response
<b>INTERIOR</b>	
<b>CAFETERIA</b>	
<b>Ceiling</b>	
Purpose of Action	LEVEL 4
Deficiency Photo1	 
	Near Entrance
Violations	35655212R
Deficiency	ACOUSTIC TILES: DAMAGED/MISSING
Deficiency Location/Instance	Near Serving Area
Deficiency Quantity	20
Quantity Uom	S.F.
Potential Action	REPLACE
Urgency of Action	PRIORITY 3
Purpose of Action	LEVEL 2
Deficiency Photo1

Near Serving Area
Violations	No violations recorded.
Instance on 5th Floor - Room 505	Inspected
Condition	2 - Between Good and Fair
Deficiency	ACOUSTIC TILES: DAMAGED/MISSING
Deficiency Location/Instance	Near center, Windows, Hall
Deficiency Quantity	70
Quantity Uom	S.F.
Potential Action	REPLACE
Urgency of Action	PRIORITY 3
Purpose of Action	LEVEL 2

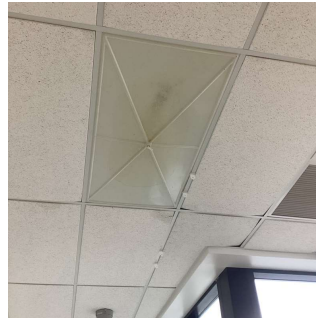
Deficiency	ACOUSTIC TILES: DAMAGED/MISSING - ACTIVE LEAK
Deficiency Location/Instance	Near Serving Area
Deficiency Quantity	20
Quantity Uom	S.F.
Potential Action	REPLACE
Urgency of Action	PRIORITY 5
Purpose of Action	LEVEL 4
Deficiency Photo1

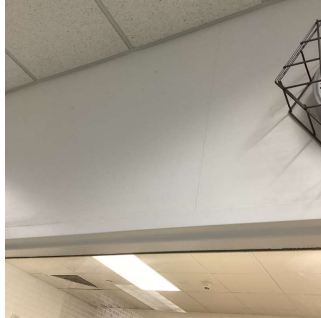
Question	Response
<b>INTERIOR</b>	
<b>CAFETERIA</b>	
<b>Sliding-folding Partition</b>	
Instance on 5th Floor - Room 505	Does not Exist
Instance on 5th Floor - Room 540/546	Does not Exist
<b>Stage</b>	
Instance on 5th Floor - Room 505	Does not Exist
Instance on 5th Floor - Room 540/546	Does not Exist
<b>Walls</b>	
Instance on 5th Floor - Room 505	Inspected
Condition	2 - Between Good and Fair
Deficiency	GYPNUM BOARD: DETERIORATED
Deficiency Location/Instance	Near Serving Area
Deficiency Quantity	10
Quantity Uom	S.F.
Potential Action	REPLACE
Urgency of Action	PRIORITY 3
Purpose of Action	LEVEL 2
Deficiency Photo1

Near Serving Area
Violations	No violations recorded.
Deficiency	CERAMIC TILE: BROKEN/ MISSING
Deficiency Location/Instance	Near Windows
Deficiency Quantity	10
Quantity Uom	S.F.
Potential Action	REPLACE
Urgency of Action	PRIORITY 3
Purpose of Action	LEVEL 2
Deficiency Photo1	 
	Near Windows
Violations	No violations recorded.

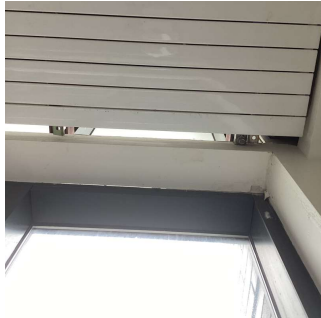
Question	Response
<b>INTERIOR</b>	
<b>CAFETERIA</b>	Inspected
<b>Window Curtains/Shades/Blinds</b>	
Instance on 5th Floor - Room 540/546	Does not Exist
<b>CLASSROOMS/CORRIDORS/ADMIN SPACES</b>	Inspected
<b>Ceiling</b>	Inspected
Condition	2 - Between Good and Fair
Deficiency	GYPSUM BOARD: DAMAGED/DETERIORATED - ACTIVE LEAK
Deficiency Location/Instance	Corridor near Room 401
Deficiency Quantity	20
Quantity Uom	S.F.
Potential Action	REPLACE
Urgency of Action	PRIORITY 5
Purpose of Action	LEVEL 2
Deficiency Photo1

Corridor near Room 401
Violations	No violations recorded.
Deficiency	ACOUSTIC TILES: DAMAGED/MISSING
Deficiency Location/Instance	Rooms 461, 521, Corridor near Rooms 246, 520, 543, and others
Deficiency Quantity	200
Quantity Uom	S.F.
Potential Action	REPLACE
Urgency of Action	PRIORITY 3
Purpose of Action	LEVEL 2
Deficiency Photo1

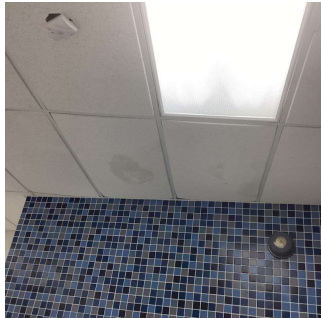
Corridor near Room 543
Violations	No violations recorded.
<b>Door(s)</b>	Inspected

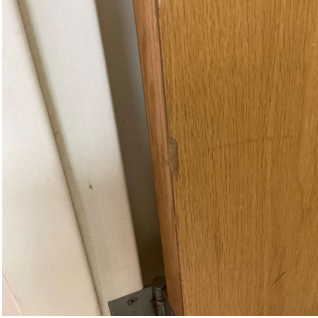
Condition	5 - Poor
Deficiency	WOOD: DETERIORATED DOOR
Deficiency Location/Instance	Rooms 220, 349, 362, 423, 457, and others
Deficiency Quantity	12
Quantity Uom	EACH

Question	Response
<b>INTERIOR</b>	
<b>CLASSROOMS/CORRIDORS/ADMIN SPACES</b>	Inspected
<b>Door(s)</b>	
Potential Action	MAINTENANCE
Urgency of Action	PRIORITY 3
Purpose of Action	LEVEL 2
Deficiency Photo1

Room 457
Violations	No violations recorded.
<b>Floor Finish</b>	Inspected
Condition	2 - Between Good and Fair
Deficiency	No deficiencies recorded
<b>Walls</b>	Inspected
Condition	2 - Between Good and Fair
Deficiency	CERAMIC TILE: BROKEN/ MISSING
Deficiency Location/Instance	Corridor near Stair A/5
Deficiency Quantity	10
Quantity Uom	S.F.
Potential Action	REPLACE
Urgency of Action	PRIORITY 3
Purpose of Action	LEVEL 2
Deficiency Photo1	 
	Corridor near Stair A/5
Violations	No violations recorded.
Deficiency	GYPSUM BOARD: DETERIORATED - ACTIVE LEAK
Deficiency Location/Instance	Corridor near Room 401
Deficiency Quantity	20
Quantity Uom	S.F.
Potential Action	REPLACE
Urgency of Action	PRIORITY 5
Purpose of Action	LEVEL 2

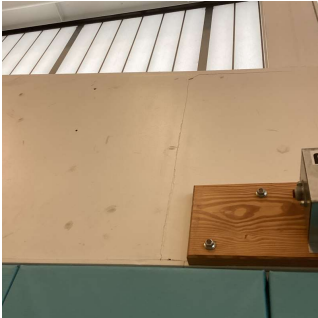
Violations	Near center No violations recorded.
<b>Stage</b>	
Instance on 1st Floor	Does not Exist
<b>Walls</b>	
Instance on 1st Floor	Inspected
Condition	2 - Between Good and Fair
Deficiency	GYPSUM BOARD: DETERIORATED
Deficiency Location/Instance	Near Entrance , Windows
Deficiency Quantity	30
Quantity Uom	S.F.
Potential Action	REPLACE
Urgency of Action	PRIORITY 3
Purpose of Action	LEVEL 2
Deficiency Photo1

Violations	Near Windows No violations recorded.
Deficiency	WALL PADDING: DETERIORATED
Deficiency Location/Instance	Near Windows, Storage Room
Deficiency Quantity	40
Quantity Uom	S.F.
Potential Action	REPLACE
Urgency of Action	PRIORITY 3

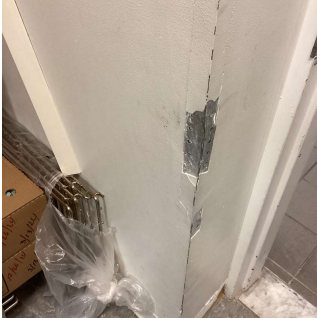
Question	Response
<b>INTERIOR</b>	
<b>KITCHEN</b>	
<b>Ceiling</b>	
Potential Action	REPLACE
Urgency of Action	PRIORITY 3
Purpose of Action	LEVEL 2
Deficiency Photo1	 
	Room 534B
Violations	No violations recorded.
<b>Door(s)</b>	
Instance on 5th Floor	Inspected
Condition	2 - Between Good and Fair
Deficiency	No deficiencies recorded
<b>Floor Finish</b>	
Instance on 5th Floor	Inspected
Condition	2 - Between Good and Fair
Deficiency	No deficiencies recorded
<b>Walls</b>	
Instance on 5th Floor	Inspected
Condition	2 - Between Good and Fair
Deficiency	GYPSUM BOARD: DETERIORATED
Deficiency Location/Instance	Room 534H
Deficiency Quantity	20
Quantity Uom	S.F.
Potential Action	REPLACE
Urgency of Action	PRIORITY 3
Purpose of Action	LEVEL 2
Deficiency Photo1

Room 534H
Violations	No violations recorded.
<b>LIBRARY</b>	
Instance on Room 205	Inspected
<b>Built-in Furnishing</b>	
Instance on Room 205	Does not Exist

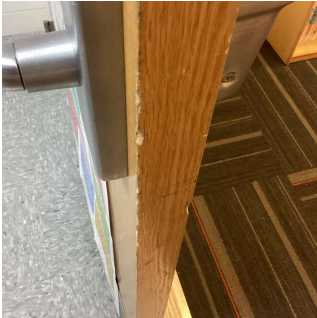
Question	Response
<b>INTERIOR</b>	
<b>LIBRARY</b>	
<b>Ceiling</b>	
Instance on Room 205	Inspected
Condition	3 - Fair
Deficiency	GYPSUM BOARD: DAMAGED/DETERIORATED
Deficiency Location/Instance	Near Entrance
Deficiency Quantity	40
Quantity Uom	S.F.
Potential Action	REPLACE
Urgency of Action	PRIORITY 3
Purpose of Action	LEVEL 2
Deficiency Photo1	 
Violations	Near Entrance No violations recorded.
<b>Door(s)</b>	
Instance on Room 205	Inspected
Condition	2 - Between Good and Fair
Deficiency	WOOD: DETERIORATED DOOR
Deficiency Location/Instance	Entrance
Deficiency Quantity	1
Quantity Uom	EACH
Potential Action	MAINTENANCE
Urgency of Action	PRIORITY 3
Purpose of Action	LEVEL 2
Deficiency Photo1

Violations	Entrance No violations recorded.
<b>Floor Finish</b>	
Instance on Room 205	Inspected
Condition	2 - Between Good and Fair
Deficiency	No deficiencies recorded
<b>Walls</b>	
Instance on Room 205	Inspected

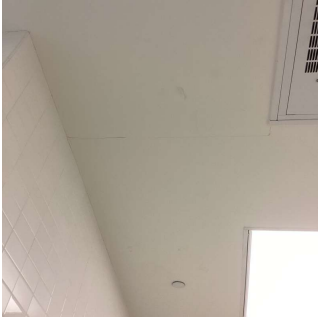
Question	Response
<b>INTERIOR</b>	
<b>LOCKER ROOM</b>	
Alternative use	No
<b>Ceiling</b>	
Instance on 1st Floor - Room 144 (144 Lockers)	Inspected
Condition	2 - Between Good and Fair
Deficiency	GYPSUM BOARD: DAMAGED/DETERIORATED
Deficiency Location/Instance	Near Shower Room
Deficiency Quantity	10
Quantity Uom	S.F.
Potential Action	REPLACE
Urgency of Action	PRIORITY 3
Purpose of Action	LEVEL 2
Deficiency Photo1

Near Shower Room
Violations	No violations recorded.
Instance on 1st Floor - Room 145 (160 Lockers)	Inspected
Condition	2 - Between Good and Fair
Deficiency	GYPSUM BOARD: DAMAGED/DETERIORATED
Deficiency Location/Instance	Room 134
Deficiency Quantity	10
Quantity Uom	S.F.
Potential Action	REPLACE
Urgency of Action	PRIORITY 3
Purpose of Action	LEVEL 2
Deficiency Photo1

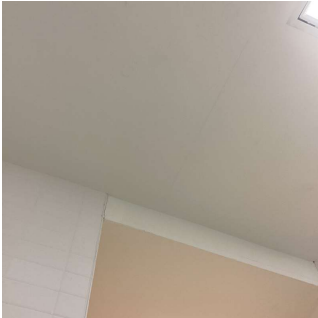
Near center
Violations	No violations recorded.
<b>Door(s)</b>	
Instance on 1st Floor - Room 134 (152 Lockers)	Inspected
Condition	2 - Between Good and Fair

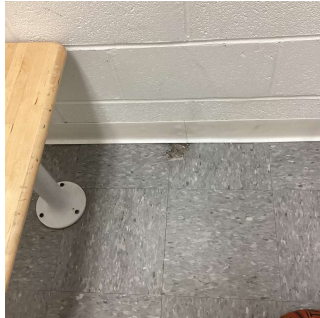
Question	Response
<b>INTERIOR</b>	
<b>LOCKER ROOM</b>	
<b>Door(s)</b>	
Deficiency	No deficiencies recorded
Instance on 1st Floor - Room 144 (144 Lockers)	Inspected
Condition	2 - Between Good and Fair
Deficiency	No deficiencies recorded
Instance on 1st Floor - Room 102 (220 Lockers)	Inspected
Condition	2 - Between Good and Fair
Deficiency	No deficiencies recorded
Instance on 1st Floor - Room 106 ( 226 Lockers)	Inspected
Condition	2 - Between Good and Fair
Deficiency	No deficiencies recorded
<b>Floor Finish</b>	
Instance on 1st Floor - Room 102 (220 Lockers)	Inspected
Condition	2 - Between Good and Fair
Deficiency	VINYL TILES: BROKEN/DETERIORATED/MISSING TILES
Deficiency Location/Instance	Near center
Deficiency Quantity	10
Quantity Uom	S.F.
Potential Action	REPLACE
Urgency of Action	PRIORITY 3
Purpose of Action	LEVEL 2
Deficiency Photo1

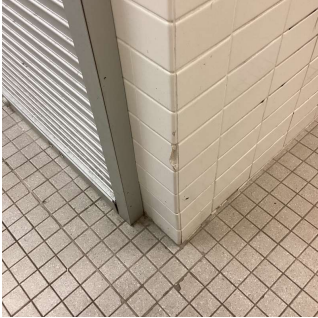
Question	Response
<b>INTERIOR</b>	
<b>LOCKER ROOM</b>	
Instance on 1st Floor - Room 144 (144 Lockers)	Inspected
Condition	2 - Between Good and Fair
Deficiency	CERAMIC TILE: BROKEN/ MISSING
Deficiency Location/Instance	Near Entrance, Shower Room
Deficiency Quantity	20
Quantity Uom	S.F.
Potential Action	REPLACE
Urgency of Action	PRIORITY 3
Purpose of Action	LEVEL 2
Deficiency Photo1

Violations	Near Shower Room No violations recorded.
Instance on 1st Floor - Room 145 (160 Lockers)	Inspected
Condition	2 - Between Good and Fair
Deficiency	CERAMIC TILE: BROKEN/ MISSING
Deficiency Location/Instance	Near Entrance
Deficiency Quantity	10
Quantity Uom	S.F.
Potential Action	REPLACE
Urgency of Action	PRIORITY 3
Purpose of Action	LEVEL 2
Deficiency Photo1

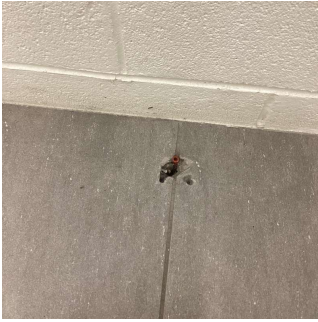
Violations	Stair B/1 No violations recorded.
Deficiency	CERAMIC TILE: BROKEN/MISSING
Deficiency Location/Instance	Stair C/5
Deficiency Quantity	10
Quantity Uom	S.F.
Potential Action	REPLACE
Urgency of Action	PRIORITY 3
Purpose of Action	LEVEL 2
Deficiency Photo1

Violations	Stair C/5 No violations recorded.
<b>Walls</b>	Inspected
Condition	2 - Between Good and Fair
Deficiency	MASONRY: CRACKS/SPALLING
Deficiency Location/Instance	Stairs A/1, 2, 3, 4, B/2, and others

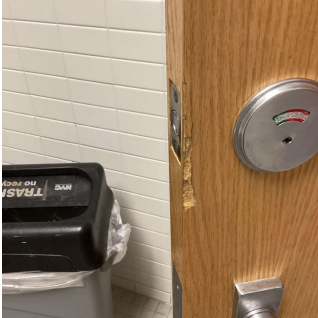
Violations	Room 131 No violations recorded.
<b>Door(s)</b>	
Condition	Inspected
Condition	2 - Between Good and Fair
Deficiency	WOOD: DETERIORATED DOOR
Deficiency Location/Instance	Room 335
Deficiency Quantity	1
Quantity Uom	EACH
Potential Action	MAINTENANCE
Urgency of Action	PRIORITY 3
Purpose of Action	LEVEL 2
Deficiency Photo1

Violations	Room 335 No violations recorded.
<b>Floor Finish</b>	
Condition	Inspected
Condition	2 - Between Good and Fair
Deficiency	No deficiencies recorded
<b>Stalls</b>	
Condition	Inspected
Condition	2 - Between Good and Fair
Deficiency	No deficiencies recorded

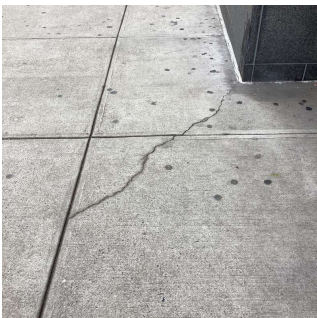
51st Avenue
Violations	No violations recorded.
Deficiency	DAMAGED/DETERIORATED/MISSING SECTIONS
Deficiency Location/Instance	51st Avenue, Borden Avenue, Center Boulevard
Deficiency Quantity	450
Quantity Uom	S.F.
Potential Action	REPLACE
Urgency of Action	PRIORITY 3
Purpose of Action	LEVEL 2
Deficiency Photo1

51st Avenue
Violations	No violations recorded.
<b>Pavers</b>	Does not Exist
<b>PLAYGROUNDS</b>	Does not Exist
<b>PLAYING SURFACE</b>	Does not Exist
<b>RETAINING WALLS</b>	Does not Exist
