**NYC Department of Education
Building Condition Assessment Survey 2023 - 2024**

Architectural Inspection

Asset: **BAYSIDE AF - QUEENS, 204-29 29TH AVENUE, New York, 11361**

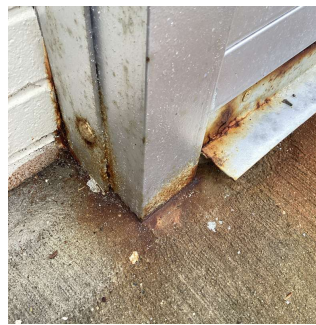
Facade C

Question	Response
Architectural	
EXTERIOR	Inspected
AREAWAY	Does not Exist
AWNINGS AND CANOPIES	Does not Exist
CHIMNEY	Inspected
Material Type(s)	Metal
Condition	2 - Between Good and Fair
Deficiency	No deficiencies recorded
COPING	Does not Exist
CORNICE	Does not Exist
DOORS	Inspected
DOORS AND FRAMES	Inspected
Condition	5 - Poor
Deficiency	ROLL-UP DOOR: DETERIORATED DOOR AND FRAME - MAJOR DETERIORATION

300
 S.F.
 REPLACE
 PRIORITY 4
 LEVEL 2

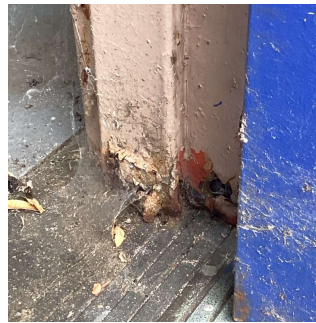
Facade A

METAL CLAD: DETERIORATED DOOR AND FRAME - MAJOR DETERIORATION

6
 EACH
 REPLACE
 PRIORITY 4
 LEVEL 2

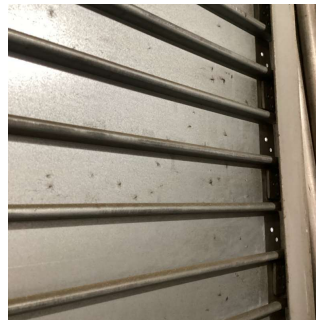
Facade A

ROLL-UP DOOR: DETERIORATED DOOR - MINOR DETERIORATION

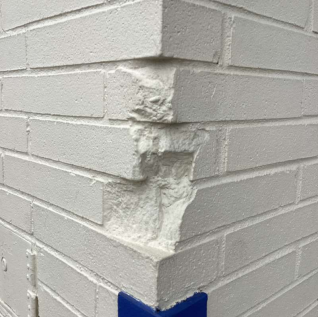
Question	Response
EXTERIOR	
EXTERIOR WALLS	Inspected
Material Type(s)	Masonry
Replacement Quantity	4,000
Replacement Uom	S.F.
Instance on All Facades	Inspected
Instance Condition	4 - Between Fair and Poor
Instance Quantity	4,000
Instance Quantity Uom	S.F.
Deficiency	BRICK: CRACKS/DISPLACED/SPALLED BRICK AT BUILDING CORNERS
Roof Plan reference	 
Elevation

Deficiency Quantity	10
Quantity Uom	S.F.
Potential Action	REMOVE AND REBUILD
Urgency of Action	PRIORITY 4
Purpose of Action	LEVEL 2
Deficiency Photo1

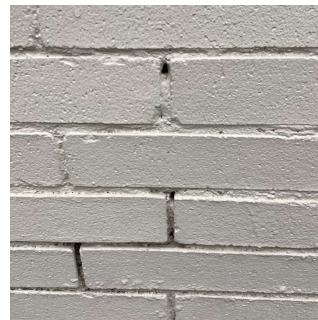
Violations	Facade A No violations recorded.
Deficiency	BRICK: DETERIORATED JOINTS

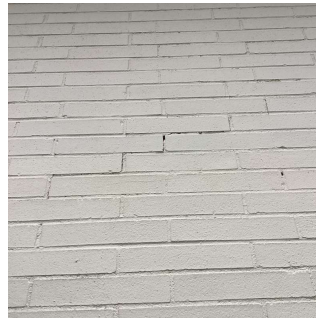
Facade A

BRICK: MINOR CRACKS AND SPALLING

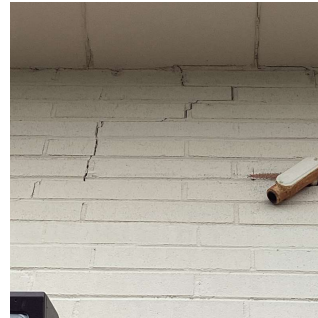
Facade A

BRICK: MAJOR / THRU CRACKS

PRIORITY 4
LEVEL 2

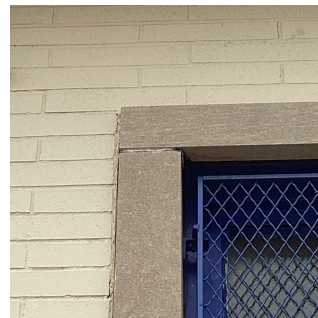
Facade C

BRICK: MASONRY SILLS - DETERIORATED JOINTS

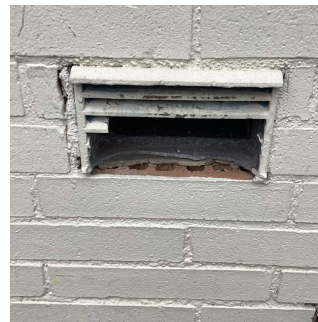
Facade A

Deficiency Quantity	30
Quantity Uom	S.F.
Potential Action	REPAIR
Urgency of Action	PRIORITY 3
Purpose of Action	LEVEL 2
Deficiency Photo1	 
Violations	Facade C No violations recorded.
LOUVER	Inspected
Condition	3 - Fair
Deficiency	BROKEN/ DENTED BLADES

REPLACE

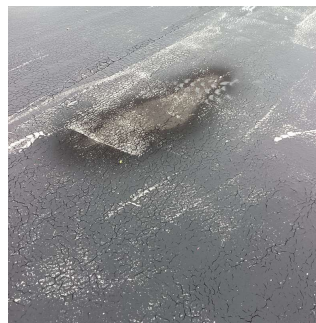
Roof 1

Deficiency	MODIFIED BITUMEN: ROOFING: DELAMINATION
------------	---

Potential Action	REPLACE ROOFING WITHOUT MAJOR EQUIPMENT REMOVAL
------------------	---

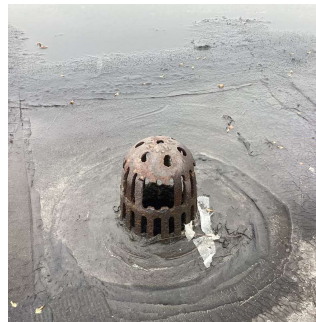
DETERIORATED

Roof 1
No violations recorded.

3
EACH
REPLACE
PRIORITY 4
LEVEL 2

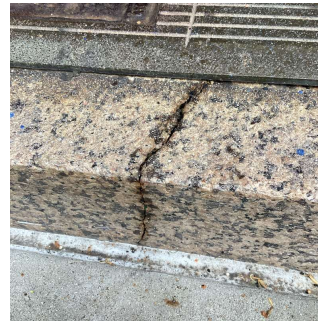
Facade A

STONE: CRACKS/SPALLING - MAJOR

REPLACE
PRIORITY 4
LEVEL 2

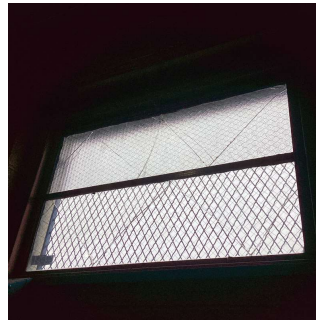
Facade A

STEEL: BROKEN PANE

150
S.F.
MAINTENANCE
PRIORITY 3
LEVEL 2

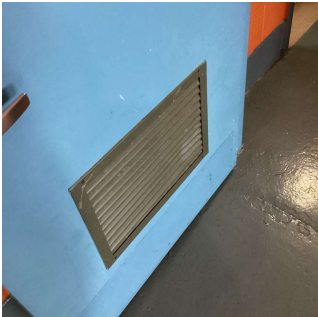
Condition	3 - Fair
Deficiency	METAL: DAMAGED LOUVER
Deficiency Location/Instance	Exit to toilet Room
Deficiency Quantity	1
Quantity Uom	EACH
Potential Action	MAINTENANCE
Urgency of Action	PRIORITY 3
Purpose of Action	LEVEL 2
Deficiency Photo1

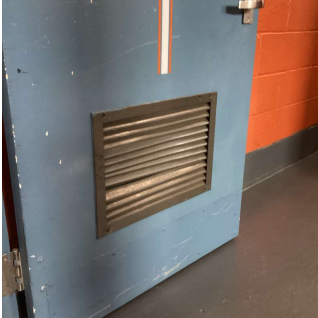
Violations	Exit to toilet Room No violations recorded.
Instance on 1st Floor - Boys South (86 Lockers)	Inspected
Condition	3 - Fair
Deficiency	METAL: DAMAGED LOUVER

Question	Response
INTERIOR	
LOCKER ROOM	
Door(s)	
Deficiency Location/Instance	Entrance
Deficiency Quantity	1
Quantity Uom	EACH
Potential Action	MAINTENANCE
Urgency of Action	PRIORITY 3
Purpose of Action	LEVEL 2
Deficiency Photo1

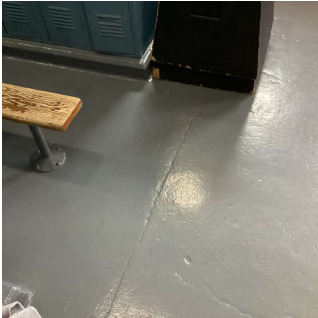
Entrance
Violations	No violations recorded.
Floor Finish	
Instance on 1st Floor - Boys North (136 Lockers)	Inspected
Condition	5 - Poor
Deficiency	CONCRETE: CRACKS
Deficiency Location/Instance	Center, Near Office
Deficiency Quantity	200
Quantity Uom	S.F.
Potential Action	REPLACE
Urgency of Action	PRIORITY 3
Purpose of Action	LEVEL 2
Deficiency Photo1

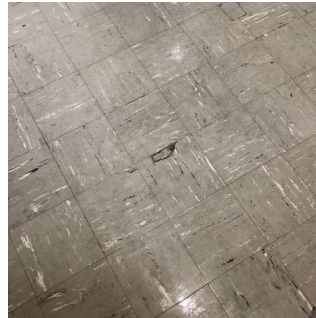
Back Room

VINYL TILES: BROKEN/DETERIORATED/MISSING TILES

REPLACE

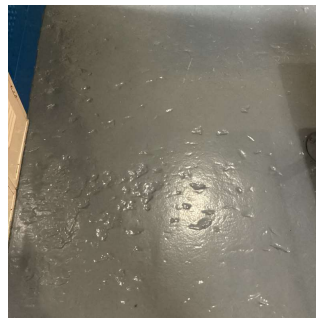
CONCRETE: CRACKS

REPLACE

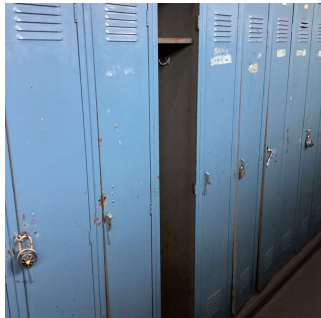
Question	Response
INTERIOR	
LOCKER ROOM	
Floor Finish	
Center	Center
Violations	No violations recorded.
Locker Room Lockers	
Instance on 1st Floor - Boys North (136 Lockers)	Inspected
Condition	5 - Poor
Deficiency	DAMAGED UNITS
Deficiency Location/Instance	Lockers 71, 72, 74, 75, 86 and others
Deficiency Quantity	14
Quantity Uom	EACH
Potential Action	REPLACE
Urgency of Action	PRIORITY 3
Purpose of Action	LEVEL 2
Deficiency Photo1

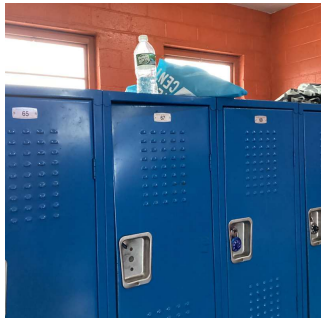
Locker 72	
Violations	No violations recorded.
Instance on 1st Floor - Boys South (86 Lockers)	Inspected
Condition	3 - Fair
Deficiency	DAMAGED UNITS
Deficiency Location/Instance	Lockers 1, 56, 67
Deficiency Quantity	3
Quantity Uom	EACH
Potential Action	REPLACE
Urgency of Action	PRIORITY 3
Purpose of Action	LEVEL 2
Deficiency Photo1

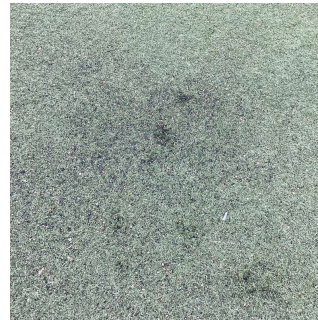
Baseball/Softball Field
 No violations recorded.

Question	Response
INTERIOR	
TOILET ROOMS - STUDENTS	
Stalls	
Deficiency Photo1	 
Violations	Inside Girls Locker Room No violations recorded.
Walls	
Condition	Inspected 2 - Between Good and Fair
Deficiency	MASONRY: CRACKS/SPALLING
Deficiency Location/Instance	Inside Girls Locker Room
Deficiency Quantity	20
Quantity Uom	S.F.
Potential Action	REPLACE
Urgency of Action	PRIORITY 3
Purpose of Action	LEVEL 2
Deficiency Photo1	 
Violations	Inside Girls Locker Room No violations recorded.
ATHLETIC FIELDS	
PLAYING SURFACE	
Synthetic Turf Field exists?	Inspected Yes
Year of Installation	2002
Replacement Quantity	250,000
Replacement Uom	S.F.
Instance on Baseball/ Softball Field	Inspected
Instance Condition	3 - Fair
Instance Quantity	75,000
Instance Quantity Uom	S.F.
Deficiency	ARTIFICIAL TURF: DAMAGED/WORN OUT
Deficiency Location/Instance	Baseball/Softball Field

120
 S.F.
 REPLACE
 PRIORITY 4
 LEVEL 2

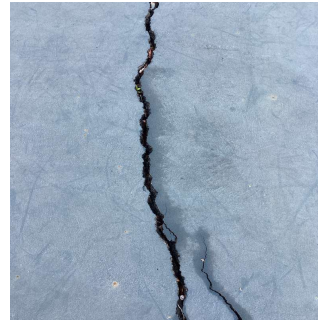
Basketball Courts

ASPHALT: DAMAGED/DETERIORATED

7,200
 S.F.
 REPLACE
 PRIORITY 5
 LEVEL 4

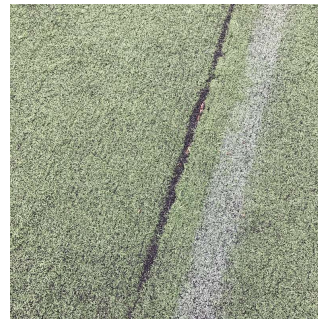
Football/Soccer Field

ARTIFICIAL TURF: DAMAGED/WORN OUT

REPLACE

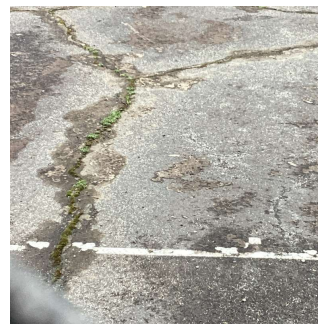
Handball Courts

ASPHALT: DAMAGED/DETERIORATED

REPLACE

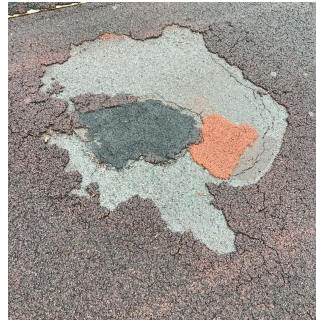
Running Track

ATHLETIC WEARING SURFACE: DAMAGED/DETERIORATED

REPLACE

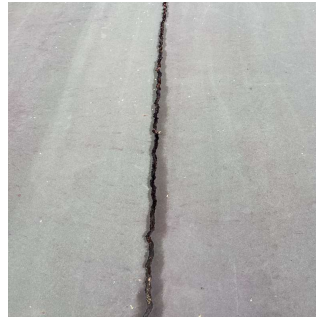
Tennis Courts

ASPHALT: DAMAGED/DETERIORATED

REPLACE

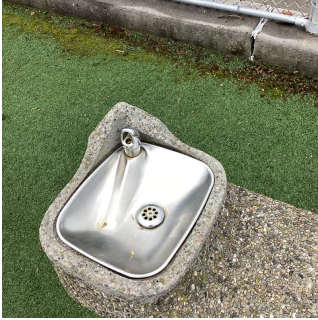
Question	Response
SITE	
Drainage System for Concrete	Inspected
Catch Basins/Manhole - Surrounded by concrete	Inspected
Violations	No violations recorded.
Culverts - Concrete Covering	Does not Exist
Drainage System for Soil	Does not Exist
DRINKING FOUNTAINS	
Condition	5 - Poor
Deficiency	DAMAGED
Deficiency Location/Instance	Near Softball Field
Deficiency Quantity	1
Quantity Uom	EACH
Potential Action	REPLACE
Urgency of Action	PRIORITY 3
Purpose of Action	LEVEL 2
Deficiency Photo1

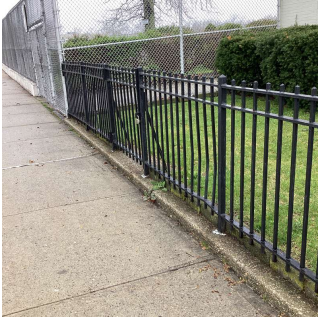
Violations	Near Softball Field No violations recorded.
FENCES	
Condition	4 - Between Fair and Poor
Deficiency	WROUGHT IRON: DAMAGED/DETERIORATED
Deficiency Location/Instance	32nd Avenue
Deficiency Quantity	160
Quantity Uom	S.F.
Potential Action	REPLACE
Urgency of Action	PRIORITY 3
Purpose of Action	LEVEL 2
Deficiency Photo1

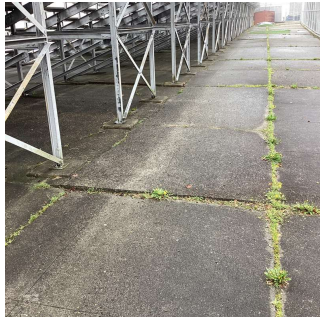
Question	Response
SITE	
PAVING	
Student Non-Use	
Concrete	
Deficiency Photo1

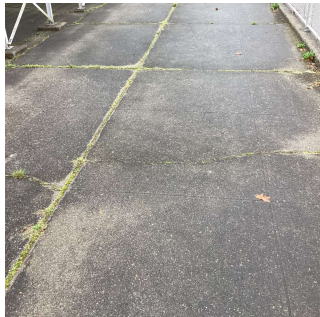
Violations	Near Bleachers No violations recorded.
Deficiency	CRACKS - MAJOR
Deficiency Location/Instance	Near Bleachers
Deficiency Quantity	2,500
Quantity Uom	S.F.
Potential Action	REPLACE
Urgency of Action	PRIORITY 3
Purpose of Action	LEVEL 2
Deficiency Photo1

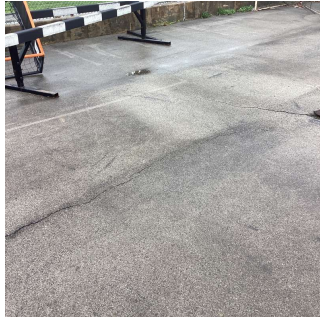
Violations	Near Bleachers No violations recorded.
Pavers	Does not Exist
Student Use	Inspected
Gravel Exists?	No
Asphalt	Inspected
Condition	3 - Fair
Deficiency	CRACKS - MAJOR
Deficiency Location/Instance	Near Handball courts, Near 32nd Avenue
Deficiency Quantity	300
Quantity Uom	S.F.
Potential Action	REPLACE
Urgency of Action	PRIORITY 3
Purpose of Action	LEVEL 2

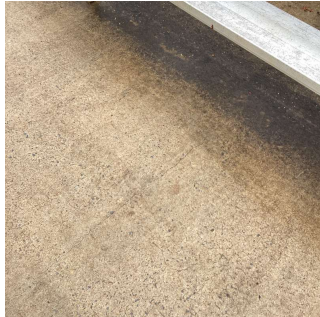
Violations	Near Handball courts No violations recorded.
Concrete	Inspected
Condition	3 - Fair
Deficiency	CRACKS - MAJOR
Deficiency Location/Instance	Baseball Field, Softball Field
Deficiency Quantity	100
Quantity Uom	S.F.
Potential Action	REPLACE
Urgency of Action	PRIORITY 3
Purpose of Action	LEVEL 2
Deficiency Photo1

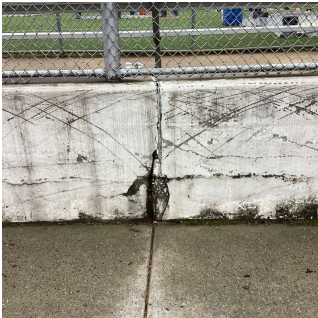
Question	Response
SITE	
PAVING	Inspected
DOT Sidewalk	
Concrete	Inspected
Violations	No violations recorded.
Pavers	Does not Exist
PLAYGROUNDS	Does not Exist
RETAINING WALLS	Inspected
Are there any Retaining Walls 6' OR higher facing public street/sidewalk?	No
Condition	4 - Between Fair and Poor
Deficiency	CAST IN PLACE CONCRETE: DETERIORATED CONTROL/EXPANSION JOINT
Deficiency Location/Instance	204th Street
Deficiency Quantity	100
Quantity Uom	L.F.
Potential Action	REPLACE
Urgency of Action	PRIORITY 3
Purpose of Action	LEVEL 2
Deficiency Photo1

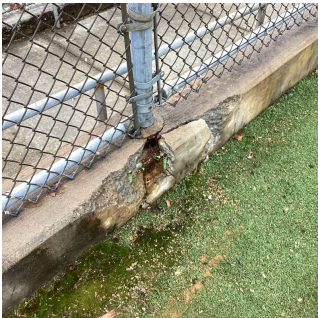
Priority Condition Exist Last Year?	Priority Category	Condition Description	Component Affected	Location Description	Person(s) Notified	Person(s) Title	PhotoImage
No	Protruding Elements	Severely damaged retaining wall with protruding metal is a potential safety hazard.	SITE RETAINING WALLS	Near Softball Field	Esteban Rodriguez	Fireman

204th Street	
Violations	No violations recorded.
Deficiency	CAST IN PLACE CONCRETE: CRACKS/SPALLING - MAJOR
Deficiency Location/Instance	Near Softball Field
Deficiency Quantity	40
Quantity Uom	S.F.
Potential Action	REPLACE
Urgency of Action	PRIORITY 5
Purpose of Action	LEVEL 6
Deficiency Photo1

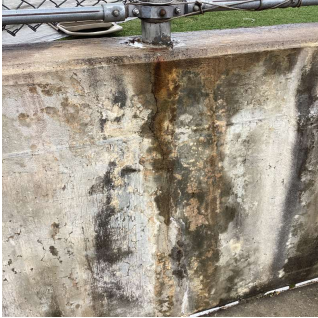
Near Softball Field	
Violations	35665576R
Deficiency	CAST IN PLACE CONCRETE: CRACKS/SPALLING - MAJOR

Question	Response
SITE	
RETAINING WALLS	Inspected
Deficiency Quantity	400
Quantity Uom	S.F.
Potential Action	REPLACE
Urgency of Action	PRIORITY 3
Purpose of Action	LEVEL 2
Deficiency Photo1

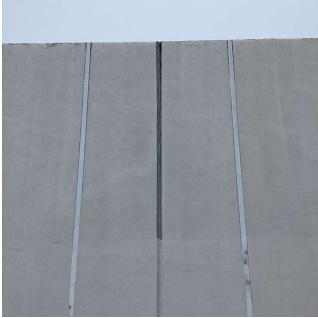
204th Street
Violations	No violations recorded.
SEATING	Does not Exist
SITE WALLS (NOT RETAINING WALLS)	Inspected
Condition	3 - Fair
Deficiency	CAST IN PLACE CONCRETE: DETERIORATED CONTROL/EXPANSION JOINT
Deficiency Location/Instance	Handball courts
Deficiency Quantity	40
Quantity Uom	L.F.
Potential Action	REPLACE
Urgency of Action	PRIORITY 3
Purpose of Action	LEVEL 2
Deficiency Photo1

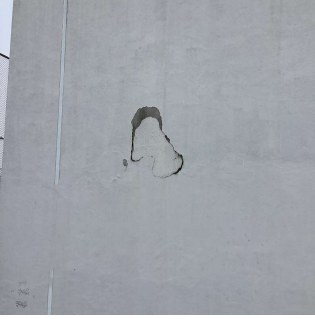
Handball courts
Violations	No violations recorded.
Deficiency	CAST IN PLACE CONCRETE: CRACKS/SPALLING - MAJOR
Deficiency Location/Instance	Handball courts
Deficiency Quantity	20
Quantity Uom	S.F.
Potential Action	REPLACE
Urgency of Action	PRIORITY 3
Purpose of Action	LEVEL 2
