**NYC Department of Education**  
**Building Condition Assessment Survey 2023 - 2024**

Architectural Inspection

Asset: **PRE-K CENTER @ 14-45 143RD STREET - QUEENS, 14-45 143RD STREET, New York, 11357**

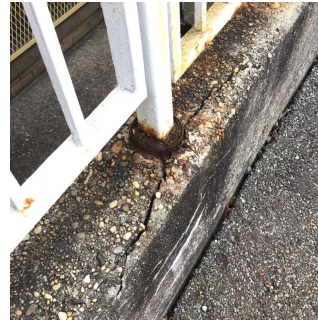
AW1

**AREAWAY WALLS: CRACKS AND SPALLING**

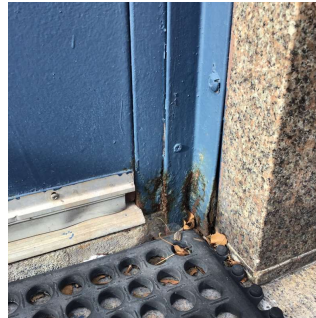
Facade C

METAL: DETERIORATED DOOR AND FRAME - MINOR DETERIORATION

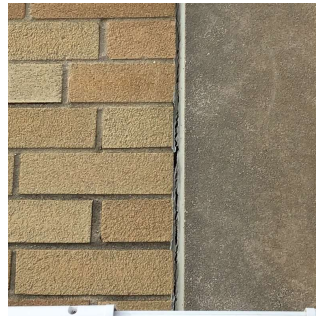
Facade C

BRICK: DETERIORATED CONTROL/EXPANSION JOINTS

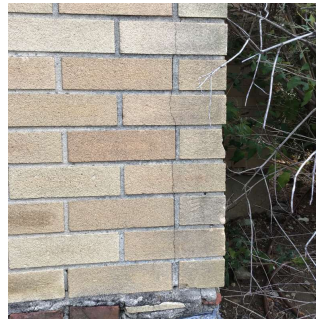
Facade A

Deficiency BRICK: CRACKS/DISPLACED/SPALLED BRICK AT BUILDING CORNERS

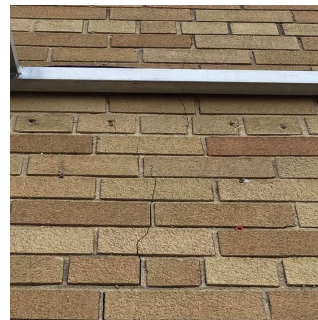
Facade A

Deficiency BRICK: MAJOR / THRU CRACKS

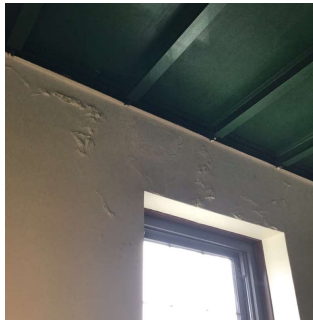
Facade C - Stair C/2

BRICK: WATER INFILTRATION IN INSTRUCTIONAL SPACE

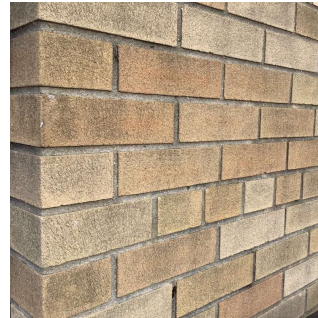
Facade A

BRICK: DETERIORATED JOINTS

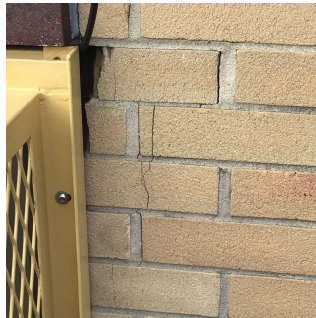
Facade C

**BRICK: MINOR CRACKS AND SPALLING**

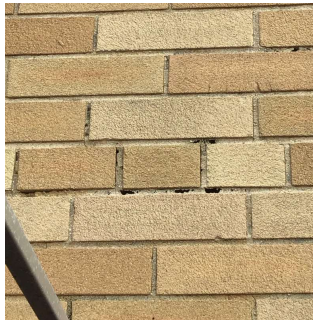
Facade A

**BRICK: DETERIORATED JOINTS**

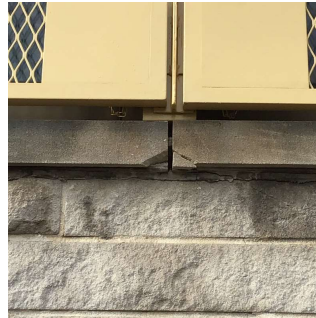
Facade C

BRICK: DETERIORATED MASONRY SILLS - MINOR

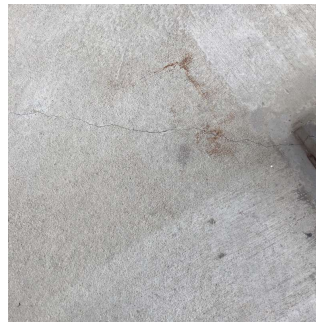
Facade A

CONCRETE: CRACKS/SPALLING - MINOR

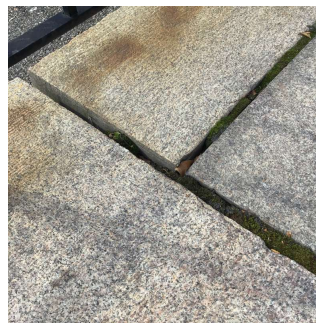
Facade C

**STONE: DETERIORATED JOINTS**

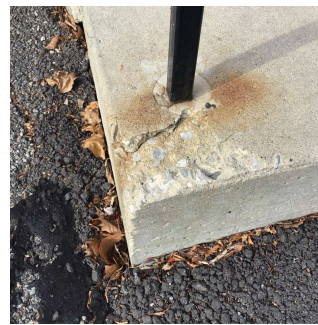
Facade C

**CONCRETE: CRACKS/SPALLING - MAJOR**

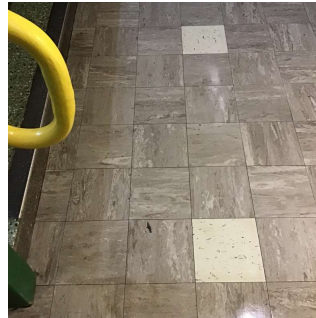
Stair B/Basement

VINYL TILES: BROKEN/DETERIORATED/MISSING TILES
