NYC Department of Education
Building Condition Assessment Survey 2023 - 2024

Architectural Inspection

Q411

Asset: BEACH CHANNEL AF - QUEENS, 100-00 BEACH CHANNEL DRIVE, New York, 11694

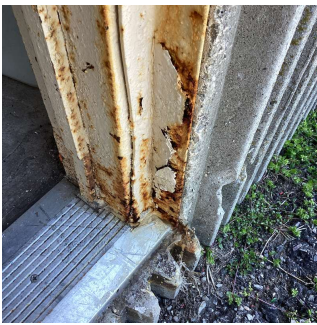
Deficiency METAL: DETERIORATED DOOR AND FRAME - MAJOR DETERIORATION

Violations	Facade B No violations recorded.
DOOR HARDWARE	Inspected
Condition	2 - Between Good and Fair
Deficiency	No deficiencies recorded
LINTELS	Inspected
Condition	2 - Between Good and Fair
Deficiency	No deficiencies recorded
TRANSOM/SIDE LIGHT	Does not Exist
EXTERIOR WALLS	Inspected
Material Type(s)	Concrete
Replacement Quantity	7,000
Replacement Uom	S.F.
Instance on All Facades	Inspected
Instance Condition	5 - Poor
Instance Quantity	7,000
Instance Quantity Uom	S.F.
Deficiency	CAST IN PLACE / PRE-CAST CONCRETE: MAJOR CRACKS/SPALLING
Roof Plan reference

REPLACE

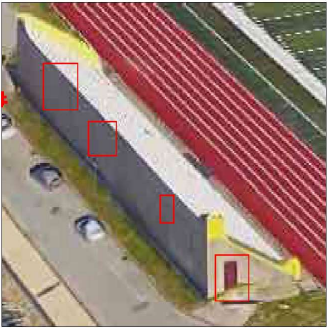
Deficiency Quantity	500

Question	Response
EXTERIOR	
EXTERIOR WALLS	
Quantity Uom	S.F.
Potential Action	REPLACE
Urgency of Action	PRIORITY 4
Purpose of Action	LEVEL 2
Deficiency Photo1	 
	Facade B
Violations	No violations recorded.
EXTERIOR SOFFITS	Does not Exist
LOUVER	Does not Exist
PARAPETS	Inspected
Material Type(s)	Concrete
Replacement Quantity	1,000
Replacement Uom	C.F.
Instance on North and South Bleachers	Inspected
Instance Condition	4 - Between Fair and Poor
Instance Quantity	1,000
Instance Quantity Uom	C.F.
Deficiency	CONCRETE: MINOR CRACKS, SPALLING
Roof Plan reference	 
Deficiency Quantity	100
Quantity Uom	S.F.
Potential Action	REPAIR
Urgency of Action	PRIORITY 3
Purpose of Action	LEVEL 2

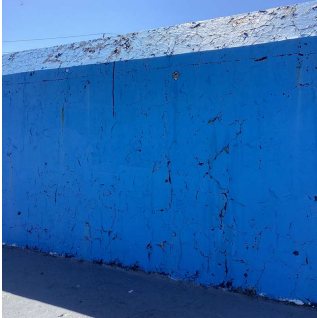
Violations	South Bleachers No violations recorded.
Deficiency	CONCRETE: MAJOR DETERIORATION/CRACKS
Roof Plan reference

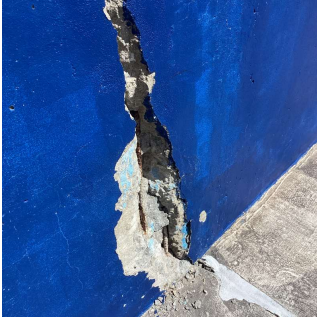
Deficiency Quantity	30
Quantity Uom	S.F.
Potential Action	REMOVE AND REBUILD
Urgency of Action	PRIORITY 4
Purpose of Action	LEVEL 2
Deficiency Photo1

Violations	North Bleachers No violations recorded.
PLAZA DECK	Inspected
Instance on Concrete: North and South Bleachers	Inspected
Instance Condition	5 - Poor
Instance Quantity	2,100
Instance Quantity Uom	S.F.
Installation Year	1973
Source of Installation	Custodial Staff
Deficiency	CONCRETE: MAJOR ACTIVE PLAZA DECK LEAKS IN NON-INSTRUCTIONAL SPACE

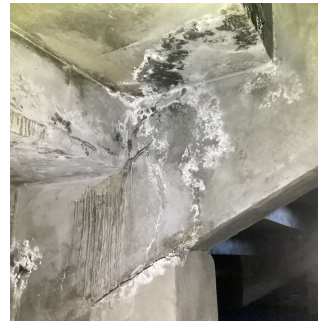
Plaza Deck

300
S.F.
REPLACE
PRIORITY 5
LEVEL 2

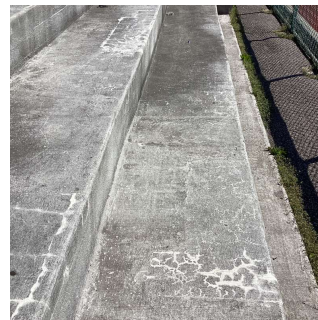
CONCRETE: MINOR CRACKS

100
S.F.
REPAIR
PRIORITY 3
LEVEL 2

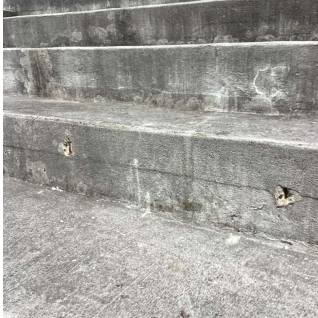
Question	Response
EXTERIOR	
PLAZA DECK	
Violations	North Bleachers No violations recorded.
Deficiency	CONCRETE: MAJOR CRACKS
Roof Plan reference

Deficiency Quantity	30
Quantity Uom	S.F.
Potential Action	REPLACE
Urgency of Action	PRIORITY 4
Purpose of Action	LEVEL 2
Deficiency Photo1

Violations	North Bleachers No violations recorded.
ROOF	Does not Exist
STAIRS/RAMPS: EXTERIOR	Does not Exist
WINDOWS	Does not Exist
INTERIOR	Inspected
STRUCTURAL	Inspected
COLUMNS/BEAMS/BEARING WALLS	Inspected
Condition	3 - Fair
Deficiency	CONCRETE COLUMNS/BEAMS: CRACKED/SPALLED/REINFORCEMENT EXPOSED
Deficiency Location/Instance	North Bleachers
Deficiency Quantity	30
Quantity Uom	S.F.
Potential Action	REPAIR
Urgency of Action	PRIORITY 3
Purpose of Action	LEVEL 5

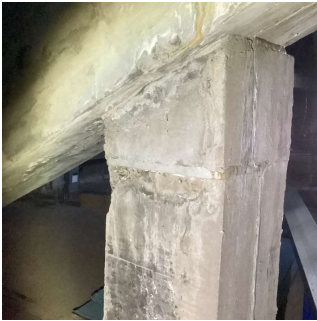
Violations	North Bleachers No violations recorded.
FLOOR STRUCTURE	
Condition	Inspected 4 - Between Fair and Poor
Deficiency	CONCRETE SLAB ON GRADE: THRU CRACKS
Deficiency Location/Instance	North and South Bleachers
Deficiency Quantity	400
Quantity Uom	S.F.
Potential Action	REPLACE
Urgency of Action	PRIORITY 4
Purpose of Action	LEVEL 5
Deficiency Photo1

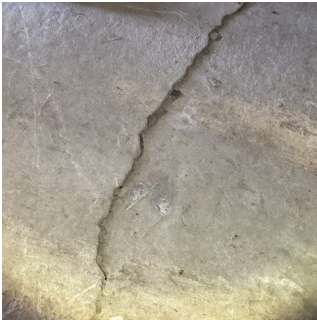
Violations	North Bleachers No violations recorded.
FOUNDATION WALLS	
Material Type(s)	Inspected Concrete
Condition	2 - Between Good and Fair
Deficiency	No deficiencies recorded
ROOF STRUCTURE	
Condition	Inspected 4 - Between Fair and Poor
Deficiency	CONCRETE: CRACKED/SPALLED/REINFORCEMENT EXPOSED
Deficiency Location/Instance	North and SouthBleachers
Deficiency Quantity	200
Quantity Uom	S.F.
Potential Action	REPAIR
Urgency of Action	PRIORITY 4
Purpose of Action	LEVEL 5

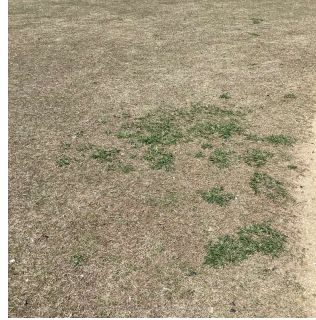
Baseball Field

Instance on Basketball Courts	Under Construction
Instance Quantity	21,000
Instance Quantity Uom	S.F.
Instance on Football/Soccer Field	Inspected
Instance Condition	2 - Between Good and Fair
Instance Quantity	79,000
Instance Quantity Uom	S.F.
Deficiency	No deficiencies recorded
Instance on Handball Courts	Under Construction
Instance Quantity	9,500
Instance Quantity Uom	S.F.
Instance on Running Track	Inspected
Instance Condition	4 - Between Fair and Poor
Instance Quantity	32,000
Instance Quantity Uom	S.F.

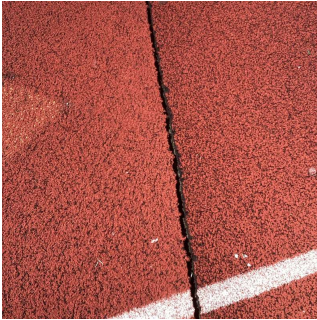
Deficiency ATHLETIC WEARING SURFACE: DAMAGED/DETERIORATED

Running Track

Violations	Running Track No violations recorded.
Instance on Tennis Courts	Inspected
Instance Condition	1 - Good
Instance Quantity	37,000
Instance Quantity Uom	S.F.
Deficiency	No deficiencies recorded
FIXED EQUIPMENT	Inspected
Basketball Backboard	Under Construction
Basketball Hoops	Under Construction
Basketball Posts	Under Construction
Football Goal Posts	Inspected
Condition	2 - Between Good and Fair
Deficiency	No deficiencies recorded
Tennis Net Posts	Inaccessible
SEATING	Inspected
Benches	Inspected
Concrete	Does not Exist
Metal/Wood/Plastic	Inspected
Condition	2 - Between Good and Fair
Deficiency	No deficiencies recorded
Bleachers	Does not Exist
SITE	Inspected
CONTAINERIZATION	Does not Exist
Drainage System for Asphalt	Inspected
Catch Basins/Manhole - Surrounded by asphalt	Inspected
Condition	2 - Between Good and Fair
Deficiency	No deficiencies recorded

REPLACE

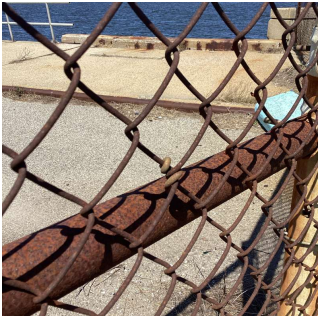
Violations	West Parking Lot 35672987R
Deficiency	CHAIN LINK: RUST - MAJOR
Deficiency Location/Instance	Around Running Track, Near South Bleachers, Beach Channel Drive
Deficiency Quantity	2,000
Quantity Uom	S.F.
Potential Action	REPLACE

Urgency of Action	PRIORITY 3
Purpose of Action	LEVEL 2
Deficiency Photo1

Question	Response
SITE	
FENCES	
Violations	Near South Bleachers No violations recorded.
Deficiency	CHAIN LINK: DAMAGED POST/RAIL
Deficiency Location/Instance	Parking Lot entrance Near Water, Handball Court
Deficiency Quantity	300
Quantity Uom	L.F.
Potential Action	REPLACE
Urgency of Action	PRIORITY 3
Purpose of Action	LEVEL 2
Deficiency Photo1

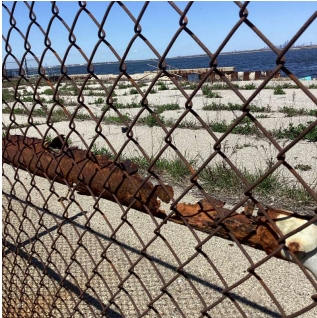
Violations	Near South Bleachers No violations recorded.
Deficiency	CHAIN LINK: DAMAGED/DETERIORATED
Deficiency Location/Instance	Parking Lot entrance Near Water, Around Running Track, Handball Court, Beach Channel Drive
Deficiency Quantity	1,300
Quantity Uom	S.F.
Potential Action	REPLACE
Urgency of Action	PRIORITY 3
Purpose of Action	LEVEL 2
Deficiency Photo1

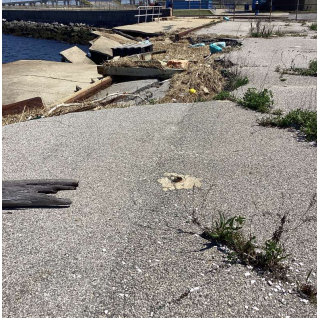
Asphalt	
Condition	Inspected
Deficiency	5 - Poor LOCALIZED SINK AREA

Question	Response
SITE	
PAVING	
Student Non-Use	
Asphalt	
Deficiency Location/Instance	West Parking Lot
Deficiency Quantity	300
Quantity Uom	S.F.
Potential Action	REPAIR
Urgency of Action	PRIORITY 5
Purpose of Action	LEVEL 6
Deficiency Photo1

Violations	West Parking Lot No violations recorded.
Deficiency	CRACKS - MAJOR
Deficiency Location/Instance	Beaching Bleachers Right Side
Deficiency Quantity	5,000
Quantity Uom	S.F.
Potential Action	REPLACE
Urgency of Action	PRIORITY 3
Purpose of Action	LEVEL 2
Deficiency Photo1

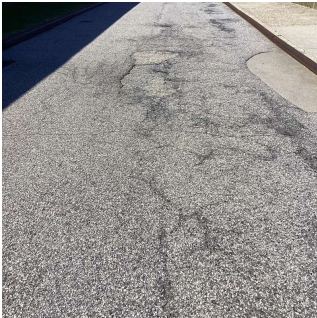
Violations	Beaching Bleachers Right Side No violations recorded.
Concrete	Inspected
Condition	2 - Between Good and Fair
Deficiency	No deficiencies recorded
Pavers	Does not Exist
Student Use	Does not Exist
Site Sidewalks & Walkways	Inspected
Asphalt	Inspected
Condition	3 - Fair
Deficiency	CRACKS - MAJOR
Deficiency Location/Instance	Near North and South Bleachers
Deficiency Quantity	200

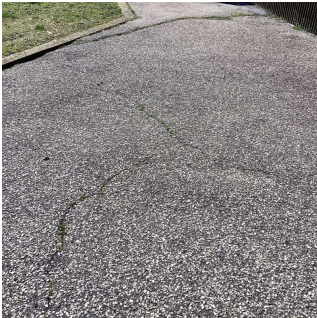
Question	Response
SITE	
PAVING	
Site Sidewalks & Walkways	
Asphalt	
Quantity Uom	S.F.
Potential Action	REPLACE
Urgency of Action	PRIORITY 3
Purpose of Action	LEVEL 2
Deficiency Photo1

Near North Bleacher
Violations	No violations recorded.
Concrete	
	Inspected
Condition	4 - Between Fair and Poor
Deficiency	DAMAGED/DETERIORATED/MISSING SECTIONS
Deficiency Location/Instance	West Parking Lot
Deficiency Quantity	600
Quantity Uom	S.F.
Potential Action	REPLACE
Urgency of Action	PRIORITY 5
Purpose of Action	LEVEL 6
Deficiency Photo1

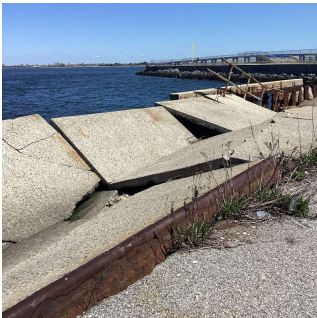
Yes	Tripping Hazard	Collapse walkway is Safety Hazard Condition	SITE PAVING Site Sidewalks & Walkways Concrete	West Parking Lot	Frank Monteleone	Fireman

West Parking Lot
Violations	No violations recorded.
Deficiency	DAMAGED CURBS
Deficiency Location/Instance	West Parking Lot, along water Retaining Wall
Deficiency Quantity	250
Quantity Uom	L.F.
Potential Action	REPLACE
Urgency of Action	PRIORITY 3
Purpose of Action	LEVEL 2

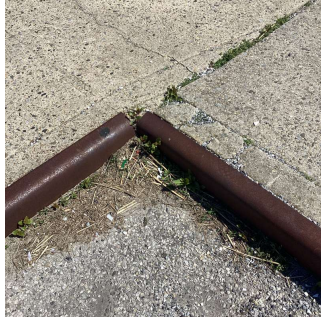
Violations	along water Retaining Wall No violations recorded.
Deficiency	DAMAGED/DETERIORATED/MISSING SECTIONS
Deficiency Location/Instance	Behind Bleachers North and South Side, Along Water retaining Wall
Deficiency Quantity	2,250
Quantity Uom	S.F.
Potential Action	REPLACE
Urgency of Action	PRIORITY 3
Purpose of Action	LEVEL 2
Deficiency Photo1

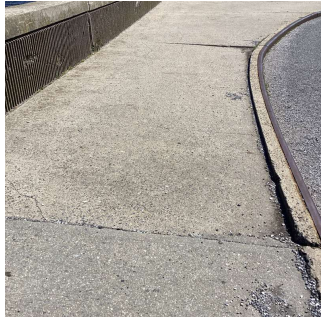
Violations	Behind Bleachers north Side No violations recorded.
Pavers	Does not Exist
DOT Sidewalk	Inspected
Asphalt	Does not Exist
Concrete	Inspected
Condition	4 - Between Fair and Poor
Deficiency	DAMAGED/DETERIORATED/MISSING SECTIONS
Deficiency Location/Instance	Beach Channel Drive
Deficiency Quantity	1,375
Quantity Uom	S.F.
Potential Action	REPLACE
Urgency of Action	PRIORITY 3
Purpose of Action	LEVEL 2

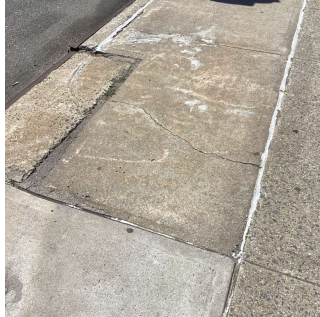
Violations	Beach Channel Drive No violations recorded.
Deficiency	DAMAGED CURBS
Deficiency Location/Instance	Beach Channel Drive
Deficiency Quantity	375
Quantity Uom	L.F.
Potential Action	REPLACE
Urgency of Action	PRIORITY 3
Purpose of Action	LEVEL 2
Deficiency Photo1

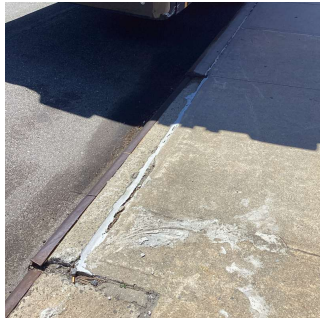
Violations	Beach Channel Drive No violations recorded.
Pavers	Does not Exist
PLAYGROUNDS	Does not Exist
RETAINING WALLS	Inspected
Are there any Retaining Walls 6' OR higher facing public street/sidewalk?	No
Condition	5 - Poor
Deficiency	CAST IN PLACE CONCRETE: CRACKS/SPALLING - MAJOR
Deficiency Location/Instance	Near Bleacher North Side, West Parking Lot
Deficiency Quantity	500
Quantity Uom	S.F.
Potential Action	REPLACE
Urgency of Action	PRIORITY 3
Purpose of Action	LEVEL 2

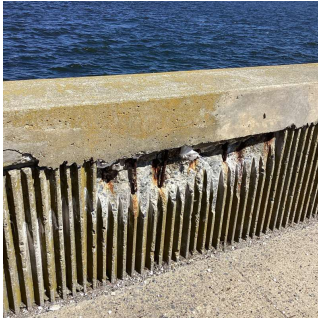
Near Bleacher Right Side	Near Bleacher Right Side
Violations	No violations recorded.
<hr/>	<hr/>
Deficiency	CAST IN PLACE CONCRETE: CRACKS/SPALLING - MAJOR
Deficiency Location/Instance	West Parking Lot
Deficiency Quantity	600
Quantity Uom	S.F.
Potential Action	REPLACE
Urgency of Action	PRIORITY 5
Purpose of Action	LEVEL 6
Deficiency Photo1

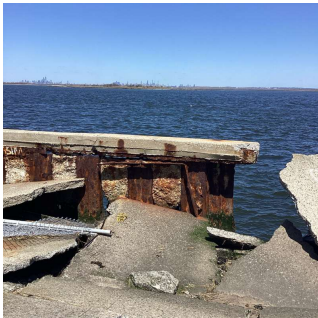
Priority Condition Exist Last Year?	Priority Category	Condition Description	Component Affected	Location Description	Person(s) Notified	Person(s) Title	PhotoImage
Yes	Potential Falling Debris	Collapse seawall is a safety hazard Condition	SITE RETAINING WALLS	West Parking Lot	Frank Monteleone	Fireman

Deteriorated Concrete	Deteriorated composite concrete/metal sheet pile seawall is a potential structural hazard	Columns / Beams / Bearing Walls	West Parking Lot between the Baseball Field and the Boating Ramp	Frank Monteleone	Fireman
-----------------------	---	---------------------------------	--	------------------	---------

West Parking Lot	West Parking Lot
Violations	35672987R
<hr/>	
SEATING	Does not Exist
<hr/>	
SITE WALLS (NOT RETAINING WALLS)	Under Construction
<hr/>	
STAIRS/RAMPS: EXTERIOR	Does not Exist
<hr/>	
ARTWORK	Does not Exist
