NYC Department of Education
Building Condition Assessment Survey 2023 - 2024

Architectural Inspection

Q412

Asset: **PRE-K CENTER @ 107-17 NORTHERN BOULEVARD - QUEENS, 107-17 NORTHERN BOULEVARD, New York, 11368**

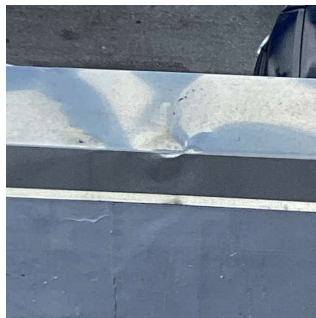
Question	Response
Architectural	
EXTERIOR	Inspected
AREAWAY	Does not Exist
AWNINGS AND CANOPIES	Does not Exist
CHIMNEY	Inspected
Material Type(s)	Metal
Condition	2 - Between Good and Fair
Deficiency	No deficiencies recorded
COPING	Inspected
Condition	3 - Fair
Deficiency	METAL: DETERIORATED
Roof Plan reference

10
 L.F.
 REPLACE-IN-KIND
 PRIORITY 4
 LEVEL 2

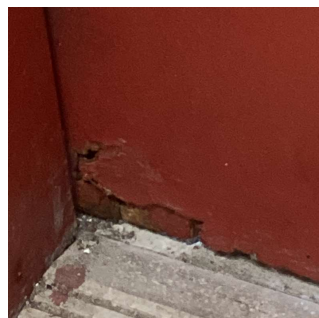
Question	Response
EXTERIOR	
COPING	
Violations	Roof 2 No violations recorded.
CORNICE	Does not Exist
DOORS	Inspected
DOORS AND FRAMES	Inspected
Condition	5 - Poor
Deficiency	METAL: DETERIORATED DOOR - MAJOR DETERIORATION
Roof Plan reference

Deficiency Quantity	1
Quantity Uom	EACH
Potential Action	REPLACE
Urgency of Action	PRIORITY 4
Purpose of Action	LEVEL 2
Deficiency Photo1

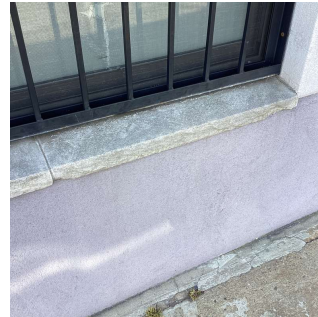
Facade A

STONE: DETERIORATED MASONRY SILLS - MINOR

10

REPAIR

PRIORITY 3

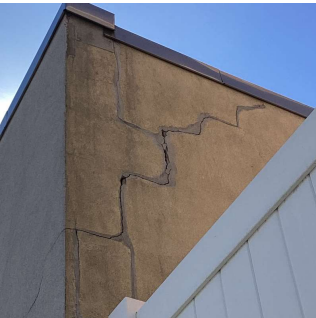
Question	Response
EXTERIOR	
EXTERIOR WALLS	
Elevation	 
Deficiency Quantity	90
Quantity Uom	S.F.
Potential Action	REPLACE
Urgency of Action	PRIORITY 4
Purpose of Action	LEVEL 2
Deficiency Photo1	 
Violations	Facade A No violations recorded.
EXTERIOR SOFFITS	Inspected
Condition	2 - Between Good and Fair
Deficiency	No deficiencies recorded
LOADING DOCK	Does not Exist
LOUVER	Inspected
Condition	2 - Between Good and Fair
Deficiency	No deficiencies recorded
PARAPETS	Inspected
Material Type(s)	Masonry, Concrete
Replacement Quantity	500
Replacement Uom	C.F.
Instance on All Roofs	Inspected
Instance Condition	5 - Poor
Instance Quantity	500
Instance Quantity Uom	C.F.
Deficiency	CONCRETE: MAJOR DETERIORATION/CRACKS

Deficiency Quantity	35
Quantity Uom	S.F.
Potential Action	REMOVE AND REBUILD
Urgency of Action	PRIORITY 4
Purpose of Action	LEVEL 2
Deficiency Photo1

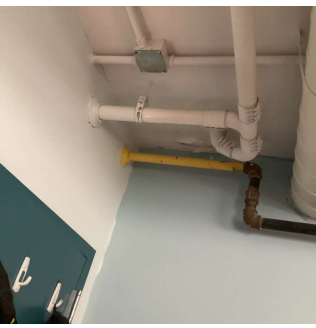
Question	Response
EXTERIOR	
ROOF	
Roofing	
ROOFING	
Deficiency	SINGLE PLY, FULLY ADHERED ROOF: ROOFING: MAJOR ACTIVE ROOF LEAKS IN INSTRUCTIONAL SPACE
Roof Plan reference

Deficiency Quantity	300
Quantity Uom	S.F.
Potential Action	REPLACE ROOFING WITHOUT MAJOR EQUIPMENT REMOVAL
Urgency of Action	PRIORITY 5
Purpose of Action	LEVEL 2
Deficiency Photo1

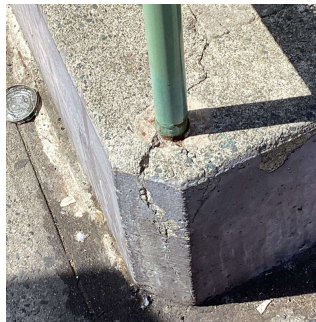
Facade A
 No violations recorded.

Condition	3 - Fair
Deficiency	CAST IN PLACE CONCRETE: CRACKS/SPALLING - MINOR

25
 S.F.
 REPAIR
 PRIORITY 3
 LEVEL 2

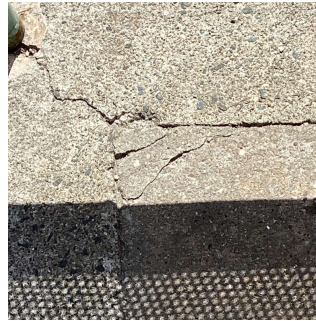
Facade A

3 - Fair
 CONCRETE: CRACKS/SPALLING - MINOR

15
 S.F.
 REPAIR
 PRIORITY 3
 LEVEL 2

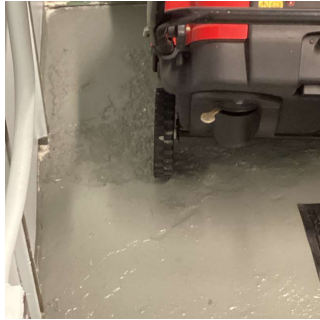
Question	Response
INTERIOR	
STRUCTURAL	
FLOOR STRUCTURE	Inspected
Condition	2 - Between Good and Fair
Deficiency	CONCRETE SLAB ON GRADE: THRU CRACKS
Deficiency Location/Instance	Basement
Deficiency Quantity	20
Quantity Uom	S.F.
Potential Action	REPAIR
Urgency of Action	PRIORITY 3
Purpose of Action	LEVEL 5
Deficiency Photo1

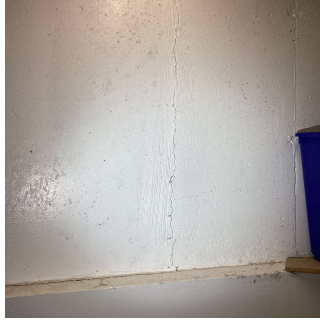
Violations	Elevator Machine Room No violations recorded.
Deficiency	CONCRETE: WATER INFILTRATION IN NON- INSTRUCTIONAL SPACE
Deficiency Location/Instance	Basement
Deficiency Quantity	100
Quantity Uom	S.F.
Potential Action	INSTALL WATERPROOFING

Violations	Electrical Panel Room No violations recorded.
FOUNDATION WALLS	Inspected
Material Type(s)	Concrete
Condition	4 - Between Fair and Poor
Deficiency	CONCRETE: CRACKED/SPALLED/REINFORCEMENT EXPOSED
Deficiency Location/Instance	Basement
Deficiency Quantity	40
Quantity Uom	S.F.
Potential Action	REPAIR
Urgency of Action	PRIORITY 3
Purpose of Action	LEVEL 5
Deficiency Photo1

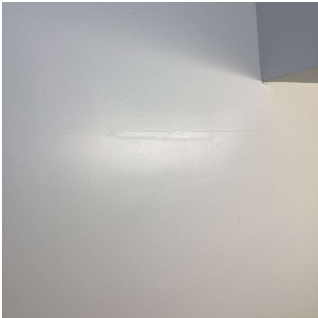
Stair C/Basement
Violations	No violations recorded.
TOILET ROOMS - STAFF	Inspected
Ceiling	Inspected
Condition	2 - Between Good and Fair
Deficiency	No deficiencies recorded

Question	Response
INTERIOR	
STAIRS/RAMPS: INTERIOR	Inspected
Do Letter Stair Signs Exist?	Yes
Ceiling	Inspected
Condition	2 - Between Good and Fair
Deficiency	No deficiencies recorded
Door(s)	Inspected
Condition	2 - Between Good and Fair
Deficiency	No deficiencies recorded
Partition	Does not Exist
Railings	Inspected
Condition	2 - Between Good and Fair
Deficiency	No deficiencies recorded
Stairs and Landings	Inspected
Condition	2 - Between Good and Fair
Deficiency	No deficiencies recorded
Walls	Inspected
Condition	2 - Between Good and Fair
Deficiency	GYP SUM BOARD: DETERIORATED
Deficiency Location/Instance	Stair C/Basement
Deficiency Quantity	10
Quantity Uom	S.F.
Potential Action	REPLACE
Urgency of Action	PRIORITY 3
Purpose of Action	LEVEL 2
Deficiency Photo1

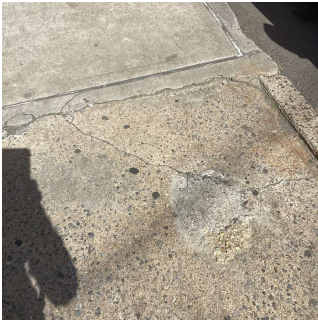
108th Street
Violations	No violations recorded.
Deficiency	DAMAGED CURBS

Question	Response
INTERIOR	Inspected
TOILET ROOMS - STUDENTS	
Walls	Inspected
Condition	2 - Between Good and Fair
Deficiency	No deficiencies recorded
LIFE SAFETY	Inspected
F.D. HOLDING AREA	Does not Exist
STEEL STAIRS	Does not Exist
SITE	Inspected
CONTAINERIZATION	Does not Exist
Drainage System for Asphalt	Does not Exist
Drainage System for Concrete	Does not Exist
Drainage System for Soil	Does not Exist
DRINKING FOUNTAINS	Does not Exist
FENCES	Does not Exist
IRRIGATION SYSTEM	Does not Exist
PAVING	Inspected
Student Non-Use	Does not Exist
Student Use	Does not Exist
Site Sidewalks & Walkways	Inspected
Asphalt	Does not Exist
Concrete	Inspected
Condition	2 - Between Good and Fair
Deficiency	No deficiencies recorded
Pavers	Does not Exist
DOT Sidewalk	Inspected
Asphalt	Does not Exist
Concrete	Inspected
Condition	3 - Fair
Deficiency	DAMAGED/DETERIORATED/MISSING SECTIONS
Deficiency Location/Instance	108th Street, Northern Boulevard

Deficiency Quantity	400
Quantity Uom	S.F.
Potential Action	REPLACE
Urgency of Action	PRIORITY 3
Purpose of Action	LEVEL 2
Deficiency Photo1
